<b>Location: Banna, Co. Kerry</b>		<b>Unique ID: 230345</b> (from PFRA database)	
<b>Initial OPW Designation</b>	<b>APSR</b> <input checked="" type="checkbox"/>	<b>AFRR</b> <input type="checkbox"/>	<b>IRR</b> <input type="checkbox"/>
<b>Co-ordinates</b>	<b>Easting: 75750</b>		<b>Northing: 123000</b>
<b>River / Catchment / Sub-catchment</b>	<b>River Tyshe / North Kerry Tralee Bay</b>		
<b>Type of Flooding / Flood Risk</b> (identify all that apply)	<b>Fluvial non-tidal</b> <input type="checkbox"/> <b>Fluvial tidal</b> <input checked="" type="checkbox"/> <b>Coastal</b> <input type="checkbox"/>

## Stage 1: Desktop Review

<b>Stage 2: Site Inspection</b>		<b>Level A Assessment</b>		
<b>Date and Time of Inspection</b>		<b>Date: 25/05/11</b>		
		<b>Time: 09:00</b>		
<b>Names of inspection team (including OPW/LA staff if present)</b>		<b>Kelly Kasperczyk</b>		
		<b>Iain Blackwell</b>		
<b>2.1 Ground-truthing of Hazard Mapping</b>	<b>Fluvial non-tidal</b> <input type="checkbox"/> <b>Fluvial tidal</b> <input checked="" type="checkbox"/> <b>Coastal</b> <input type="checkbox"/> <b>Not available</b> <input type="checkbox"/>			
	Overall, mapping appears reasonable. Visibly higher locations are

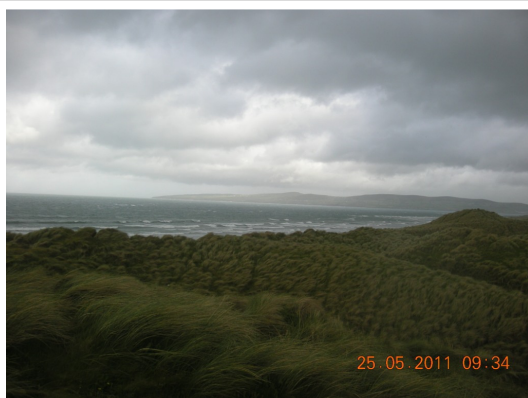
**Photo 1:** Sand dune system immediately west of Banna (looking NW) protecting inland low lying areas

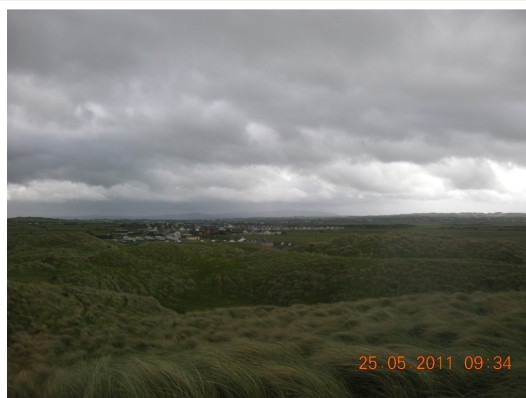
**Photo 2:** Low lying land to the east inshore of the dune system. The group of properties shown is in Banna.

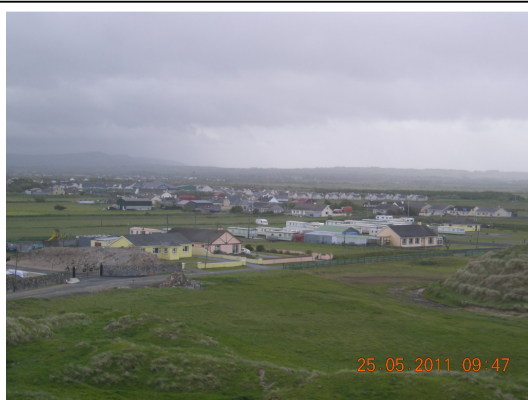
**Photo 3:** Low lying land in Banna and Banna Mountain, inshore of the dune system

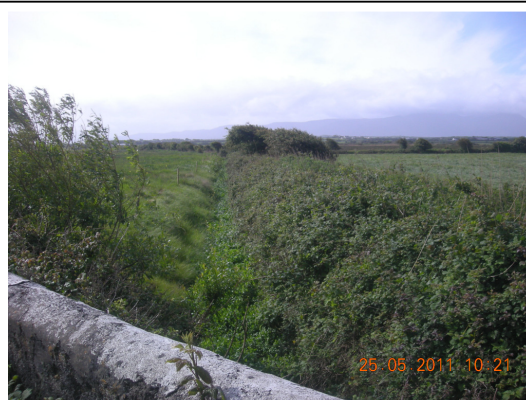
**Photo 4:** SE of Banna, part of the Akeragh drainage system looking south at the crossing of the drain at the R551 (which flows into the Tyshe River). Large storage area in the event of tide lock.

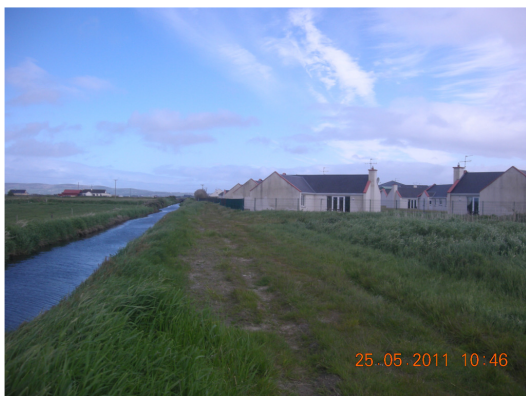
**Photo 5:** South of Banna / Banna-Mountain looking north at the Tyshe River, properties potentially at risk on the right bank

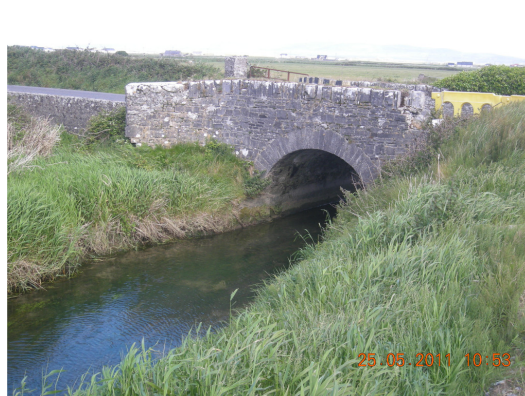
**Photo 6:** Single arch crossing of the Tyshe River looking north d/s

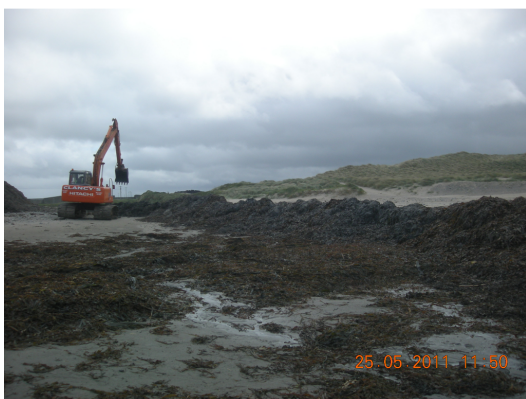
**Photo 7:** Removal of seaweed and sand from the channel entrance. Clearance works take place at least every two weeks, but this can be daily in the winter months

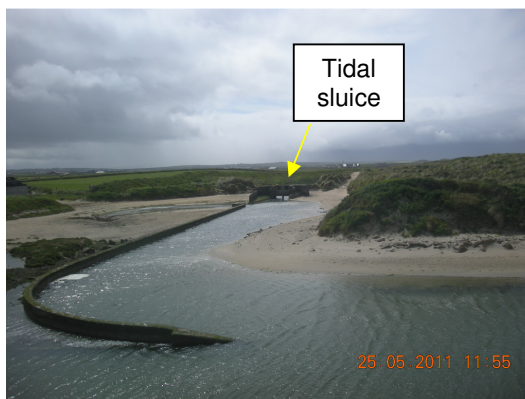
**Photo 8:** Manually operated tidal sluice structure on the Tyshe River at its outlet at Black Rock
