Location: Adare, Co. Limerick		Unique ID: 240364 (from PFRA database)	
Initial OPW Designation	APSR <input checked="" type="checkbox"/>	AFRR <input type="checkbox"/>	IRR <input type="checkbox"/>
Co-ordinates	Easting: 146500	Northing: 146750	
River / Catchment / Sub-catchment	River Maigue		
Type of Flooding / Flood Risk (identify all that apply)	Fluvial non-tidal <input checked="" type="checkbox"/> Fluvial tidal <input checked="" type="checkbox"/> Coastal <input type="checkbox"/>

Stage 2: Site Inspection		Level B Assessment	
Date and Time of Inspection		Date: 13/04/11	
		Time: 10:00	
Names of inspection team (including OPW/LA staff if present)		Iain Blackwell	
		Kelly Kasperczyk

Project	Shannon CFRAM Study Flood Risk Review Map		
Title	Adare		
Drawing Status	FINAL	Job No.	32102500
Figure No.	CAR 3	Scale	1:20,000 @ A3
Scale	1:20,000 @ A3	Author	AD/SF
		Checked	JC
		Drawn	KK/JM
		Reviewed	IB/PS
Copyright reserved Jacobs UK Ltd 95 Bothwell Street, Glasgow, G2 7HX

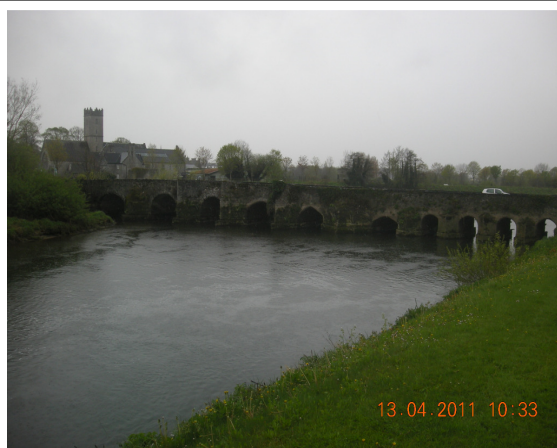
2.3 Local knowledge - on-site comments (OPW, LA and any info volunteered by local residents during visit)	No on-site comments.		
2.4 Comments on hydraulic constrictions (bridges, etc.) and conveyance routes	10-arch bridge on the Mague, next to the School and Church could potentially act as a restriction during significant fluvial flows as the arches are not large compared to the channel cross-sectional area. The tributary (watercourse A) is culverted twice in the town (twin culverts) for various road / access crossings.

Photo 1: Main bridge over the River Maigue in Adare looking d/s

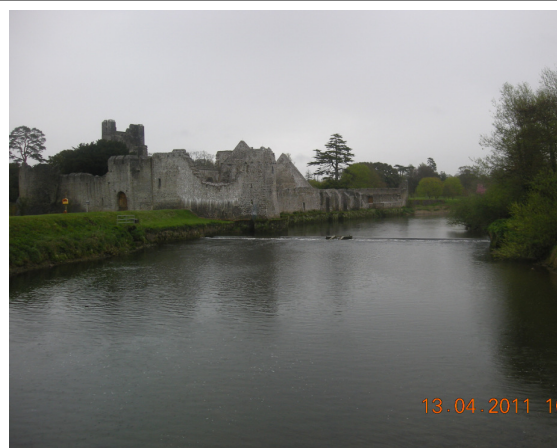
Photo 2: Adare Castle and weir looking u/s from main bridge in Adare

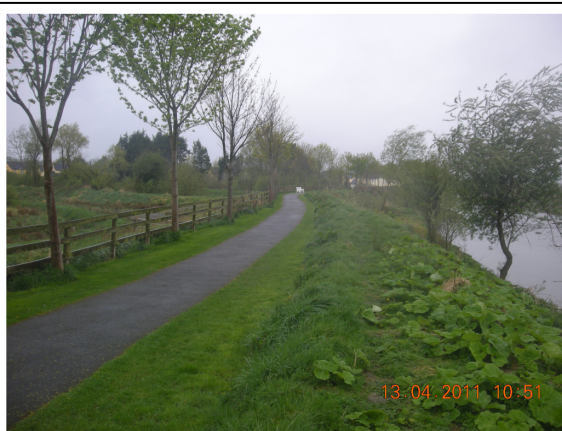
Photo 3: River Maigue embankment (left bank), d/s of main bridge

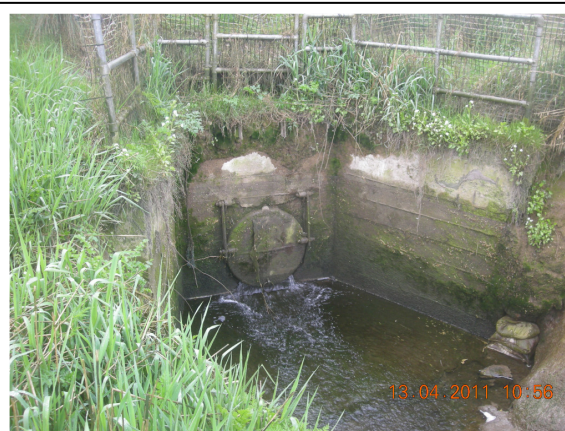
Photo 4: Typical drainage outfall through the Maigue embankments

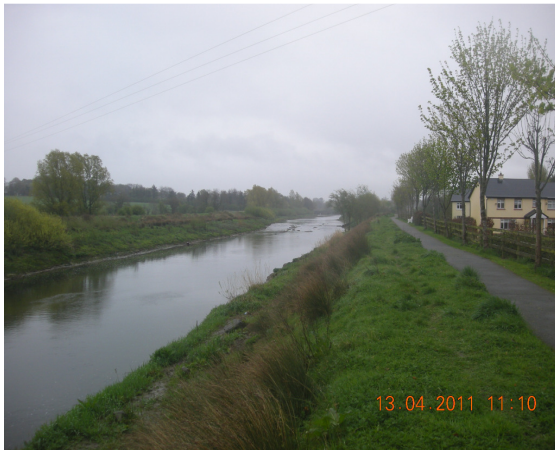
Photo 5: River Maigue embankment (left bank) protecting properties behind

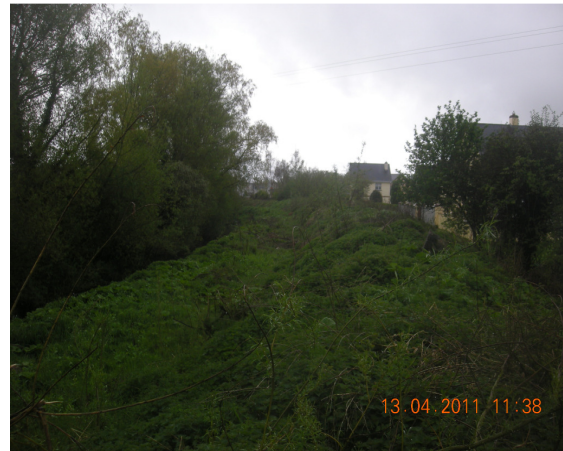
Additional notes (if required): Most FD assets in Adare are associated with the River Maigue. There is an additional tributary which flows through the centre of town and into the Maigue from the left bank which also has embankments and crossings / culverts associated with it. Some of these embankments are not effective as they are not tied into high ground (or other defences).

Photo 6: Embankment adjacent to small tributary on left bank of the River Maigue
