Location: Clarina, Co. Limerick		Unique ID: 240377 (from PFRA database)	
Initial OPW Designation	APSR <input checked="" type="checkbox"/>	AFRR <input type="checkbox"/>	IRR <input type="checkbox"/>
Co-ordinates	Easting: 150000	Northing: 154000	
River / Catchment / Sub-catchment	Barnakyle River / Maigue Catchment		
Type of Flooding / Flood Risk (identify all that apply)	Fluvial non-tidal <input checked="" type="checkbox"/> Fluvial tidal <input checked="" type="checkbox"/> Coastal <input type="checkbox"/>

Project	Shannon CFRAM Study Flood Risk Review Map		
Title	Clarina		
Drawing Status	FINAL		
Job No.	32102500		
Figure No.	CAR 22		
Scale	1:10,000 @ A3		
Drawn	AD/SF	Checked	JC
Drawn	KK/JM	Checked	IB/PS
Copyright reserved Jacobs UK Ltd 95 Bothwell Street, Glasgow, G2 7HX

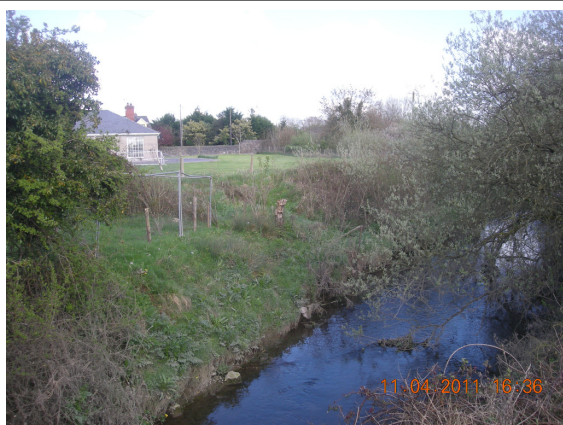
Photo 1: U/s end of Clarina on Barnakyle River, looking u/s

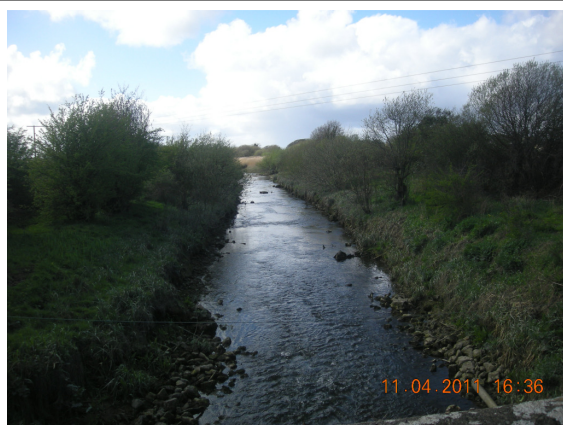
Photo 2: U/s end of Clarina on Barnakyle River, looking d/s

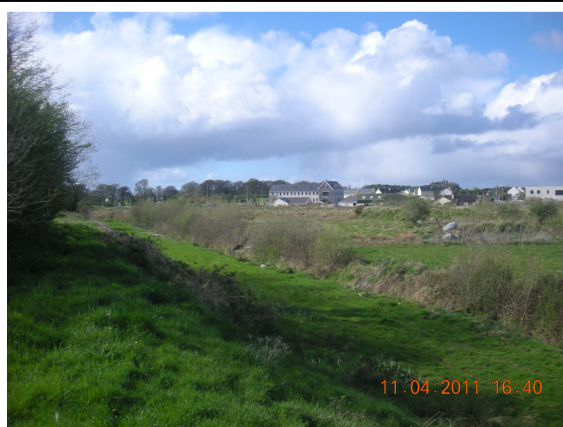
Photo 3: Looking North towards Clarinet left bank embankment in the foreground

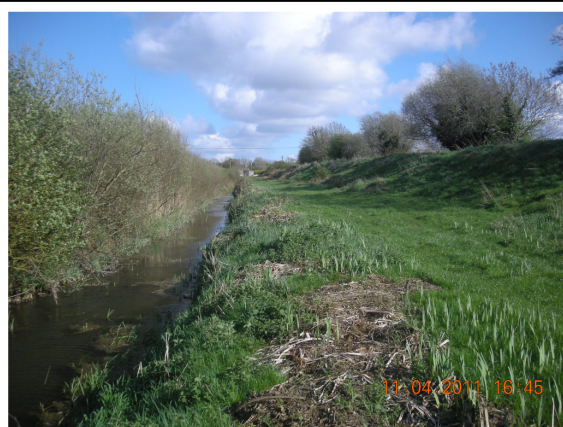
Photo 4: Back drains and embankment on right bank looking u/s

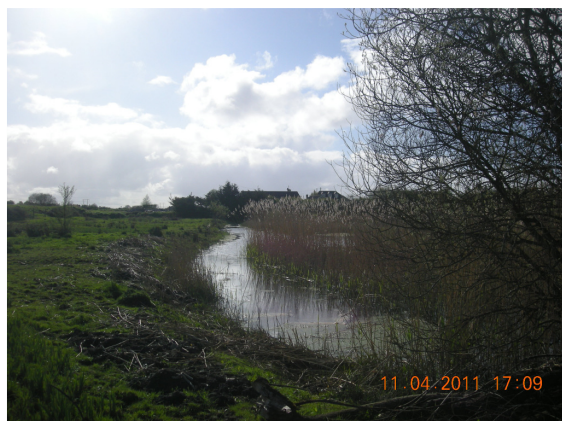
Photo 5: Drainage area and marshland on right bank looking d/s

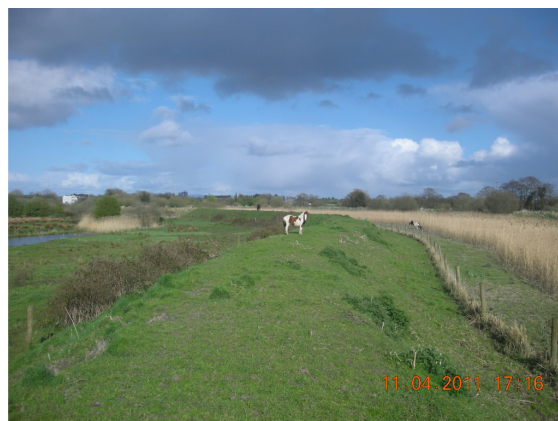
Photo 6: Typical Embankment along the River Barnakyle

2.8 Initial Potential Mitigation Measures	
Non-structural measures	Planning and Development control <input checked="" type="checkbox"/> Sustainable Urban Drainage Systems <input type="checkbox"/> Flood forecasting / warning <input type="checkbox"/> Change in Operating Procedures for water level control: <input type="checkbox"/> Public awareness campaign <input type="checkbox"/> Individual property protection <input type="checkbox"/> Land use management <input type="checkbox"/>
Structural measures	Strategic development management for floodplain development: <input checked="" type="checkbox"/> <i>(integration of measures into strategic development proposals)</i> Storage: On-line <input type="checkbox"/> Off-line <input checked="" type="checkbox"/> Flow diversion: Flood relief channel <input type="checkbox"/> Flood relief culvert <input type="checkbox"/> Increase conveyance: Bridge works <input checked="" type="checkbox"/> Channel works <input type="checkbox"/> Floodplain <input type="checkbox"/> Flood defences: Walls <input type="checkbox"/> Embankments <input checked="" type="checkbox"/> Localised works: Defence raising <input type="checkbox"/> In-fill gaps <input checked="" type="checkbox"/> Trash screen <input type="checkbox"/> Maintenance works: Culvert / channel clearance <input type="checkbox"/> Asset maintenance <input checked="" type="checkbox"/> Relocation of properties: <input type="checkbox"/> Improve existing defences: <input checked="" type="checkbox"/> (describe) Improvements to embankments may be appropriate as current side slopes are quite steep. Possible changes to embankment profile may be appropriate. Other (describe):

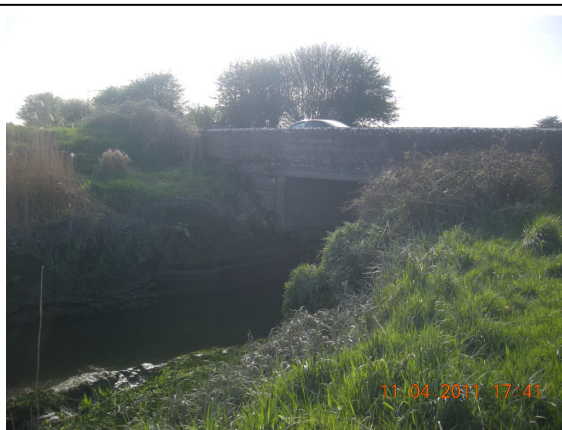
2.3 Local knowledge - on-site comments (OPW, LA and any info volunteered by local residents during visit)	No on site comments.			
2.4 Comments on hydraulic constrictions (bridges, etc.) and conveyance routes	Massey's Bridge – possible restriction on fluvial flow, exacerbated at high tide. Bridge opening is approximately 1/3 of the channel cross section. Possible low spot on the right bank at Massey's Bridge – likely that flows would be directed away from surrounding area.

Photo 7: Masseys Bridge at d/s end of Clarina

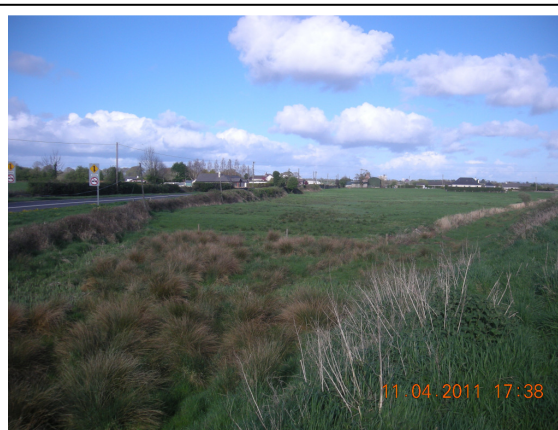
Photo 8: Road to Clarina from embankment next to Massey's Bridge
