<b>Location: Killacolla, Co. Limerick</b>		<b>Unique ID: 240386</b> (from PFRA database)	
<b>Initial OPW Designation</b>	<b>APSR</b> <input type="checkbox"/>	<b>AFRR</b> <input checked="" type="checkbox"/>	<b>IRR</b> <input type="checkbox"/>
<b>Co-ordinates</b>	<b>Easting: 148250</b>	<b>Northing: 127250</b>	
<b>River / Catchment / Sub-catchment</b>	<b>Minor tributary to the River Maigue / Maigue Catchment</b>		
<b>Type of Flooding / Flood Risk</b> (identify all that apply)	<b>Fluvial non-tidal</b> <input checked="" type="checkbox"/> <b>Fluvial tidal</b> <input type="checkbox"/> <b>Coastal</b> <input type="checkbox"/>

<b>Stage 2: Site Inspection</b>		<b>Level A Assessment</b>		
<b>Date and Time of Inspection</b>		<b>Date: 31/03/11</b>		
		<b>Time: 11:00</b>		
<b>Names of inspection team (including OPW/LA staff if present)</b>		<b>Iain Blackwell</b>		
		<b>Kelly Kasperczyk</b>		
<b>2.1 Ground-truthing of Hazard Mapping</b>	<b>Fluvial non-tidal</b> <input checked="" type="checkbox"/> <b>Fluvial tidal</b> <input type="checkbox"/> <b>Coastal</b> <input type="checkbox"/> <b>Not available</b> <input type="checkbox"/>			
	Area under consideration is very localised hence the detailed accur

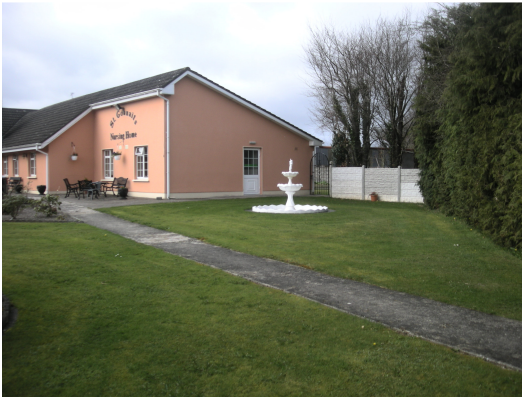
**Photo 1:** St. Gobnait's Nursing Home - watercourse located behind the hedge on the right

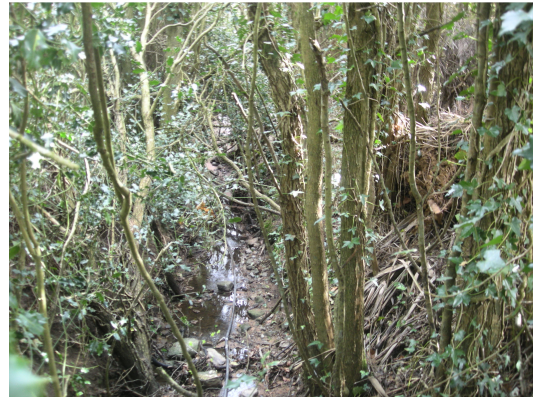
**Photo 2:** Small watercourse adjacent to Nursing Home on the right bank d/s

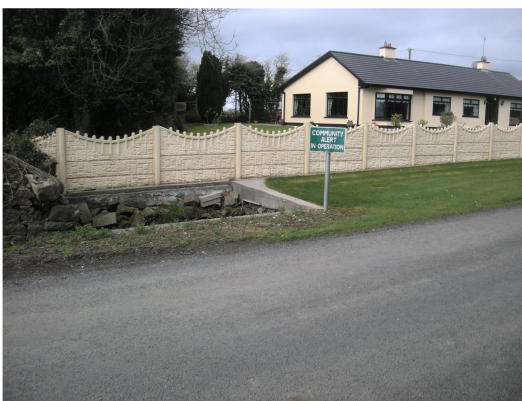
**Photo 3:** Property adjacent to the watercourse on the lower left bank

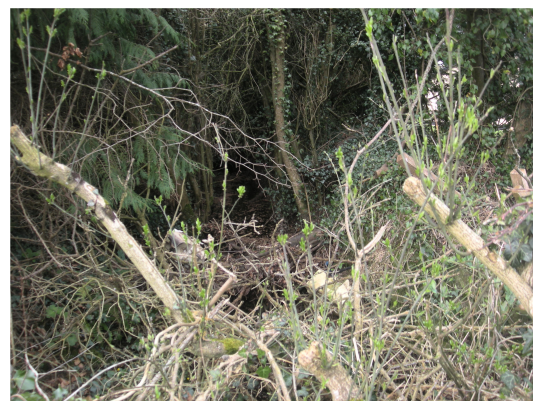
**Photo 4:** Ditch adjacent to the nursing home is not maintained
