Location: Ahascragh, Co. Galway		Unique ID: 263,234 (from PFRA database)	
Initial OPW Designation	APSR <input type="checkbox"/>	AFRR <input checked="" type="checkbox"/>	IRR <input type="checkbox"/>
Co-ordinates	Easting: 178,025	Northing: 239,014	
River / Catchment / Sub-catchment	Ahascragh River / Bunowen River / River Suck		
Type of Flooding / Flood Risk (identify all that apply)	Fluvial non-tidal <input checked="" type="checkbox"/> Fluvial tidal <input type="checkbox"/> Coastal <input type="checkbox"/>

Stage 2: Site Inspection		Level A Assessment		
Date and Time of Inspection		Date: 26/05/11		
		Time: 10:45		
Names of inspection team (including OPW/LA staff if present)		Alan Dew		
		Peter Smyth

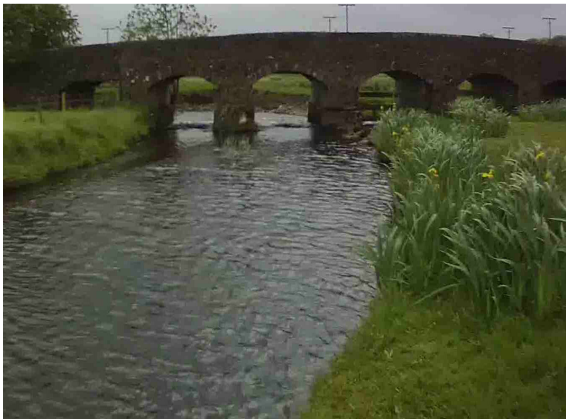
2.4 Comments on hydraulic constrictions (bridges, etc.) and conveyance routes	<p>The R358 bridge has 6 arches, of which 2 are used by the main channel. The remaining arches are partly blocked by fences to prevent livestock access and would easily block during flood events. However, no flooding was recalled upstream of the bridge in 2009 by Dermot at Greene's Hardware.</p> <p>Possible flood embankments upstream (formal or informal) noted on plans; however these could not be inspected.</p> <p>The soffit level of the Mill Race culvert beneath the R358 is below the channel walls on both banks.</p>

Photo 1: Main road bridge over the Ahascragh River looking downstream from the right bank.

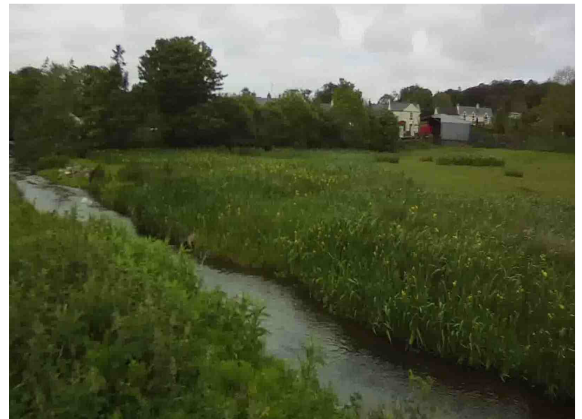
Photo 2: Right bank of the mill race looking upstream from the hardware store site.

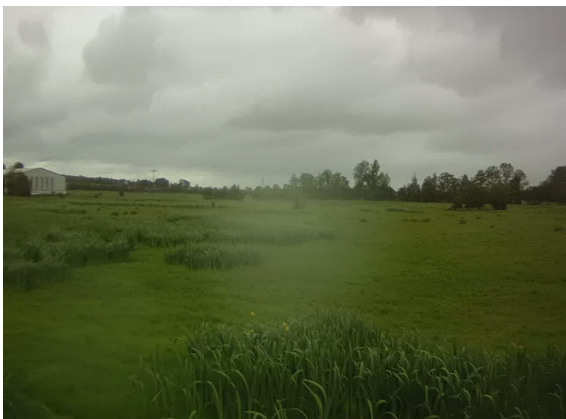
Photo 3: View from the main road bridge over the Ahascragh River towards the hardware store site.
