Location: Banagher, Co. Offaly, includes townland in Co. Galway		Unique ID: 252835 (from PFRA database)	
Initial OPW Designation	APSR <input type="checkbox"/>	AFRR <input checked="" type="checkbox"/>	IRR <input type="checkbox"/>
Co-ordinates	Easting: 200915	Northing: 215334	
River / Catchment / Sub-catchment	River Shannon / Shannon		
Type of Flooding / Flood Risk (identify all that apply)	Fluvial non-tidal <input checked="" type="checkbox"/> Fluvial tidal <input type="checkbox"/> Coastal <input type="checkbox"/>

Stage 2: Site Inspection		Level A Assessment		
Date and Time of Inspection		Date: 06/05/11		
		Time: 09:00		
Names of inspection team (including OPW/LA staff if present)		James Murray		
		Peter Smyth

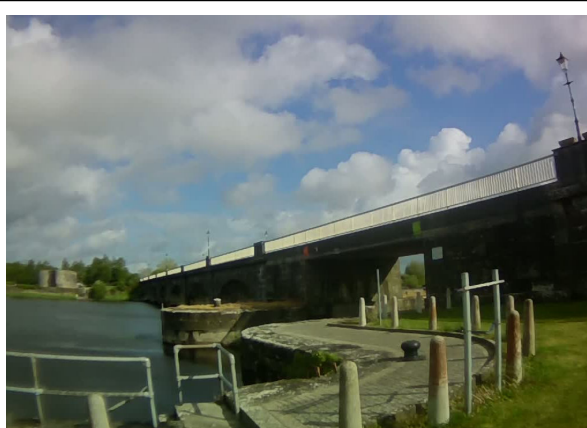
2.4 Comments on hydraulic constrictions (bridges, etc.) and conveyance routes	The bridge over the Shannon is a large multi arch bridge (six arches) raised to accommodate navigation. It could cause minimal hydraulic constriction but afflux is possible due to piers. The springing and soffit levels are very high. The bridge was built in 1843 and refurbished in 1971

Photo 1: Downstream view of bridge from left bank.

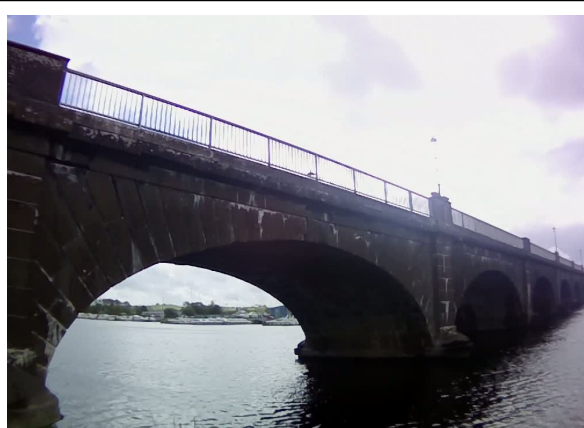
Photo 2: Downstream view of bridge from right bank.

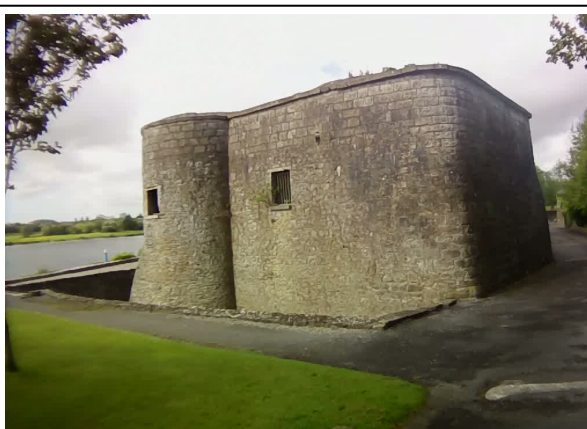
2.2 Spot check ground-truthing of selected receptor vulnerability (also note any key receptors noted during visit that are not identified by PFRA)	Receptor Type	Location description (if not obvious)	Exists?	Overall Vulnerability / Risk (L / M / H)
	Castle	On right bank downstream of bridge over the Shannon	Yes	Medium

Photo 3: Castle on right bank downstream of bridge over the Shannon.

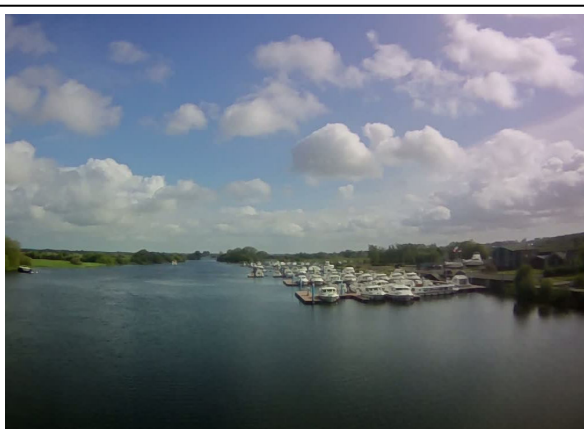
Photo 4: View from bridge looking upstream.
