Location: Kilrush, Co. Clare		Unique ID: 270476 (from PFRA database)	
Initial OPW Designation	APSR <input checked="" type="checkbox"/>	AFRR <input type="checkbox"/>	IRR <input type="checkbox"/>
Co-ordinates	Easting: 99458	Northing: 155376	
River / Catchment / Sub-catchment	Wood River / Shannon Estuary North		
Type of Flooding / Flood Risk (identify all that apply)	Fluvial non-tidal <input checked="" type="checkbox"/> Fluvial tidal <input type="checkbox"/> Coastal <input type="checkbox"/>

Stage 2: Site Inspection		Level A Assessment		
Date and Time of Inspection		Date: 08/06/11		
		Time: 17:10		
Names of inspection team (including OPW/LA staff if present)		Iain Blackwell		
		Lewis Maani

Project	Shannon CFRAM Study Flood Risk Review Map		
Title	Kiltrush		
Drawing Status	FINAL		
Job No.	32102500		
Figure No.	CAR 36		
Scale	1:15,000 @ A3		
Drawn	AD/SF	Checked	JC
Drawn	KK/JM	Checked	IB/PS
Copyright reserved Jacobs UK Ltd 95 Bothwell Street, Glasgow, G2 7HX

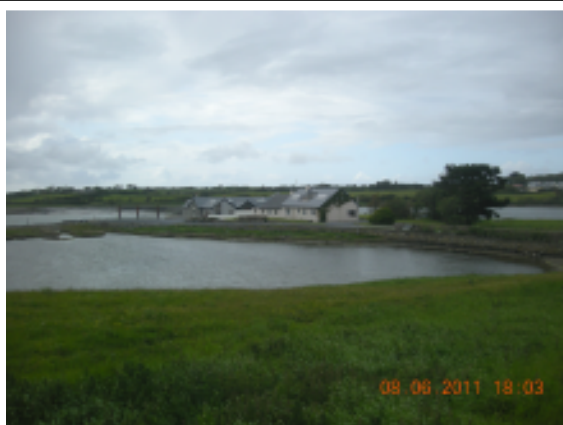
Photo 1: Entrance to Kilrush Creek. Tidal lock is located behind this property

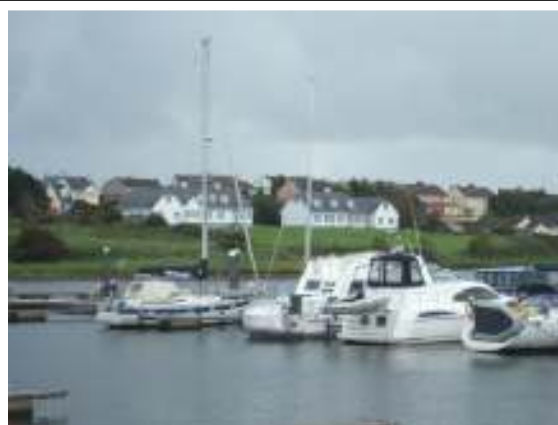
Photo 2: Properties to the south of Kilrush Creek (now forming the Marina) located on high ground

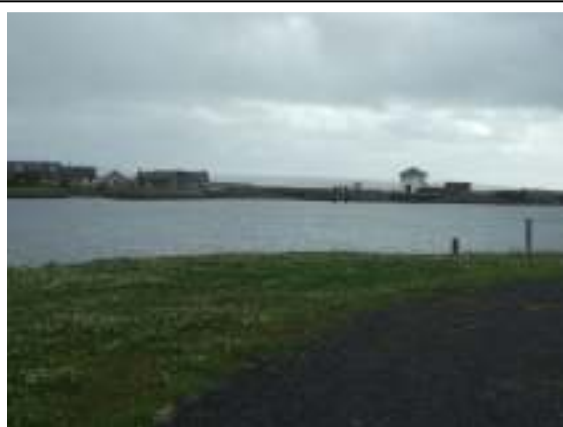
2.3 Local knowledge - on-site comments (OPW, LA and any info volunteered by local residents during visit)	No on site comments			
2.4 Comments on hydraulic constrictions (bridges, etc.) and conveyance routes	Tidal lock present at marina entrance maintains a constant level in the marina. The Wood River discharges into this water-level controlled creek. Single arch bridge on Cappa Road (where the Wood River flows into Kilrush Creek) may present a hydraulic restriction. Multi-arch bridge on Steward Street presents a restriction for the Wood River.

Photo 3: Tidal lock at the entrance to Kilrush Marina

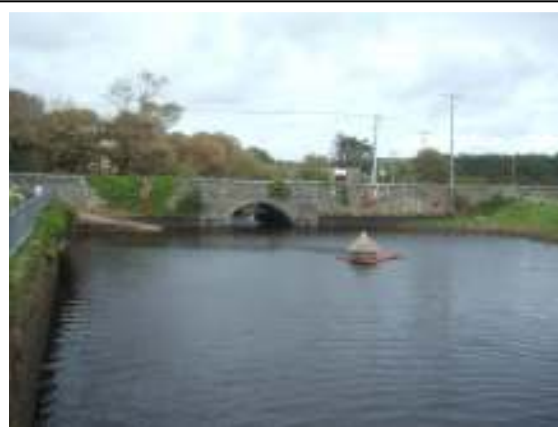
Photo 4: Bridge at the downstream end of the Wood River where it flows into Kilrush Creek

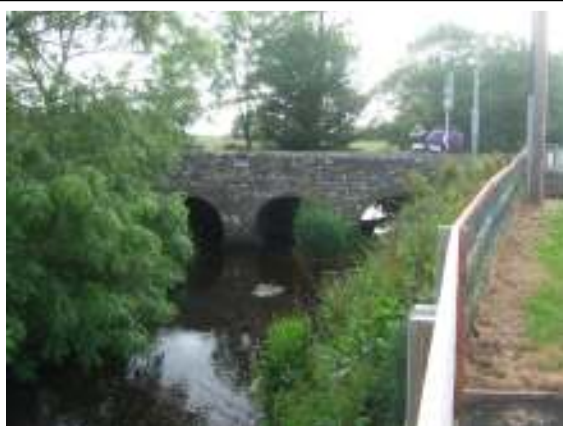
Photo 5: Multi-arch bridge crossing of the Wood River at Steward Street

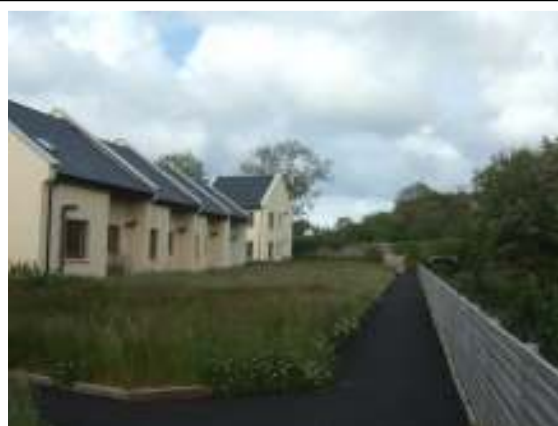
Photo 6: Kilrush Nursing Home on the right bank. Wood River is located to the right of the fence, looking upstream

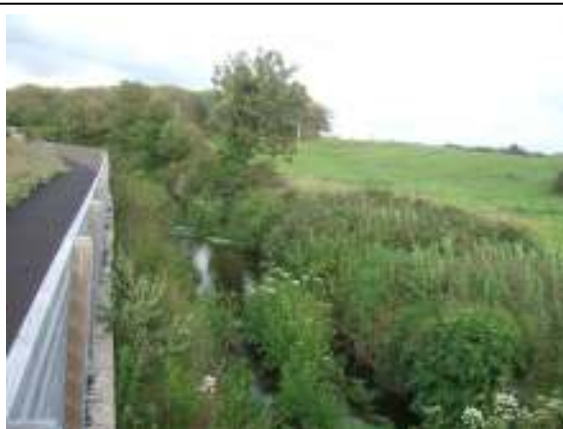
Photo 7: Wood River adjacent to Kilrush Nursing Home

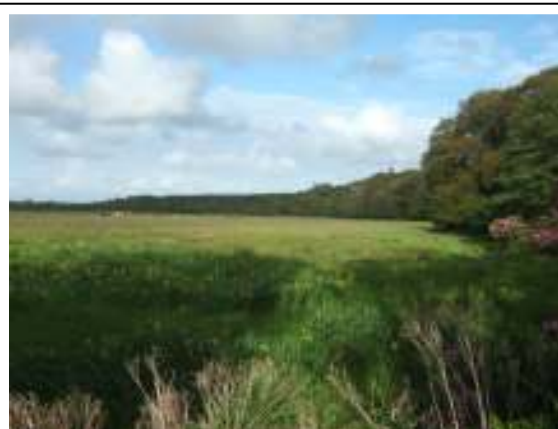
Photo 8: Floodplain on the right bank upstream of Kilrush
