<b>Location: Carrowmore, Co. Clare</b>		<b>Unique ID: 280484</b> (from PFRA database)	
<b>Initial OPW Designation</b>	<b>APSR</b> <input checked="" type="checkbox"/>	<b>AFRR</b> <input type="checkbox"/>	<b>IRR</b> <input type="checkbox"/>
<b>Co-ordinates</b>	<b>Easting: 98741</b>		<b>Northing: 166936</b>
<b>River / Catchment / Sub-catchment</b>	<b>Skivileen River/ Inagh Catchment</b>		
<b>Type of Flooding / Flood Risk</b> (identify all that apply)	<b>Fluvial non-tidal</b> <input type="checkbox"/> <b>Fluvial tidal</b> <input checked="" type="checkbox"/> <b>Coastal</b> <input type="checkbox"/>

## Stage 1: Desktop Review

<b>Stage 2: Site Inspection</b>		<b>Level A Assessment</b>		
<b>Date and Time of Inspection</b>		<b>Date: 08/06/11</b>		
		<b>Time: 12:00</b>		
<b>Names of inspection team (including OPW/LA staff if present)</b>		<b>Iain Blackwell</b>		
		<b>Lewis Maani</b>		
<b>2.1 Ground-truthing of Hazard Mapping</b>	<b>Fluvial non-tidal</b> <input type="checkbox"/> <b>Fluvial tidal</b> <input checked="" type="checkbox"/> <b>Coastal</b> <input type="checkbox"/> <b>Not available</b> <input type="checkbox"/>			
	Outline appears to be reasonable for most areas. However, the accommod

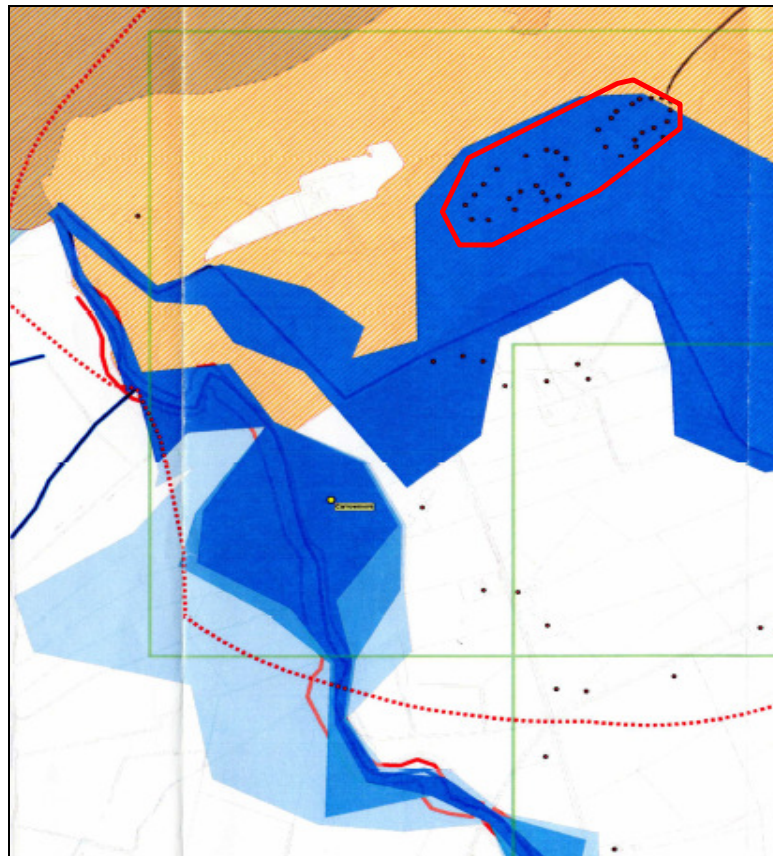
There is very little at risk of flooding – just a handful of properties at relatively low risk. The golf club and associated accommodation is elevated well above the surrounding floodplain. The 30+ properties shown as being at risk of flooding on the PFRA map (when overlaid with the Geo-directory database) is considered to be an over-estimate of the flood outline. OPW noted that the golf club was requested to build the properties elevated, which has been done. All of these are about 1.5 to 2.0m above the surrounding flood plain. As these properties contribute significantly to the PFRA FRI score, the removal of the properties would dramatically reduce FRI score.

The location of these 30+ properties is shown in the red outline on the figure below.

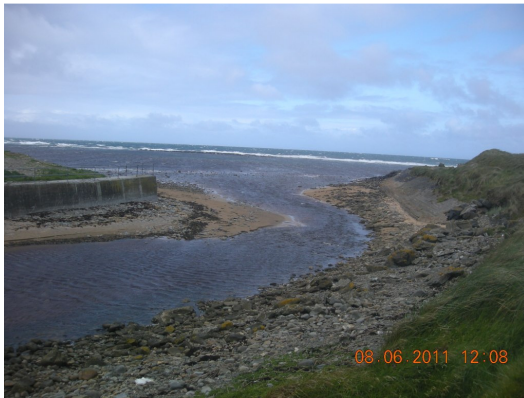
**Photo 1:** The mouth of the Skivileen river

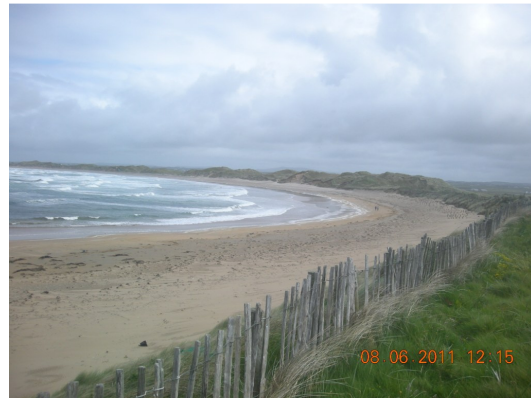
**Photo 2:** Extensive length and height of dune system protecting Carrowmore from coastal flooding.

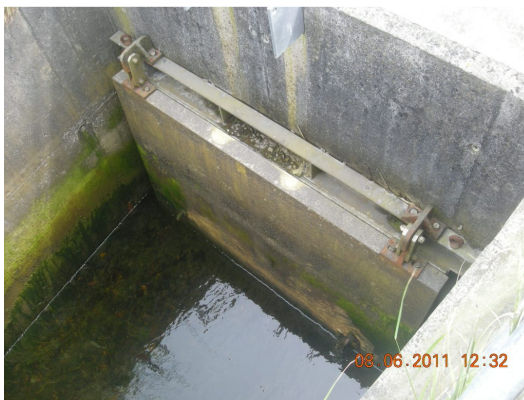
**Photo 3:** Tidal flap on a tributary to the Skivileen River on the right bank, close to the river mouth.

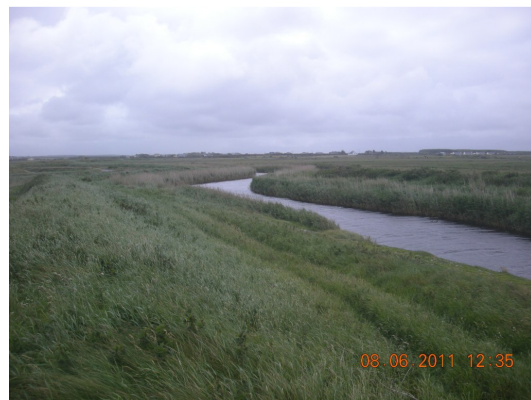
**Photo 4:** Skivileen River looking inland, flowing through a very flat area with raised embankments on both sides of the river.

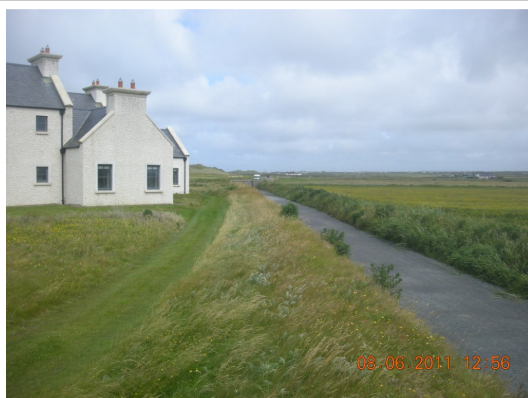
**Photo 5:** Golf club residences (30+ properties) all located 1.5m to 2m above the surrounding flood plain (to the right of the road).

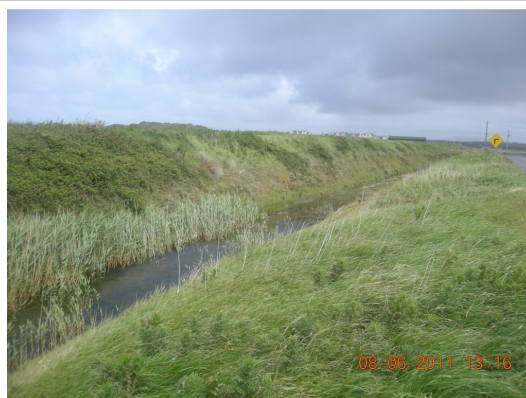
**Photo 6:** Back drain adjacent to the embankment on the right bank.

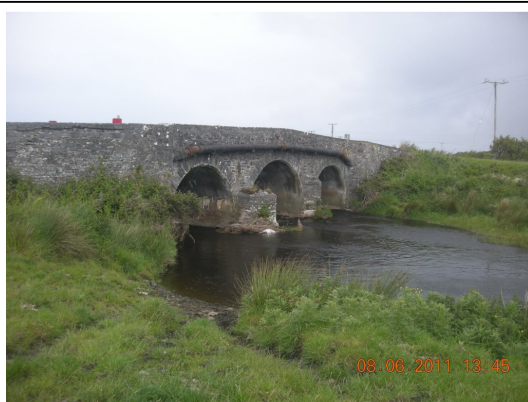
**Photo 7:** Upstream side of the bridge over the Skivileen River on the N67 south of Carrowmore (in Caherfeenick South).

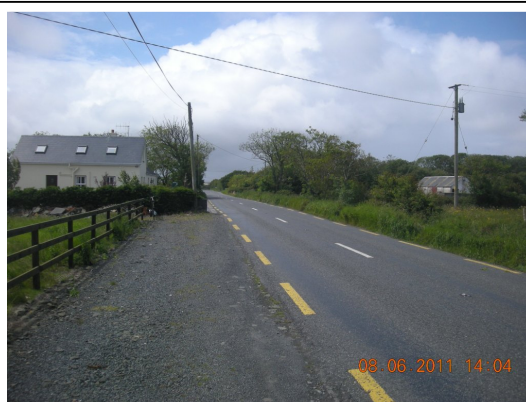
Clare County Council noted that there are flooding problems on the N67 just to the east of the small road leading to Carrowmore. On inspection, this is considered to be surface water flooding. The area is very flat, but also elevated up to 2m above the N67 road level at the crossing of the Skivleen River. Hence, this reported regular flooding of the road is considered to be a surface water / land drainage issue rather than fluvial flooding.

**Photo 8:** N67 just east of the crossing of the Skivileen River. This road is approximately 2m higher than the road level at the bridge crossing. Flooding here is considered to be surface water and land drainage related, rather than fluvial.
