Location: Lisselton, Co. Kerry		Unique ID: 230356 (from PFRA database)	
Initial OPW Designation	APSR <input type="checkbox"/>	AFRR <input checked="" type="checkbox"/>	IRR <input type="checkbox"/>
Co-ordinates	Easting: 92937	Northing: 138577	
River / Catchment / Sub-catchment	Cashen River/ Feale Catchment		
Type of Flooding / Flood Risk (identify all that apply)	Fluvial non-tidal <input checked="" type="checkbox"/> Fluvial tidal <input type="checkbox"/> Coastal <input type="checkbox"/>

Stage 2: Site Inspection		Level A Assessment		
Date and Time of Inspection		Date: 26/05/2011		
		Time: 14:30		
Names of inspection team (including OPW/LA staff if present)		Iain Blackwell		
		Kelly Kasperczyk

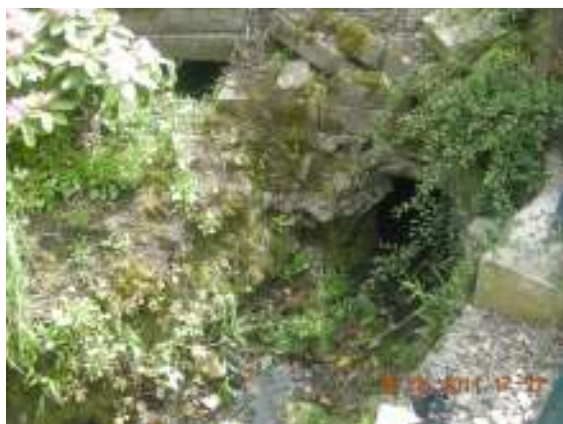
Photo 1: Small watercourse east of Lisselton Village

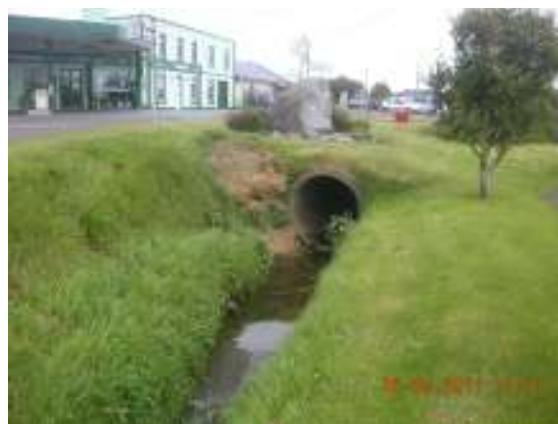
Photo 2: Small watercourse west of Lisselton Village

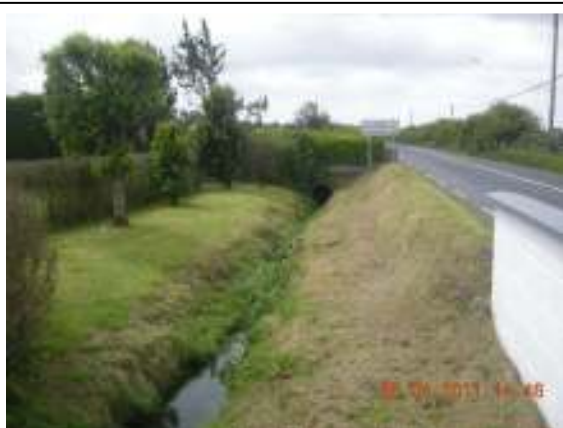
2.4 Comments on hydraulic constrictions (bridges, etc.) and conveyance routes	The stream adjacent to the school is culverted under the crossroads at Lisselton village centre. This culvert opens u/s of the school to the south of the R554 and running parallel to it. As this stream flows past the school, it is crossed by 3 box culvert bridges (access to/from the school). The stream is then culverted again under the front gardens of the four properties west of the School. The culvert opens to the west of the last property. If these culverts were blocked, there is potential for water to enter the school grounds at high flows. The conveyance route for the water would be to the south across expansive flat areas.

Photo 3: Watercourse adjacent to the R554 with several crossings and partially culverted, east of Lisselton Village

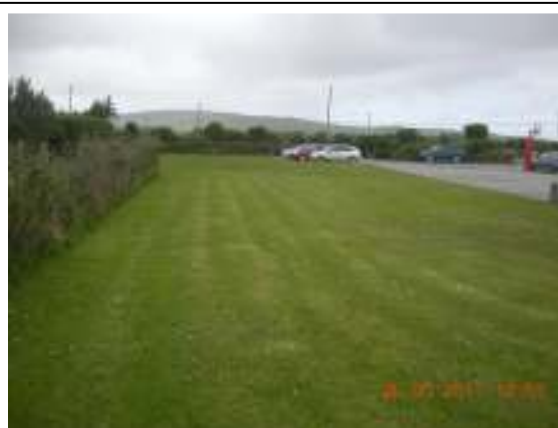
2.3 Local knowledge - on-site comments (OPW, LA and any info volunteered by local residents during visit)	School Principal: Water from the stream in front of the school reached the school yard once in 20 years. This did not 'flood' the school yard and did not reach the school building. Water did not reach the road (R554).

Photo 4: Looking north towards the watercourse (and road) large green area adjacent to school which is on the right

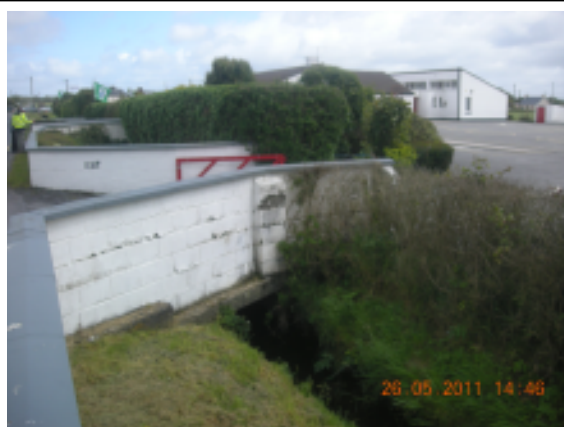
Photo 5: Access crossing to the school

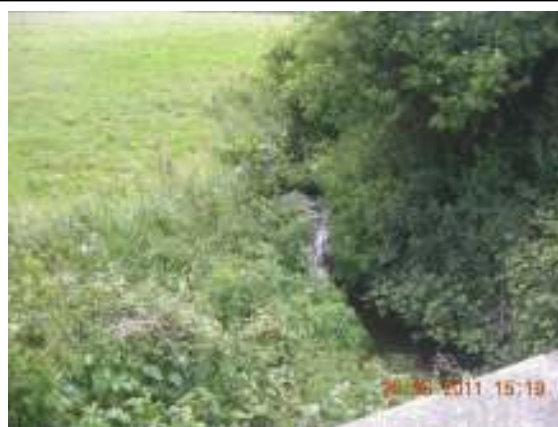
Photo 6: Water course extreme west of the study area
