Location: Moneycashen, Co. Kerry		Unique ID: 232679 (from PFRA database)	
Initial OPW Designation	APSR <input type="checkbox"/>	AFRR <input checked="" type="checkbox"/>	IRR <input type="checkbox"/>
Co-ordinates	Easting: 85964	Northing: 137951	
River / Catchment / Sub-catchment	River Cashen / Feale Catchment		
Type of Flooding / Flood Risk (identify all that apply)	Fluvial non-tidal <input type="checkbox"/> Fluvial tidal <input checked="" type="checkbox"/> Coastal <input checked="" type="checkbox"/>

Stage 2: Site Inspection		Level A Assessment		
Date and Time of Inspection		Date: 13/05/11		
		Time: 14:00		
Names of inspection team (including OPW/LA staff if present)		Mathieu Valois		
		Kelly Kasperczyk

Project	Shannon CFRAM Study Flood Risk Review Map
Title	Moneycashen
Drawing Status	FINAL
Job No.	32102500
Figure No.	AFRR34
Scale	1:10,000 @ A3
Drawn	AD/SF
Checked	JC
Reviewed	KK/JM
Approved	IB/PS
Copyright reserved Jacobs UK Ltd 95 Bothwell Street, Glasgow, G2 7HX

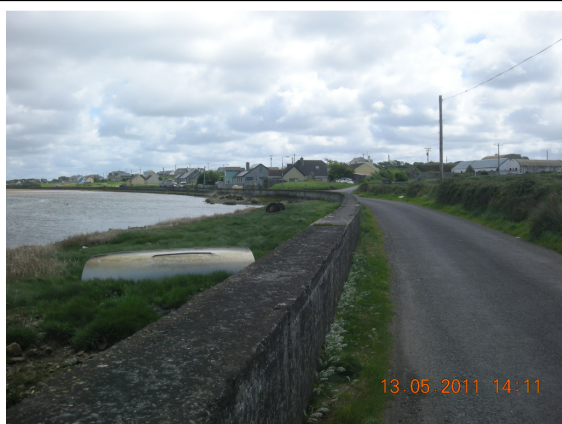
Photo 1: Sea wall protecting properties from wave overtopping

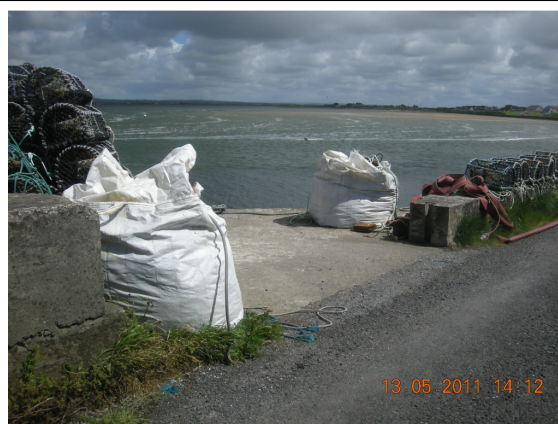
<p>Outfalls</p> <p>Flapped outfall(s) into watercourse <input type="checkbox"/> Unflapped outfall(s) into watercourse <input type="checkbox"/> <i>i.e. from smaller watercourses, drains etc. into river / estuary / sea</i></p> <p>Tidal flap(s) <input type="checkbox"/> Tidal sluice(s) <input type="checkbox"/> <i>i.e. from main watercourse into estuary / sea</i></p> <p>Other</p> <p>Pumping Station <input type="checkbox"/> Erosion Protection <input type="checkbox"/> Sand Dunes <input type="checkbox"/></p> <p>Additional notes (if required):</p> <p>Sea wall starts at Knoppoge junction at the sand dunes and extends west to the pier where there is a gap providing access to fishing pots/traps stored here. Gap is approx 3m long. The sea wall then extends towards the second last house to the west.</p>

Photo 2: Gap in the seawall defence

2.8 Initial Potential Mitigation Measures	
Non-structural measures	<p>Planning and Development control <input type="checkbox"/></p> <p>Sustainable Urban Drainage Systems <input type="checkbox"/></p> <p>Flood forecasting / warning <input checked="" type="checkbox"/></p> <p>Change in Operating Procedures for water level control: <input type="checkbox"/></p> <p>Public awareness campaign <input type="checkbox"/></p> <p>Individual property protection <input type="checkbox"/></p> <p>Land use management <input type="checkbox"/></p>
Structural measures	<p>Strategic development management for floodplain development: <input type="checkbox"/> <i>(integration of measures into strategic development proposals)</i></p> <p>Storage: On-line <input type="checkbox"/> Off-line <input type="checkbox"/></p> <p>Flow diversion: Flood relief channel <input type="checkbox"/> Flood relief culvert <input type="checkbox"/></p> <p>Increase conveyance: Bridge works <input type="checkbox"/> Channel works <input type="checkbox"/> Floodplain <input type="checkbox"/></p> <p>Flood defences: Walls <input checked="" type="checkbox"/> Embankments <input type="checkbox"/></p> <p>Localised works: Defence raising <input checked="" type="checkbox"/> In-fill gaps <input checked="" type="checkbox"/> Trash screen <input type="checkbox"/></p> <p>Maintenance works: Culvert / channel clearance <input type="checkbox"/> Asset maintenance <input type="checkbox"/></p> <p>Relocation of properties: <input type="checkbox"/></p> <p>Improve existing defences: <input type="checkbox"/> (describe)</p> <p>Other (describe):</p> <p>Improve surface water drainage system to alleviate trapped water after wave overtopping, allowing water to drain through the sea wall.</p> <p>The gap in the defences at the west end (approx. 3m) is required for fishing related activities. Could consider a gate or removable flood boards / stoplogs at this location to avoid interfering with fishing / quay activities.</p>

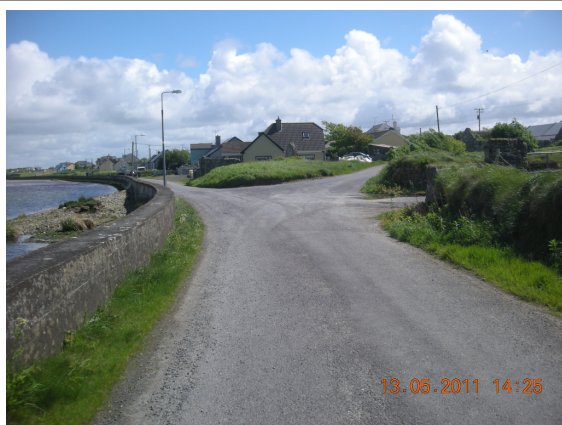
Photo 3: Location of potential road flooding at Cloghane

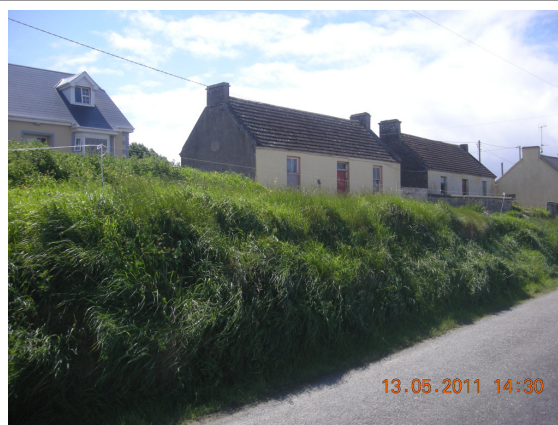
Photo 4: Looking west, start of elevated properties behind the sea wall

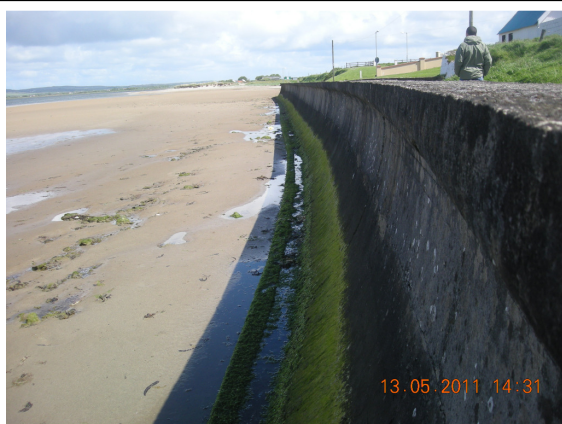
Photo 5: Sea wall height, properties higher in the background

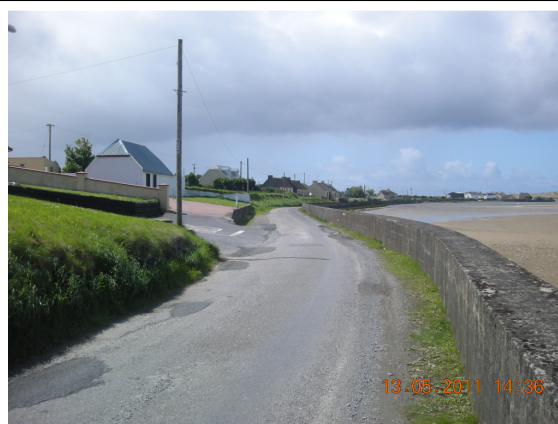
Photo 6: Looking west the road runs along the length of the sea wall near Knoppoge. This road has previously flooded as water becomes trapped behind the sea wall
