Location: Charleville, Co. Cork		Unique ID: 240375 (from PFRA database)	
Initial OPW Designation	APSR <input checked="" type="checkbox"/>	AFRR <input type="checkbox"/>	IRR <input type="checkbox"/>
Co-ordinates	Easting: 152250	Northing: 122500	
River / Catchment / Sub-catchment	Glen River / Maigne Catchment		
Type of Flooding / Flood Risk (identify all that apply)	Fluvial non-tidal <input checked="" type="checkbox"/> Fluvial tidal <input type="checkbox"/> Coastal <input type="checkbox"/>

Stage 2: Site Inspection		Level A Assessment		
Date and Time of Inspection		Date: 30/03/11		
		Time: 13:45		
Names of inspection team (including OPW/LA staff if present)		Iain Blackwell		
		Kelly Kasperczyk

Project	Shannon CFRAM Study Flood Risk Review Map
Title	Charleville
Drawing Status	FINAL
Job No.	32102500
Figure No.	CAR 20
Scale	1:20,000 @ A3
Date	Jun 27, 2011
Drawn	AD/SF
Checked	JC
Reviewed	KK/JM
Approved	IB/PS
Copyright reserved Jacobs UK Ltd 95 Bothwell Street, Glasgow, G2 7HX

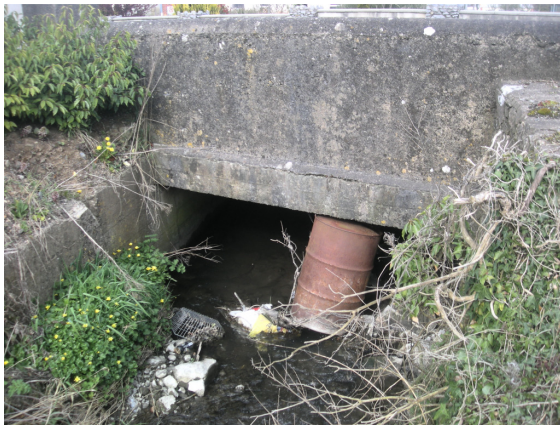
Photo 1: Culvert west of Charleville requiring maintenance

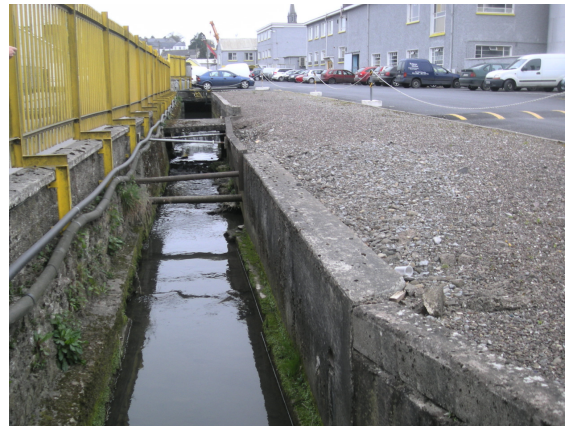
Photo 2: Channel along Chapel Street u/s at culvert exit with props for support

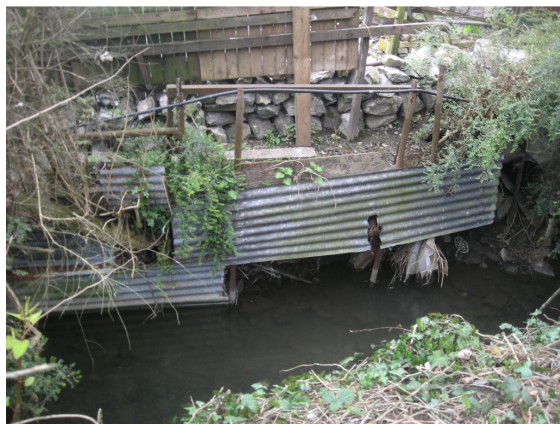
Photo 3: Charleville channel adjacent to the Health Centre on Chapel Street

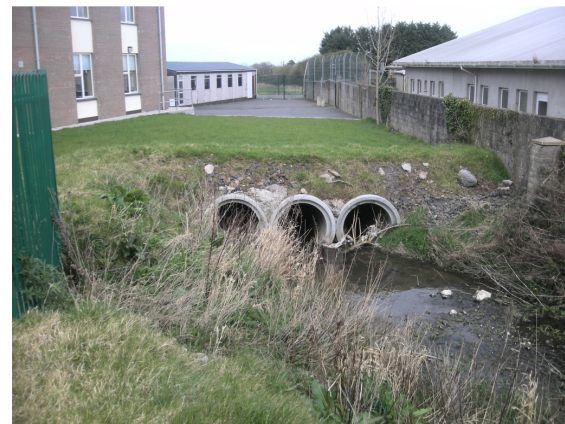
Photo 4: Triple culvert in school grounds, under new playground area. 90 degree bend in 3 culverts under playground.
