Location: Kildimo New, Co. Limerick		Unique ID: 240385 (from PFRA database)	
Initial OPW Designation	APSR <input checked="" type="checkbox"/>	AFRR <input type="checkbox"/>	IRR <input type="checkbox"/>
Co-ordinates	Easting: 145250	Northing: 152750	
River / Catchment / Sub-catchment	Unnamed tributary of the Maigue / Maigue Catchment		
Type of Flooding / Flood Risk (identify all that apply)	Fluvial non-tidal <input checked="" type="checkbox"/> Fluvial tidal <input checked="" type="checkbox"/> Coastal <input type="checkbox"/>

Stage 2: Site Inspection		Level A Assessment		
Date and Time of Inspection		Date: 13/04/11 and 08/09/11		
		Time: 18:00 and 10:00		
Names of inspection team (including OPW/LA staff if present)		Iain Blackwell (13/04/11)		
		Kelly Kasperczyk (13/04/11)		
		Iain Blackwell (08/09/11)		
		Peter Smyth (08/09/11)

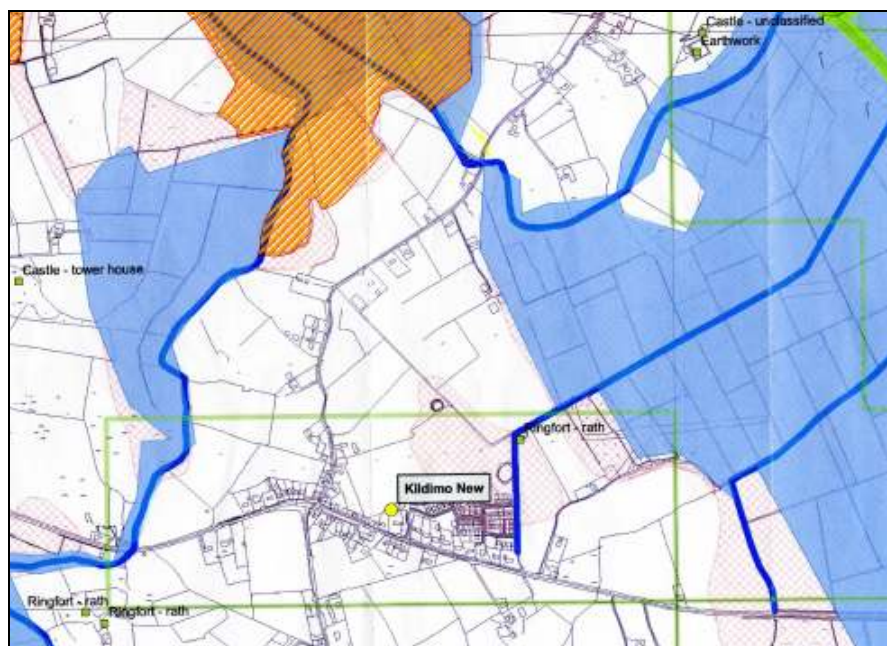
The flood mapping extents appear reasonable, reflecting the topography of the area, with Kildimo New itself being located on slightly raised ground. This is apparent from the flood mapping shown below, where the blue shaded area is from the PFRA mapping, strongly reflecting the location of the low lying land. The plan on the following page shows a colour coded relief plan of the area between Kildimo New and the River Maigue.

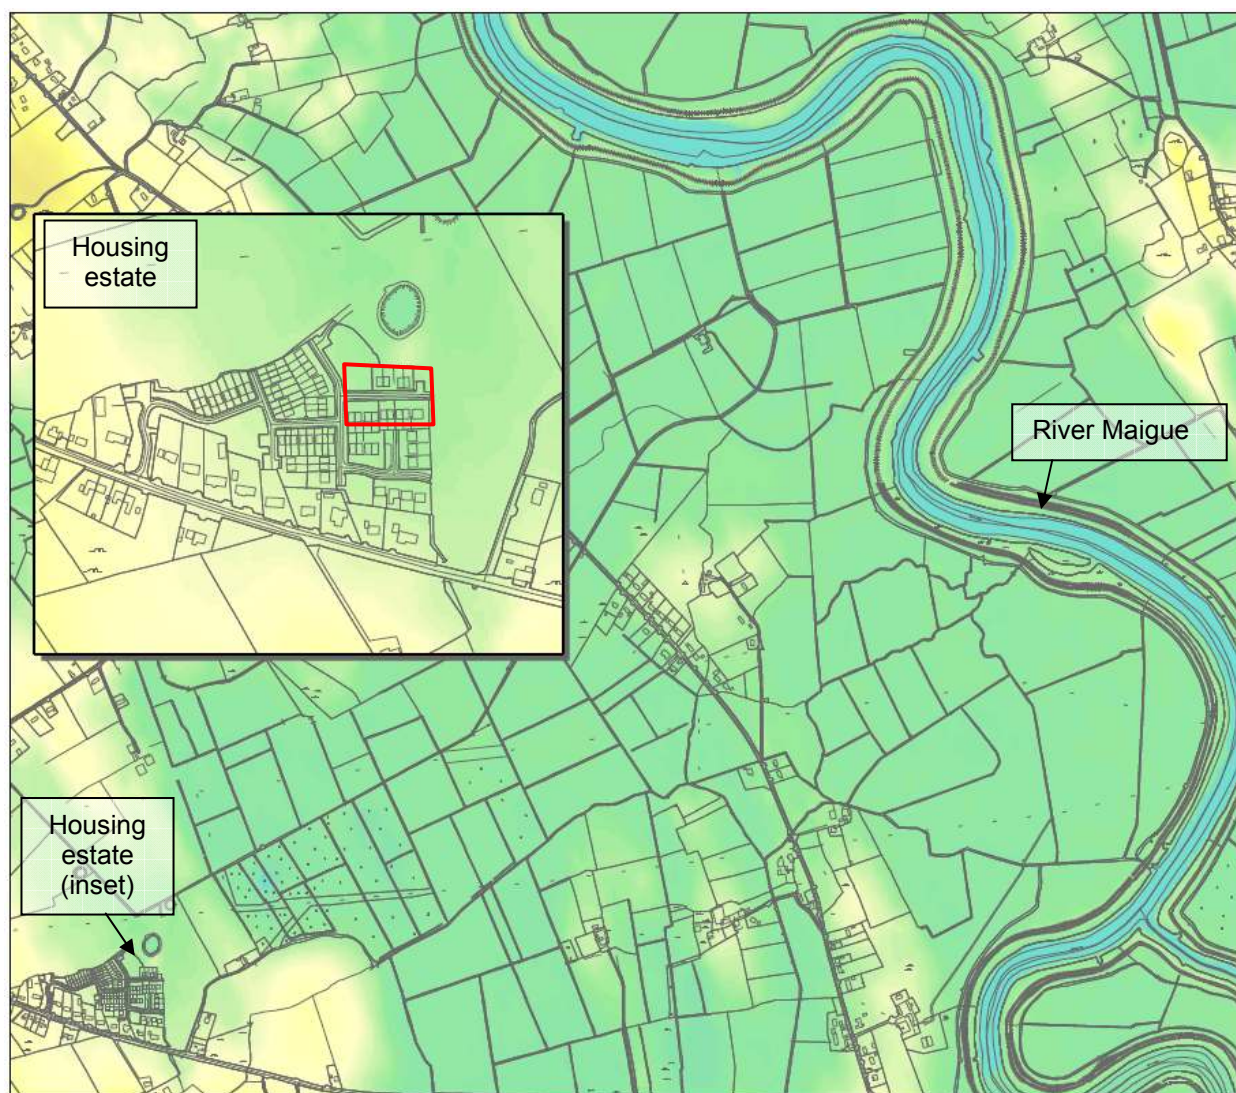
This plan shows the relief of the local area, with the green showing the lowest lying land. Ground levels across much of the floodplain (from the NHDM) are typically 1.5m (Malin Head); ground levels at the lowest point on the housing estate are around 3.2m (Malin Head). This area is within the red boundary shown on the inset plan above.

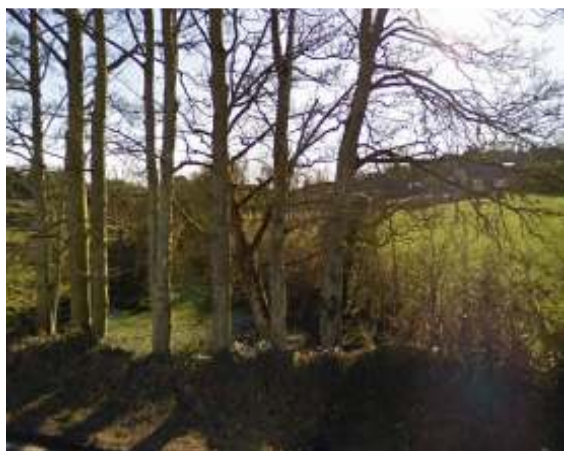
Photo 1: Looking u/s from N69 bridge crossing at the only watercourse in Kildimo New (extreme eastern end of the village). Kildimo New is located on high ground relative to the low lying area to the northeast. (image from Google)

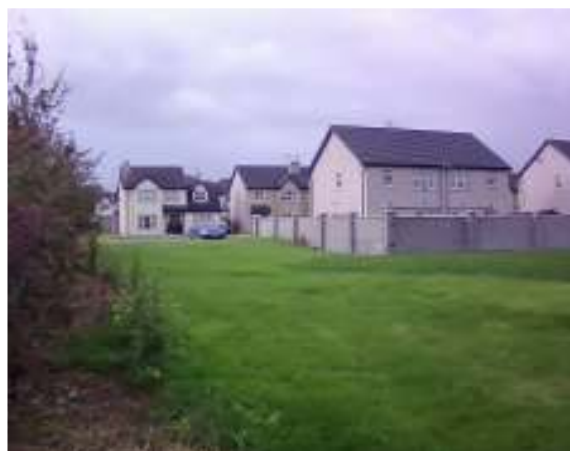
Photo 2: Properties on housing estate on eastern edge of New Kildimo.

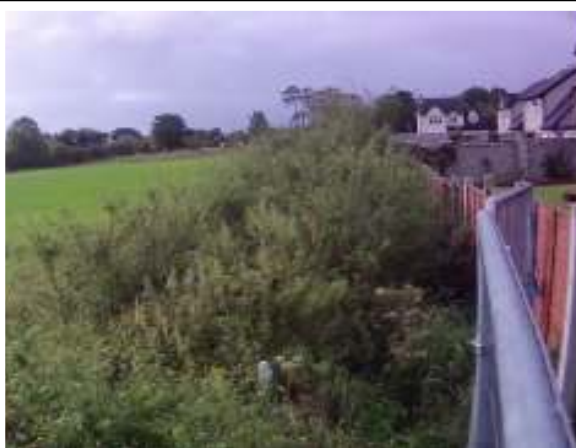
Photo 3: Eastern edge of housing estate (looking south towards N69). Properties are located on ground typically 0.8-1m higher than land immediately to the east.

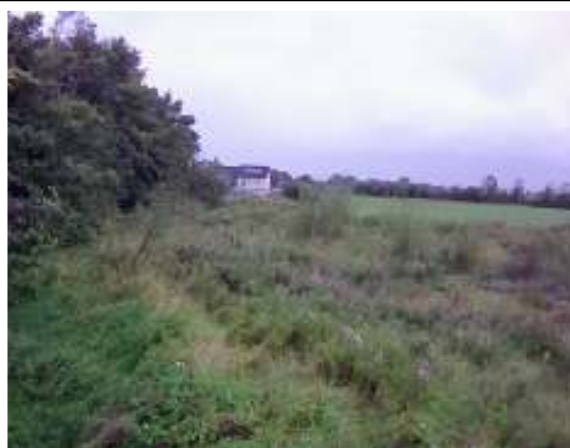
Photo 4: New Kildimo Looking d/s from the culvert crossing on the N69 at the eastern edge of the village. Property in the distance is on the edge of the housing estate. Minor watercourse is located adjacent to the trees on the left.

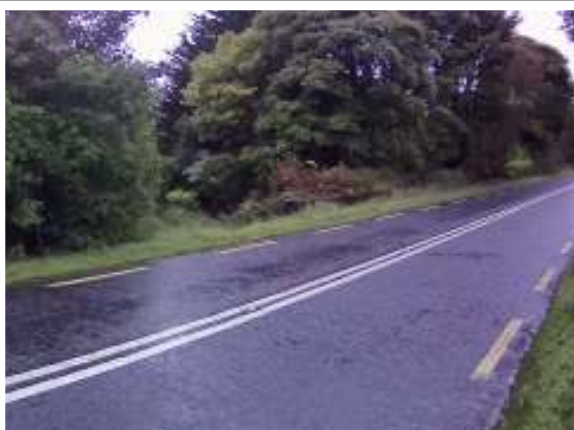
Photo 5: Road crossing of culvert for minor watercourse west of Kildimo New (outside the village). No significant flood risk posed by this watercourse.

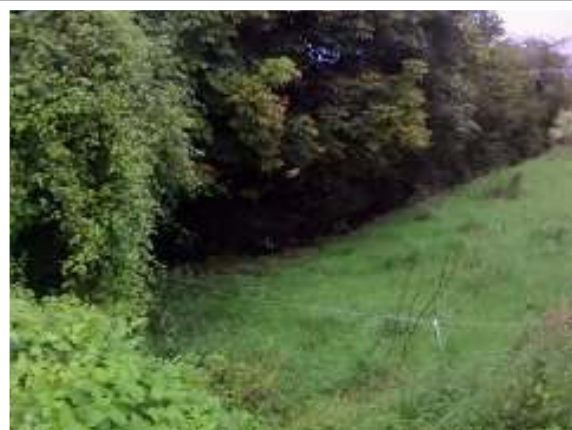
Photo 6: Watercourse downstream of crossing (shown in Photo 5) located in rural area with only a few properties located nearby (not at significant risk).

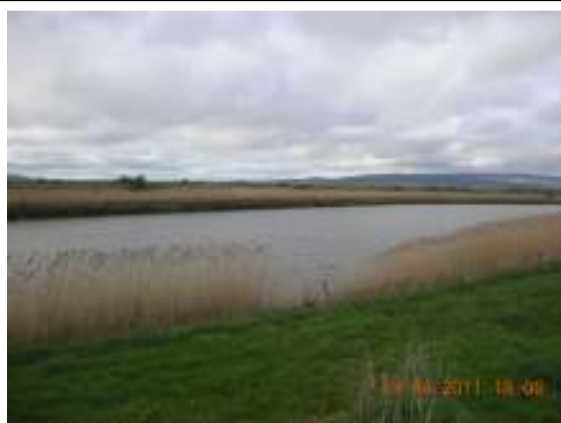
Photo 7: River Maigue from the left bank (top of embankment) northeast of Kildimo New.

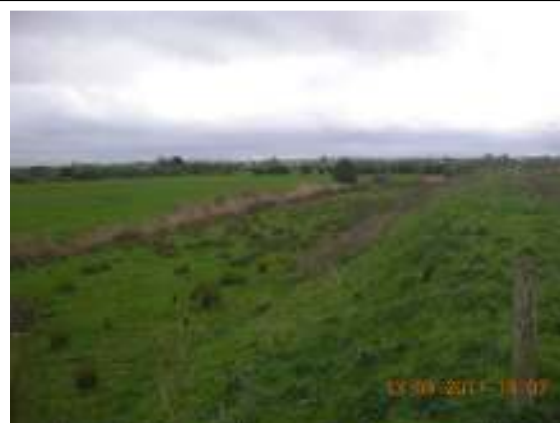
Photo 8: Low lying land behind the Maigue embankment on the left bank, northeast of Kildimo New near Faha. Ground level here is estimated to be around 1.5 to 2.0m below the ground level at the housing estate.
