| Location: Kildimo New, Co. Limerick | | Unique ID: 240385 (from PFRA database) | |

| Stage 2: Site Inspection | | Level A Assessment | | |

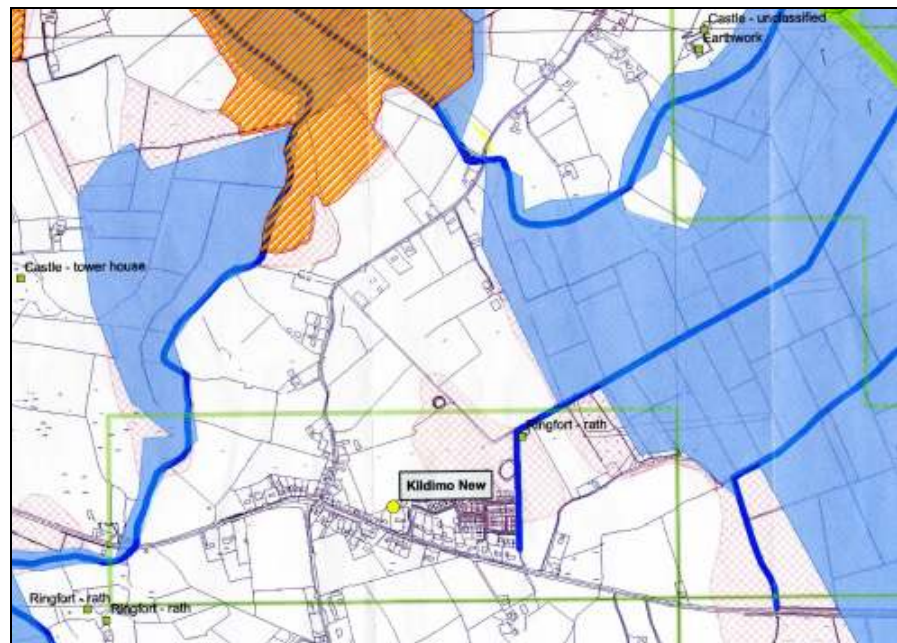
The flood mapping extents appear reasonable, reflecting the topography of the area, with Kildimo New itself being located on slightly raised ground. This is apparent from the flood mapping shown below, where the blue shaded area is from the PFRA mapping, strongly reflecting the location of the low lying land. The plan on the following page shows a colour coded relief plan of the area between Kildimo New and the River Maigue.

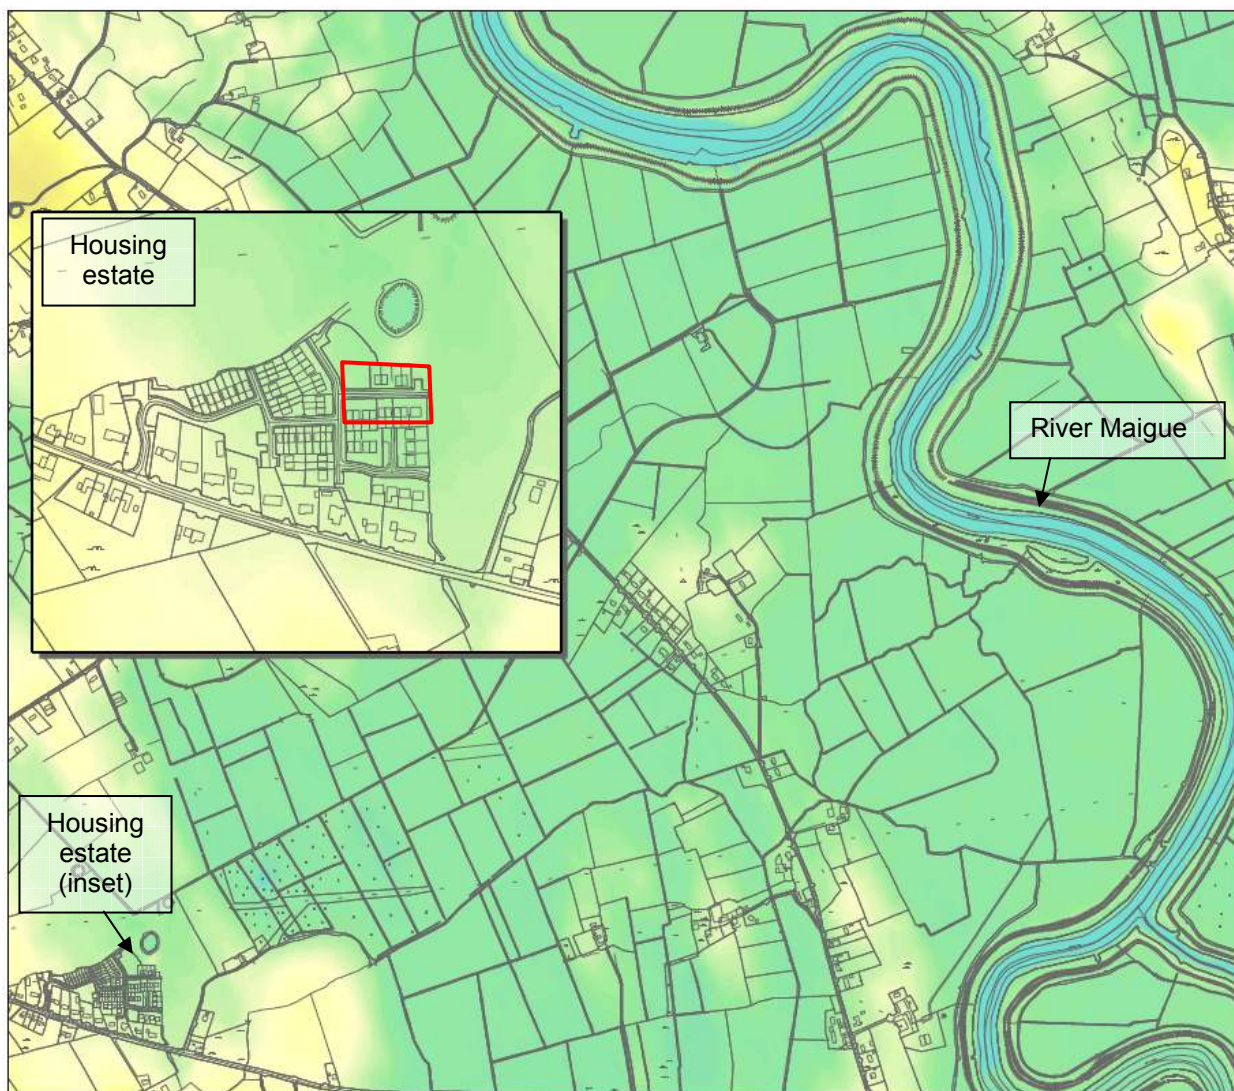
This plan shows the relief of the local area, with the green showing the lowest lying land. Ground levels across much of the floodplain (from the NHDM) are typically 1.5m (Malin Head); ground levels at the lowest point on the housing estate are around 3.2m (Malin Head). This area is within the red boundary shown on the inset plan above.

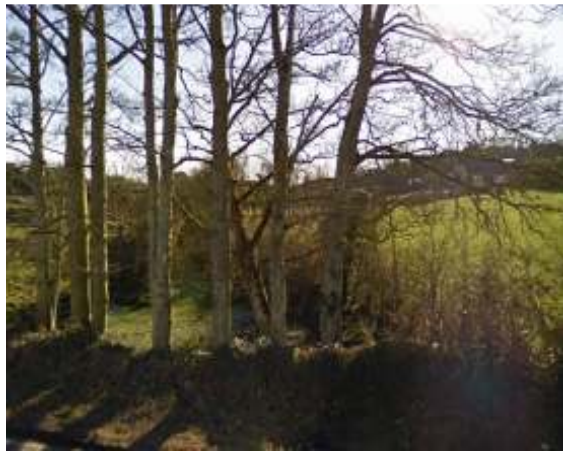
Photo 1: Looking u/s from N69 bridge crossing at the only watercourse in Kildimo New (extreme eastern end of the village). Kildimo New is located on high ground relative to the low lying area to the northeast. (image from Google)

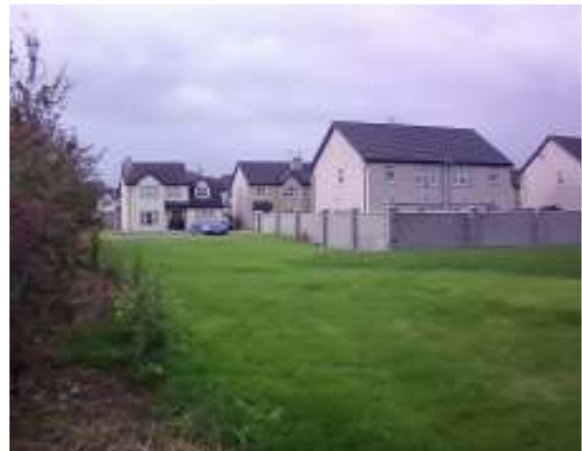
Photo 2: Properties on housing estate on eastern edge of New Kildimo.

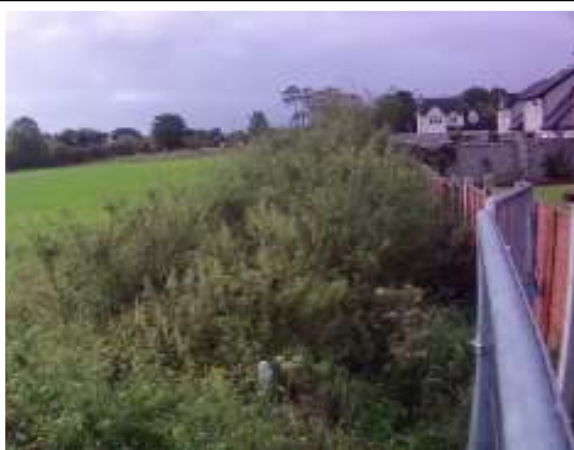
Photo 3: Eastern edge of housing estate (looking south towards N69). Properties are located on ground typically 0.8-1m higher than land immediately to the east.

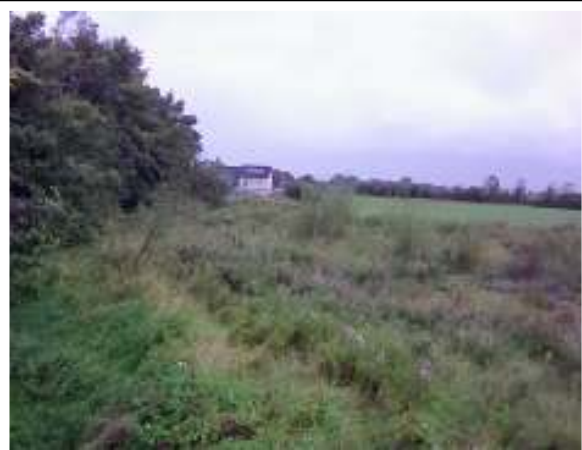
Photo 4: New Kildimo Looking d/s from the culvert crossing on the N69 at the eastern edge of the village. Property in the distance is on the edge of the housing estate. Minor watercourse is located adjacent to the trees on the left.

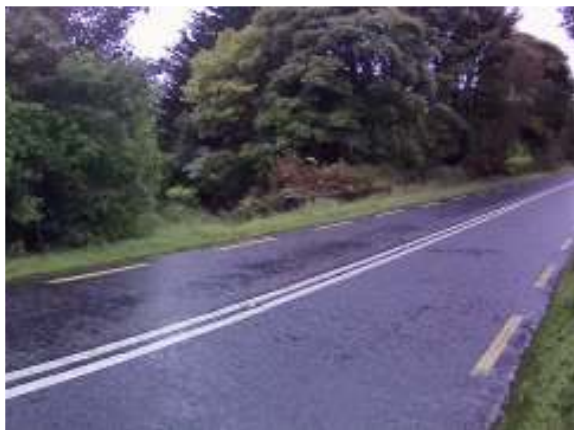
Photo 5: Road crossing of culvert for minor watercourse west of Kildimo New (outside the village). No significant flood risk posed by this watercourse.

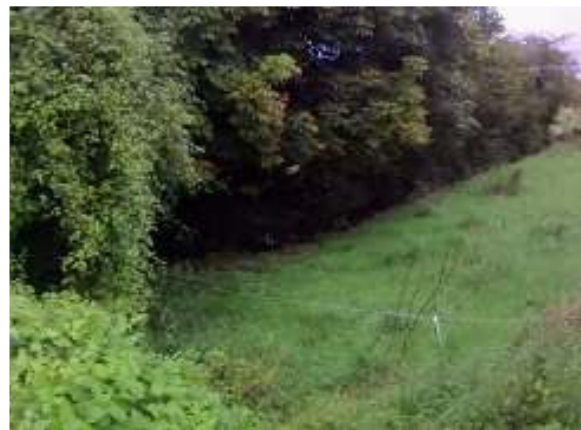
Photo 6: Watercourse downstream of crossing (shown in Photo 5) located in rural area with only a few properties located nearby (not at significant risk).

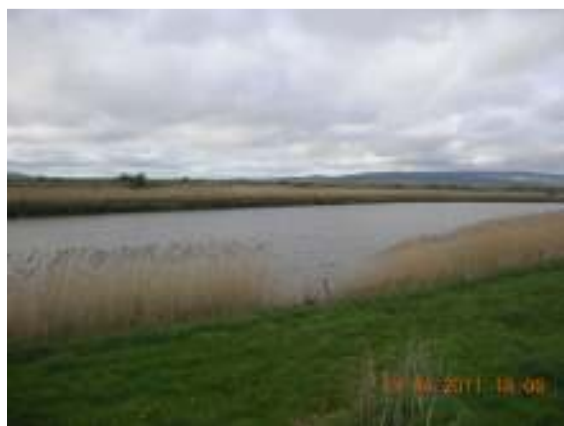
Photo 7: River Maigue from the left bank (top of embankment) northeast of Kildimo New.

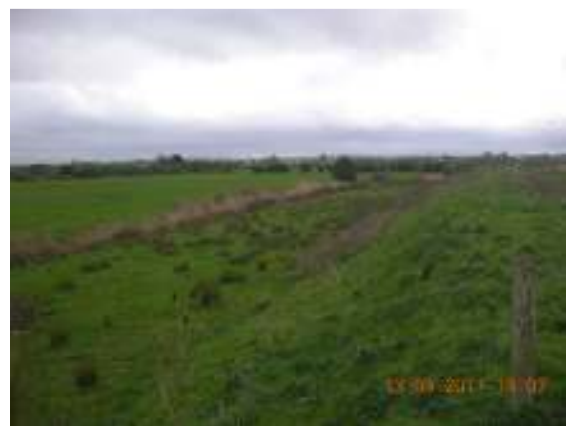
Photo 8: Low lying land behind the Maigue embankment on the left bank, northeast of Kildimo New near Faha. Ground level here is estimated to be around 1.5 to 2.0m below the ground level at the housing estate.
