Location: Ahascragh, Co. Galway		Unique ID: 263,234 (from PFRA database)	
Initial OPW Designation	APSR <input type="checkbox"/>	AFRR <input checked="" type="checkbox"/>	IRR <input type="checkbox"/>
Co-ordinates	Easting: 178,025	Northing: 239,014	
River / Catchment / Sub-catchment	Ahascragh River / Bunowen River / River Suck		
Type of Flooding / Flood Risk (identify all that apply)	Fluvial non-tidal <input checked="" type="checkbox"/> Fluvial tidal <input type="checkbox"/> Coastal <input type="checkbox"/>

Stage 2: Site Inspection		Level A Assessment		
Date and Time of Inspection		Date: 26/05/11		
		Time: 10:45		
Names of inspection team (including OPW/LA staff if present)		Alan Dew		
		Peter Smyth

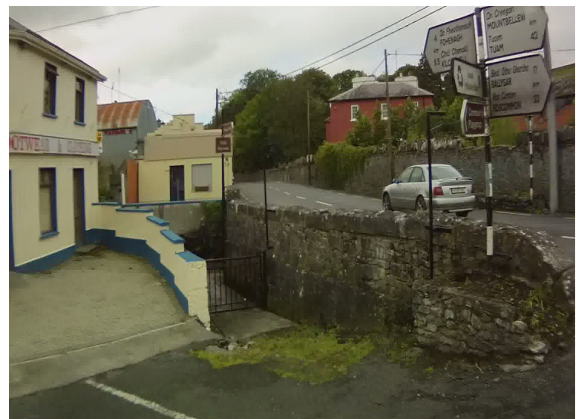
Photo 4: Mill race crossing
