Location: Ballinasloe, Co. Galway		Unique ID: 260451 (from PFRA database)	
Initial OPW Designation	APSR <input checked="" type="checkbox"/>	AFRR <input type="checkbox"/>	IRR <input type="checkbox"/>
Co-ordinates	Easting: 184,750	Northing: 231,999	
River / Catchment / Sub-catchment	Bunowen River & Deer Park River / River Suck		
Type of Flooding / Flood Risk (identify all that apply)	Fluvial non-tidal <input checked="" type="checkbox"/>	Fluvial tidal <input type="checkbox"/>	Coastal <input type="checkbox"/>

Stage 2: Site Inspection		Level B Assessment		
Date and Time of Inspection		Date: 26/05/11		
		Time: 12:30		
Names of inspection team (including OPW/LA staff if present)		Alan Dew		
		Peter Smyth

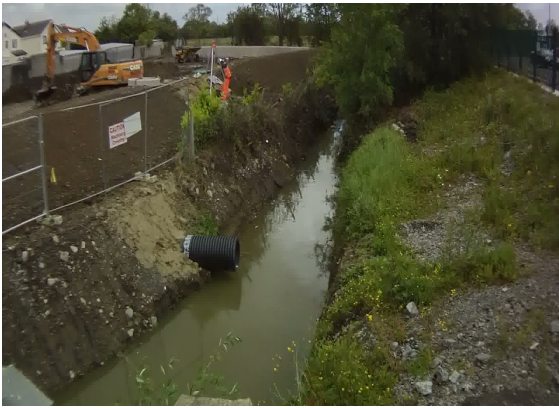
Photo 1: Looking downstream of the road bridge adjacent to the OPW flood alleviation scheme (nearing completion) in the upper section of Ballinasloe.

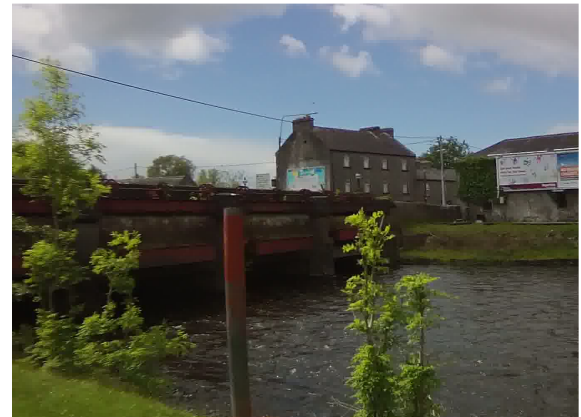
2.3 Local knowledge - on-site comments (OPW, LA and any info volunteered by local residents during visit)	No on-site comments			
2.4 Comments on hydraulic constrictions (bridges, etc.) and conveyance routes	<p>The sluice gates on the old N6 bridge significantly reduce conveyance capacity during high flows.</p> <p>The railway line upstream of the town centre may provide constraint to high flows.</p> <p>There are 2 Armco culverts beneath the roadway adjacent to Galway CoCo building along route of original River Suck which may provide a constraint at times of high flows.</p>

Photo 2: Old N6 road bridge over the River Suck from the upstream left bank. Note the sluice gates beneath the bridge parapets.

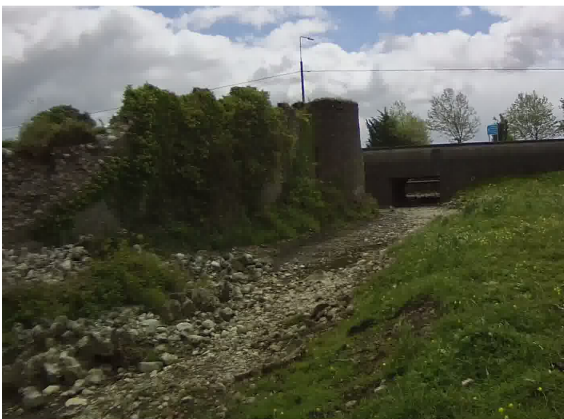
Photo 3: Flood relief channel for the River Suck constructed along the former mill race, looking towards the old N6 from upstream.

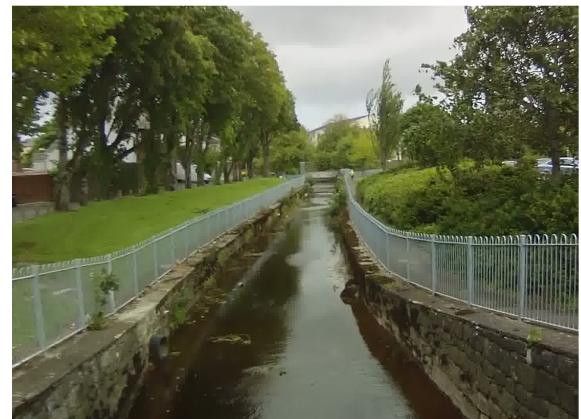
Photo 4: Former course of the River Suck looking upstream.
