<b>Location: Ballinasloe, Co. Galway</b>		<b>Unique ID: 260451</b> (from PFRA database)	
<b>Initial OPW Designation</b>	<b>APSR</b> <input checked="" type="checkbox"/>	<b>AFRR</b> <input type="checkbox"/>	<b>IRR</b> <input type="checkbox"/>
<b>Co-ordinates</b>	<b>Easting: 184,750</b>	<b>Northing: 231,999</b>	
<b>River / Catchment / Sub-catchment</b>	<b>Bunowen River &amp; Deer Park River / River Suck</b>		
<b>Type of Flooding / Flood Risk</b> (identify all that apply)	<b>Fluvial non-tidal</b> <input checked="" type="checkbox"/> <b>Fluvial tidal</b> <input type="checkbox"/> <b>Coastal</b> <input type="checkbox"/>

<b>Stage 2: Site Inspection</b>		<b>Level B Assessment</b>	
<b>Date and Time of Inspection</b>		<b>Date: 26/05/11</b>	
		<b>Time: 12:30</b>	
<b>Names of inspection team (including OPW/LA staff if present)</b>		<b>Alan Dew</b>	
		<b>Peter Smyth</b>	
<b>2.3 Local knowledge - on-site comments (OPW, LA and any info volunteered by local residents during visit)</b>	No on-site comments		
<b>2.4 Comments on hydraulic constrictions (bridges, etc.) and conveyance routes</b>	<p>The sluice gates on the old N6 bridge significantly reduce conveyance capacity during high flows.</p> <p>Th

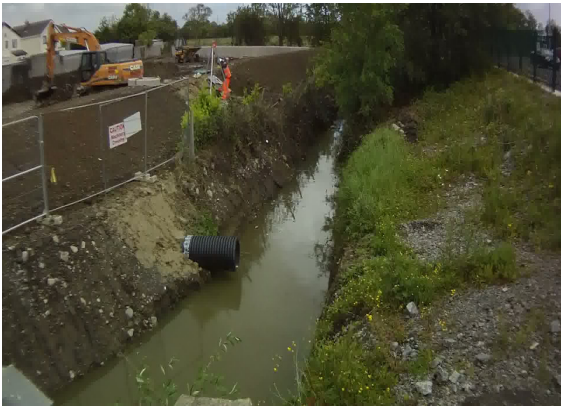
**Photo 1:** Looking downstream of the road bridge adjacent to the OPW flood alleviation scheme (nearing completion) in the upper section of Ballinasloe.

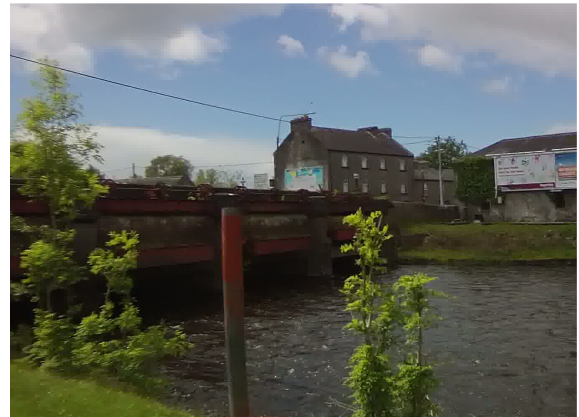
**Photo 2:** Old N6 road bridge over the River Suck from the upstream left bank. Note the sluice gates beneath the bridge parapets.

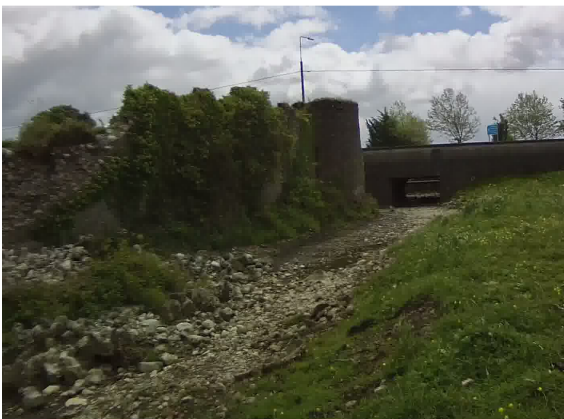
**Photo 3:** Flood relief channel for the River Suck constructed along the former mill race, looking towards the old N6 from upstream.

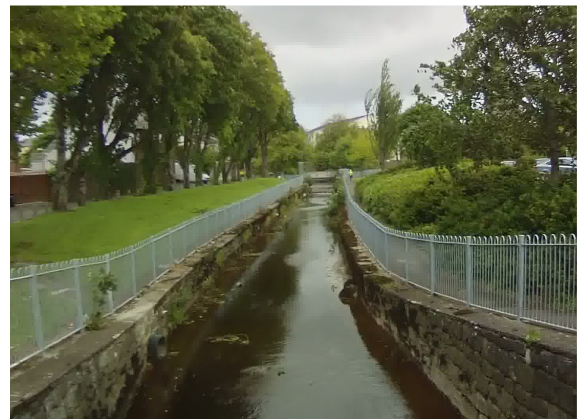
**Photo 4:** Former course of the River Suck looking upstream.
