Location: Ballinasloe, Co. Galway		Unique ID: 260451 (from PFRA database)	
Initial OPW Designation	APSR <input checked="" type="checkbox"/>	AFRR <input type="checkbox"/>	IRR <input type="checkbox"/>
Co-ordinates	Easting: 184,750	Northing: 231,999	
River / Catchment / Sub-catchment	Bunowen River & Deer Park River / River Suck		
Type of Flooding / Flood Risk (identify all that apply)	Fluvial non-tidal <input checked="" type="checkbox"/>	Fluvial tidal <input type="checkbox"/>	Coastal <input type="checkbox"/>

Stage 2: Site Inspection		Level B Assessment	
Date and Time of Inspection		Date: 26/05/11	
		Time: 12:30	
Names of inspection team (including OPW/LA staff if present)		Alan Dew	
		Peter Smyth

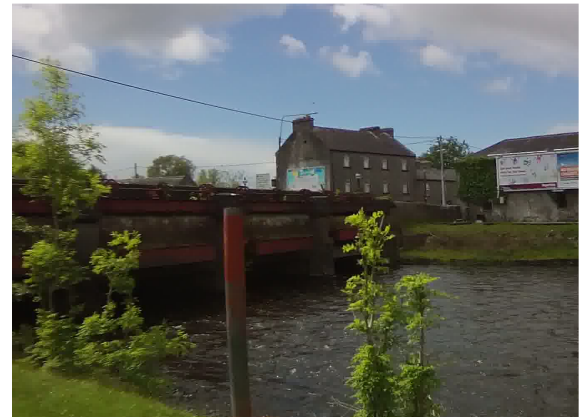
2.3 Local knowledge - on-site comments (OPW, LA and any info volunteered by local residents during visit)	No on-site comments		
2.4 Comments on hydraulic constrictions (bridges, etc.) and conveyance routes	<p>The sluice gates on the old N6 bridge significantly reduce conveyance capacity during high flows.</p> <p>The railway line upstream of the town centre may provide constraint to high flows.</p> <p>There are 2 Armco culverts beneath the roadway adjacent to Galway CoCo building along route of original River Suck which may provide a constraint at times of high flows.</p>

Photo 2: Old N6 road bridge over the River Suck from the upstream left bank. Note the sluice gates beneath the bridge parapets.

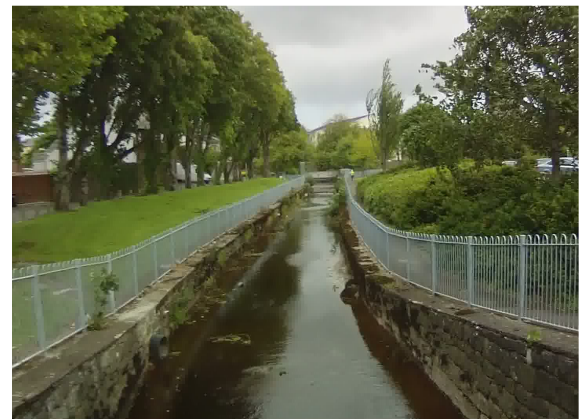
Photo 4: Former course of the River Suck looking upstream.
