Location: Castleconnell, Co. Limerick		Unique ID: 252889 (from PFRA database)	
Initial OPW Designation	APSR <input checked="" type="checkbox"/>	AFRR <input type="checkbox"/>	IRR <input type="checkbox"/>
Co-ordinates	Easting: 166,390	Northing: 162,679	
River / Catchment / Sub-catchment	River Shannon / Shannon		
Type of Flooding / Flood Risk (identify all that apply)	Fluvial non-tidal <input checked="" type="checkbox"/> Fluvial tidal <input type="checkbox"/> Coastal <input type="checkbox"/>

Project	Shannon CFRAM Study Flood Risk Review Map		
Title	Castleconnell		
Drawing Status	FINAL		
Job No.	32102500		
Figure No.	CAR 18		
Scale	1:15,000 @ A3		
Drawn	AD/SF	Checked	JC
Drawn	KK/JM	Checked	IB/PS
Copyright reserved Jacobs UK Ltd 95 Bothwell Street, Glasgow, G2 7HX

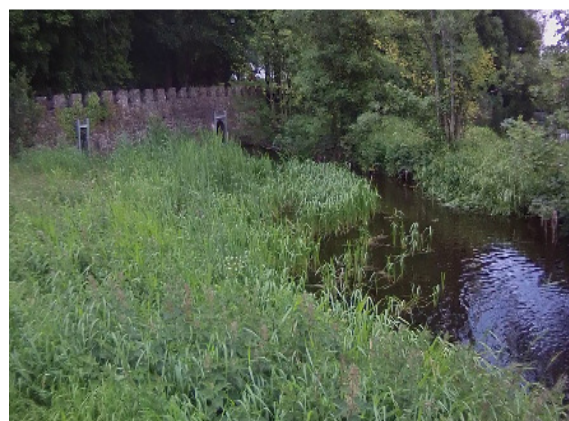
2.4 Comments on hydraulic constrictions (bridges, etc.) and conveyance routes		The same resident stated that flood gates were installed in the last 2 months on upstream entrances to 3 no. culverts beneath access roadway to Island House; the runners were observed during the inspection, however the gates have been removed, possibly by the County Council. These gates would block off a historic channel of the Shannon, which could lead to flood waters backing up within the Shannon channel and possibly lead to bypassing of the Island House culvert either on the right bank of this channel (would re-enter channel downstream of track) or over/through gaps in wall on left bank along roadside.

Photo 2: Flood gates installed at culverts beneath access roadway to Island House.

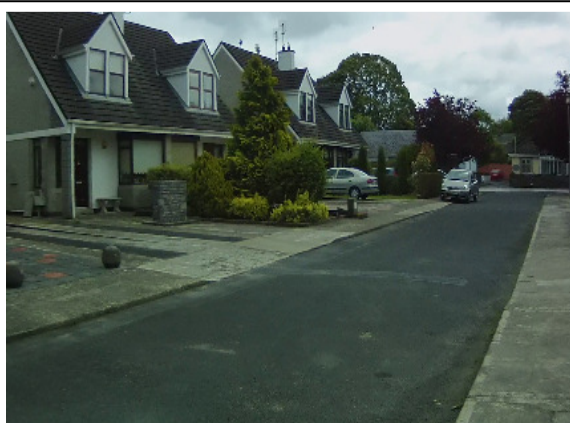
2.3 Local knowledge - on-site comments (OPW, LA and any info volunteered by local residents during visit)		Resident in cul-de-sac downstream of Island House stated that the 2009 floods inundated his garage extension with 9 inches of water. The whole cul-de-sac was flooded. Flood waters came from the back of the house opposite his property (upstream) and also through gaps in the adjacent wall. He has subsequently raised his driveway and floor levels and installed sumps to allow him to pump water back into river during flooding. The power supply (part-way up cul-de-sac) was sandbagged off during the 2009 flooding but is at risk.

Photo 3: Cul-de-sac flooded during the November 2009 flood event.

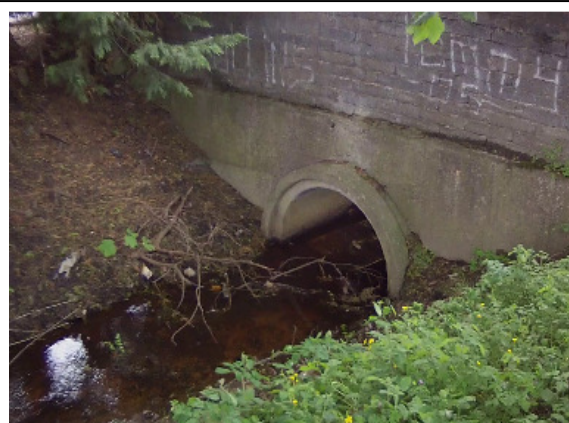
Photo 4: Upstream entrance to tributary culvert beneath minor road.
