Location: Clonfert, Co. Galway		Unique ID: 252906 (from PFRA database)	
Initial OPW Designation	APSR <input type="checkbox"/>	AFRR <input checked="" type="checkbox"/>	IRR <input type="checkbox"/>
Co-ordinates	Easting: 197134	Northing: 221731	
River / Catchment / Sub-catchment	Un-named minor tributaries / River Shannon		
Type of Flooding / Flood Risk (identify all that apply)	Fluvial non-tidal <input checked="" type="checkbox"/> Fluvial tidal <input type="checkbox"/> Coastal <input type="checkbox"/>

Stage 2: Site Inspection		Level A Assessment		
Date and Time of Inspection		Date: 26/05/11		
		Time: 15:00		
Names of inspection team (including OPW/LA staff if present)		Alan Dew		
		Peter Smyth

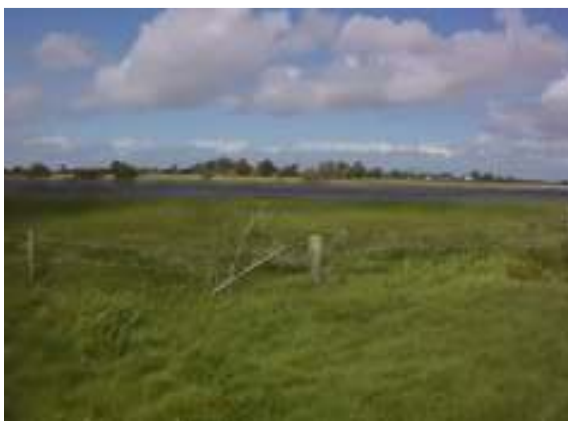
Photo 1: River Shannon east of Clonfert, viewed from the right bank

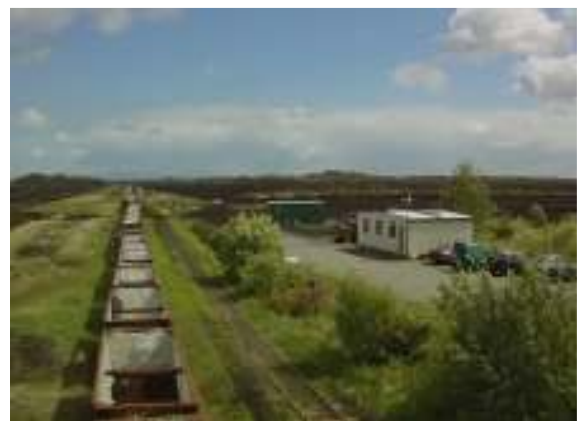
Photo 2: Bord na Mona land east of Clonfert, viewed from the railway bridge

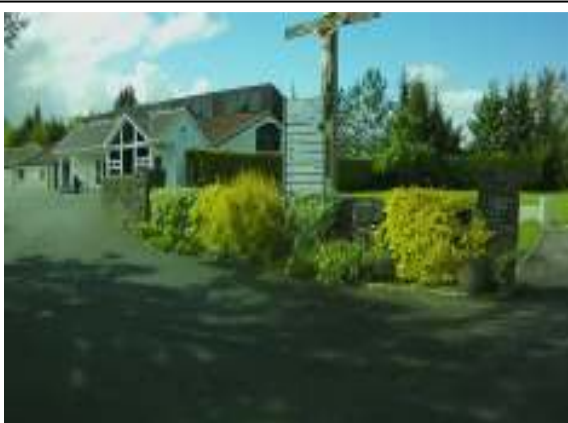
Photo 3: Emmanuel House of Providence church building at raised level.

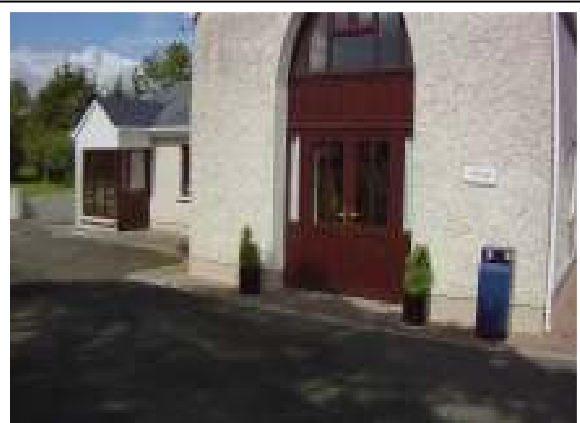
2.3 Local knowledge - on-site comments (OPW, LA and any info volunteered by local residents during visit)	A local employee was interviewed. The fields to north of the shop / restaurant building flood every year. In November 2009, all buildings nearby were flooded, with the main shop being flooded to a depth of 600mm. This height of flood water was reached inside an hour. Further residential properties on the other side of main road through village, were also flooded in November 2009.

Other Pumping Station <input type="checkbox"/> Erosion Protection <input type="checkbox"/> Sand Dunes <input type="checkbox"/> Additional notes (if required): The Emmanuel House of Providence has constructed a flood wall of approximately 50 metres in length to the north of the shop building. This was incomplete at the time of inspection; awaiting 2 flood gates.

Photo 4: Emmanuel House of Providence shop building. Note the newly constructed flood wall at the rear of the building.
