Location: Dromod, Co. Leitrim		Unique ID: 263,661 (from PFRA database)	
Initial OPW Designation	APSR <input type="checkbox"/>	AFRR <input checked="" type="checkbox"/>	IRR <input type="checkbox"/>
Co-ordinates	Easting: 205,362	Northing: 289,756	
River / Catchment / Sub-catchment	River Eslin / Shannon (Lough Bofin)		
Type of Flooding / Flood Risk (identify all that apply)	Fluvial non-tidal <input checked="" type="checkbox"/> Fluvial tidal <input type="checkbox"/> Coastal <input type="checkbox"/>

Stage 2: Site Inspection		Level A Assessment		
Date and Time of Inspection		Date: 19/05/11		
		Time: 11:30		
Names of inspection team (including OPW/LA staff if present)		Alan Dew		
		James Murray		
		Brian Kenny, Leitrim CoCo (briefly present on arrival)

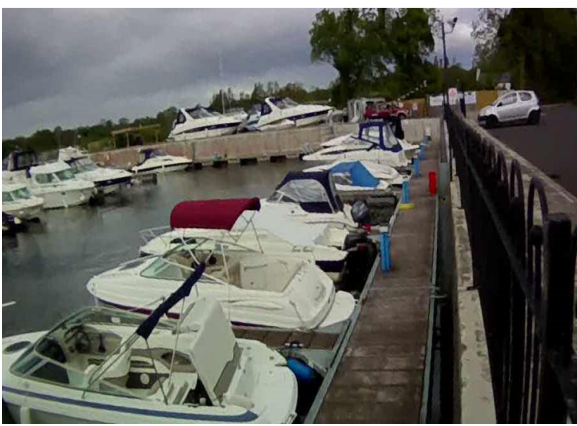
Photo1: Dromod harbour wall

2.8 Initial Potential Mitigation Measures	
Non-structural measures	Planning and Development control <input checked="" type="checkbox"/> Sustainable Urban Drainage Systems <input type="checkbox"/> Flood forecasting / warning <input type="checkbox"/> Change in Operating Procedures for water level control: <input checked="" type="checkbox"/> Public awareness campaign <input checked="" type="checkbox"/> Individual property protection <input type="checkbox"/> Land use management <input type="checkbox"/>
Structural measures	Strategic development management for floodplain development: <input type="checkbox"/> <i>(integration of measures into strategic development proposals)</i> Storage: On-line <input checked="" type="checkbox"/> Off-line <input type="checkbox"/> Flow diversion: Flood relief channel <input type="checkbox"/> Flood relief culvert <input type="checkbox"/> Increase conveyance: Bridge works <input checked="" type="checkbox"/> Channel works <input checked="" type="checkbox"/> Floodplain <input type="checkbox"/> Flood defences: Walls <input checked="" type="checkbox"/> Embankments <input checked="" type="checkbox"/> Localised works: Defence raising <input checked="" type="checkbox"/> In-fill gaps <input checked="" type="checkbox"/> Trash screen <input type="checkbox"/> Maintenance works: Culvert / channel clearance <input type="checkbox"/> Asset maintenance <input type="checkbox"/> Relocation of properties: <input type="checkbox"/> Improve existing defences: <input type="checkbox"/> (describe) Other (describe): <ul style="list-style-type: none"> Raise quay wall level and tie into other defences on Lough shore.

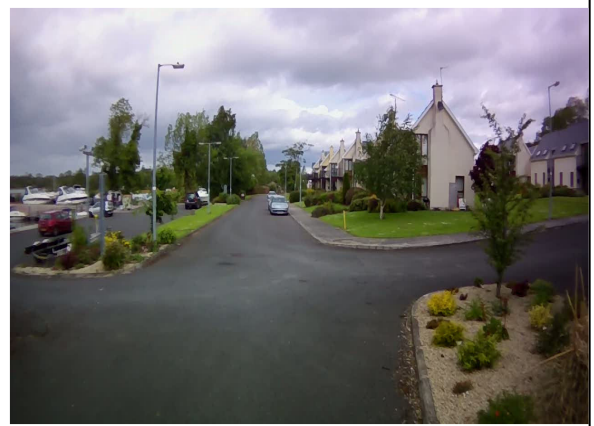
Photo 2: Housing adjacent to Dromod harbour

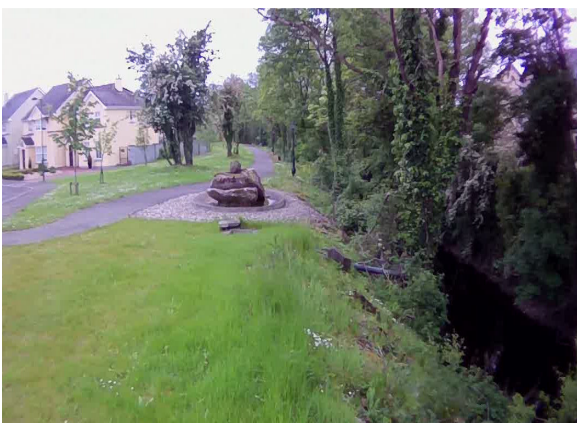
Photo 3: Recent development on left bank of River Eslin, downstream of the railway station.

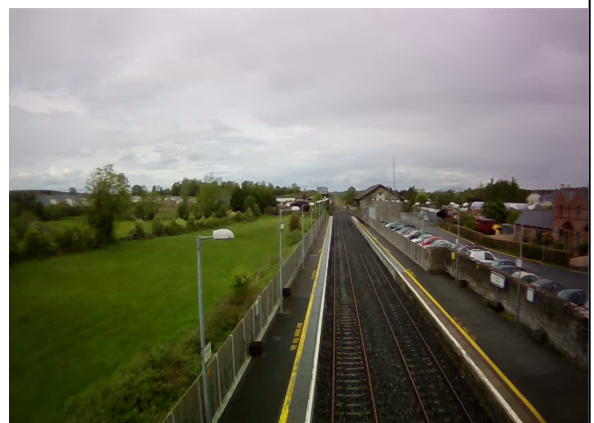
Photo 4: The River Eslin (on the left) as viewed from the footbridge at Dromod Railway Station.
