| Location: Abbeydorney, Co. Kerry | | Unique ID: 230341 (from PFRA database) | |
| River / Catchment / Sub-catchment | Shanow River / River Brick / Feale Catchment | | |

| Stage 2: Site Inspection | | Level A Assessment | | |

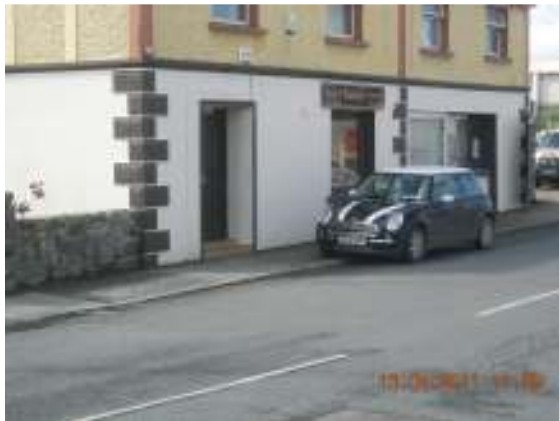
Photo 1: Local business (beauty salon) surface water from the community centre located to the west of this building reached 1st step

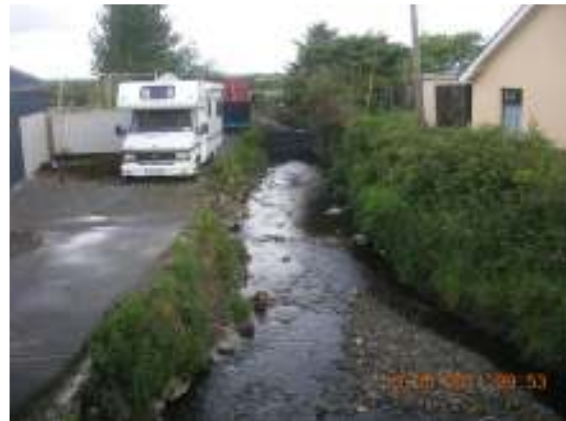
Photo 2: Watercourse (tributary of the Shanow River) adjacent to the Abbey Hair Studio d/s of the bridge

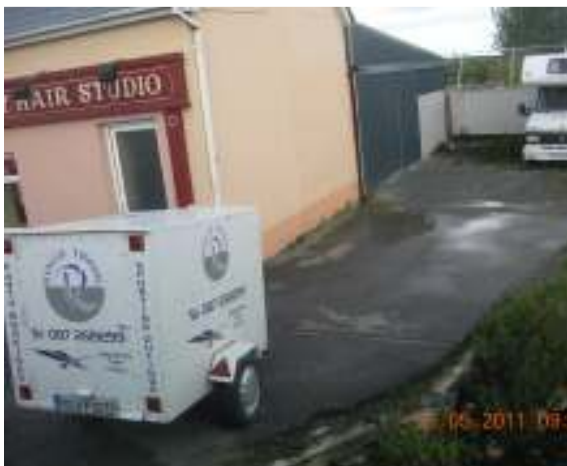
Photo 3: The Abbey Hair Studio west of watercourse

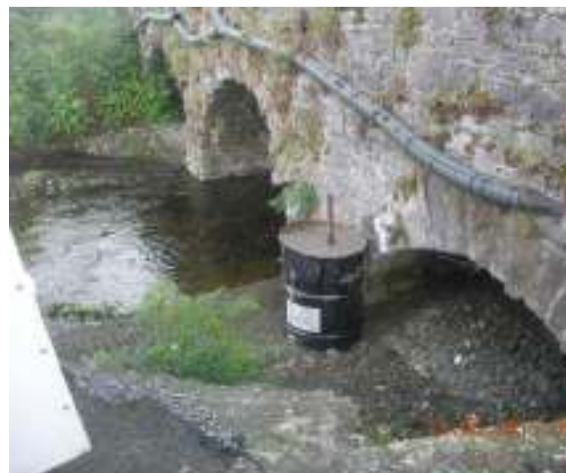
| 2.4 Comments on hydraulic constrictions (bridges, etc.) and conveyance routes | <p>3-arch bridge next Abbey Hair Studio – only the central arch is operating, other two are partially blocked with gravel deposition. The owner of Studio has never seen these arches open. The open area of the bridge is considerably less than the channel cross-sectional area.</p> <p>A sheet of corrugated iron has been placed d/s of the 3-arch bridge (this was not here at the time of the flood in 2009).</p> <p>Fly-tipping between 3-arch and single-arch bridges.</p> <p>Single arch bridge d/s – soffit is near bank top level.</p> |

Photo 4: The 3 Arch Bridge next Abbey Hair Studio (d/s)

| Summary Comments (if required) | <p>There is no fluvial flood history in this town or at the Nursing Home.</p> <p>The town does experience surface water issues from the lands adjacent to the Community Centre.</p> <p>There is potential for blockage at the 3-arch bridge (next to Abbey Hair Studio), and this bridge is already partially blocked. With existing walls on the u/s banks near the bridge, flooding could occur u/s where walls stop, with potential for flooding of several properties on right and left banks.</p> <p>Whilst the nursing home may not be at at high risk of flooding, even without the nursing home included in the PFRA FRI score, the FRI score would still be around 900 points, well above the PFRA threshold for recommendation as a "Community at Risk".</p> <p>It is therefore recommended that Abbeydorney is designated as an APSR.</p> | | | |
