Location: Ardfert, Co. Kerry		Unique ID: 232629 (from PFRA database)	
Initial OPW Designation	APSR <input type="checkbox"/>	AFRR <input checked="" type="checkbox"/>	IRR <input type="checkbox"/>
Co-ordinates	Easting: 78466		Northing: 120966
River / Catchment / Sub-catchment	Tyshe River / North Kerry Tralee Bay Catchment		
Type of Flooding / Flood Risk (identify all that apply)	Fluvial non-tidal <input checked="" type="checkbox"/> Fluvial tidal <input type="checkbox"/> Coastal <input type="checkbox"/>

Stage 2: Site Inspection		Level A Assessment		
Date and Time of Inspection		Date: 24/05/11		
		Time: 17:00		
Names of inspection team (including OPW/LA staff if present)		Iain Blackwell		
		Kelly Kasperczyk

Project	Shannon CFRAM Study Flood Risk Review Map		
Title	Ardfert		
Drawing Status	FINAL		
Job No.	32102500		
Figure No.	AFRR5		
Scale	1:5,000 @ A3		
Drawn	AD/SF	Checked	JC
Drawn	KK/JM	Checked	IB/PS
Copyright reserved Jacobs UK Ltd 95 Bothwell Street, Glasgow, G2 7HX

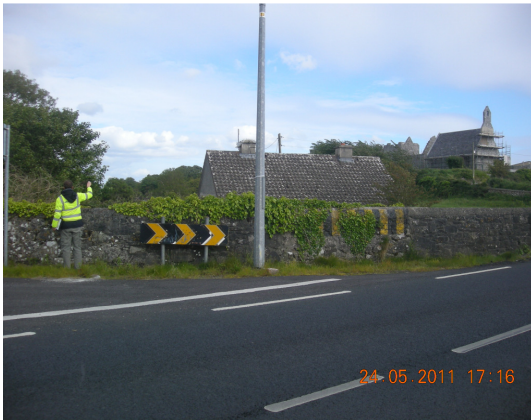
Photo 1: Property adjacent to the R551 Bridge (NW of the village). This is the only property potentially at risk of fluvial flooding

2.8 Initial Potential Mitigation Measures		
Non-structural measures	Planning and Development control <input type="checkbox"/> Sustainable Urban Drainage Systems <input type="checkbox"/> Flood forecasting / warning <input type="checkbox"/> Change in Operating Procedures for water level control: <input type="checkbox"/> Public awareness campaign <input type="checkbox"/> Individual property protection <input checked="" type="checkbox"/> Land use management <input type="checkbox"/>	
Structural measures	Strategic development management for floodplain development: <input type="checkbox"/> <i>(integration of measures into strategic development proposals)</i> Storage: On-line <input type="checkbox"/> Off-line <input type="checkbox"/> Flow diversion: Flood relief channel <input type="checkbox"/> Flood relief culvert <input type="checkbox"/> Increase conveyance: Bridge works <input type="checkbox"/> Channel works <input type="checkbox"/> Floodplain <input type="checkbox"/> Flood defences: Walls <input checked="" type="checkbox"/> Embankments <input type="checkbox"/> Localised works: Defence raising <input type="checkbox"/> In-fill gaps <input type="checkbox"/> Trash screen <input type="checkbox"/> Maintenance works: Culvert / channel clearance <input checked="" type="checkbox"/> Asset maintenance <input type="checkbox"/> Relocation of properties: <input type="checkbox"/> Improve existing defences: <input type="checkbox"/> (describe) Other (describe): If required, a defence wall could be constructed on the left bank u/s of the R551 bridge to protect the single property.

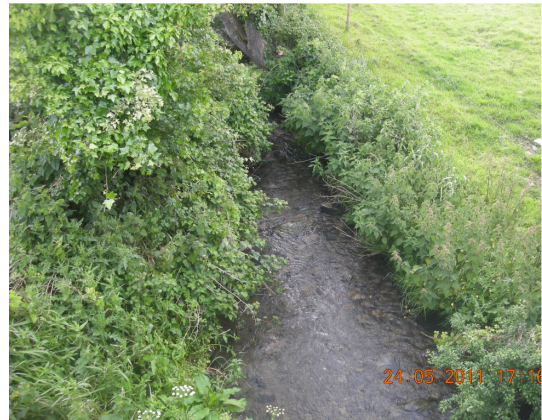
2.3 Local knowledge - on-site comments (OPW, LA and any info volunteered by local residents during visit)	No on site comments			
2.4 Comments on hydraulic constrictions (bridges, etc.) and conveyance routes	Vegetation u/s of the single arch R551 bridge (next to house) is very overgrown and could block this arch. Masonry twin arch culvert at Tyshe Bridge.

Photo 2: Tyshe River at the R551

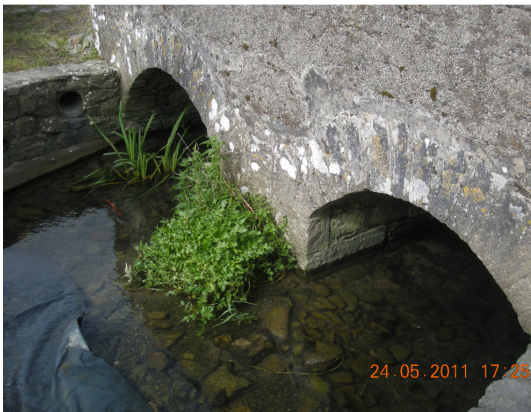
Photo 3: Tyshe Bridge (NE of the village) on the local road running north from the village

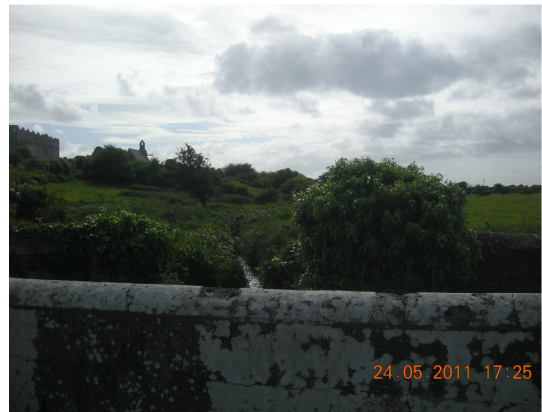
Photo 4: Tyshe Bridge looking west downstream. The village is located high up to the south (left of picture)
