Location: Athea, Co. Limerick		Unique ID: 232630 (from PFRA database)	
Initial OPW Designation	APSR <input checked="" type="checkbox"/>	AFRR <input type="checkbox"/>	IRR <input type="checkbox"/>
Co-ordinates	Easting: 112411		Northing: 134873
River / Catchment / Sub-catchment	River Galey / Feale Catchment		
Type of Flooding / Flood Risk (identify all that apply)	Fluvial non-tidal <input checked="" type="checkbox"/> Fluvial tidal <input type="checkbox"/> Coastal <input type="checkbox"/>

Stage 1: Desktop Review

Stage 2: Site Inspection		Level A Assessment		
Date and Time of Inspection		Date: 12/05/11		
		Time: 12:30		
Names of inspection team (including OPW/LA staff if present)		Mathieu Valois		
		Kelly Kasperczyk

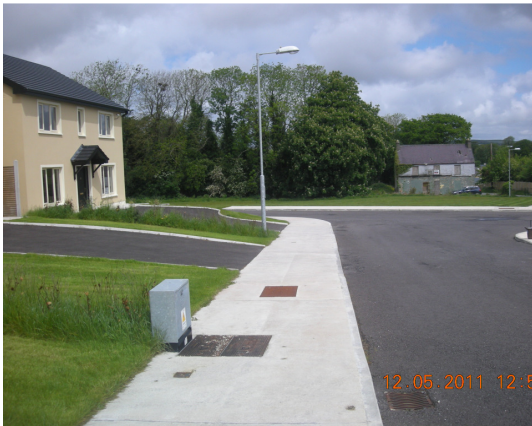
Photo 1: New housing estate in Athea looking North towards the realigned stream

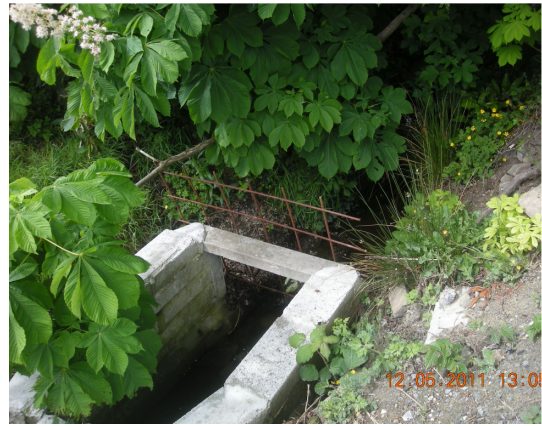
Photo 2: 800mm culvert on the realigned stream at the new housing estate

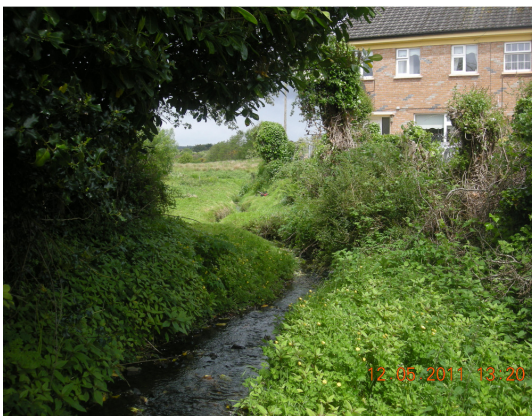
<p>that joins this culvert at the south end of the laneway is culverted further u/s east of the new estate.</p> <p>The culvert from the laneway opens north of the main street through a series of small step weirs, then flows adjacent to the property referred to in Section 2.3 above. Debris (thin wood board) currently partially blocks the culvert at this location. There is limited hydraulic capacity at this location.</p>
--	--

Photo 3: Previously flooded property on tributary of the Galey River looking north

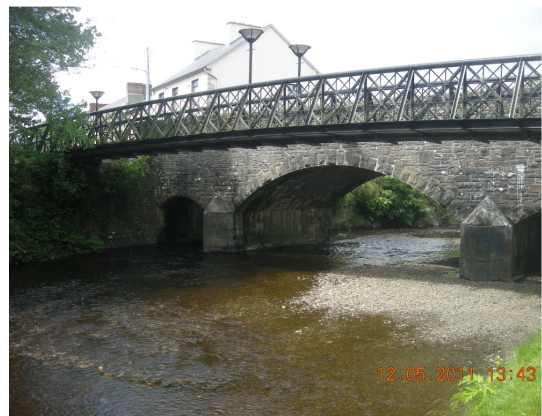
2.4 Comments on hydraulic constrictions (bridges, etc.) and conveyance routes	<p>Build up of gravel in the Galey particularly at the main street bridge (could be up to 1.5m). Also refer to point above regarding material removed from the Galey River.</p> <p>Tributary of the Galey west of Athea is diverted to the rear (west) of new properties through a constructed channel which has a severe right angle bend d/s of these properties. This tributary is then culverted (~800mm) at a derelict house north of these new properties at which point its thought to join a second tributary, then flow through a culvert north down the laneway and under the main street (refer to comment on recent blockage above). The second tributary</p>

Photo 4: The 3 arch bridge over the Galey river
