<b>Location: Carhoonaknock, Co. Kerry</b>		<b>Unique ID: 230346</b> (from PFRA database)	
<b>Initial OPW Designation</b>	<b>APSR</b> <input type="checkbox"/>	<b>AFRR</b> <input checked="" type="checkbox"/>	<b>IRR</b> <input type="checkbox"/>
<b>Co-ordinates</b>	<b>Easting: 96500</b>	<b>Northing: 137750</b>	
<b>River / Catchment / Sub-catchment</b>	<b>The Galey River / Feale Catchment</b>		
<b>Type of Flooding / Flood Risk</b> (identify all that apply)	<b>Fluvial non-tidal</b> <input checked="" type="checkbox"/> <b>Fluvial tidal</b> <input type="checkbox"/> <b>Coastal</b> <input type="checkbox"/>

<b>Stage 2: Site Inspection</b>		<b>Level A Assessment</b>		
<b>Date and Time of Inspection</b>		<b>Date: 26/05/11</b>		
		<b>Time: 16:00</b>		
<b>Names of inspection team (including OPW/LA staff if present)</b>		<b>Iain Blackwell</b>		
		<b>Kelly Kasperczyk</b>		
<b>2.1 Ground-truthing of Hazard Mapping</b>	<b>Fluvial non-tidal</b> <input checked="" type="checkbox"/> <b>Fluvial tidal</b> <input type="checkbox"/> <b>Coastal</b> <input type="checkbox"/> <b>Not available</b> <input type="checkbox"/>			
	<p>The flood extents look reasonable, including at critical locations observed on site in

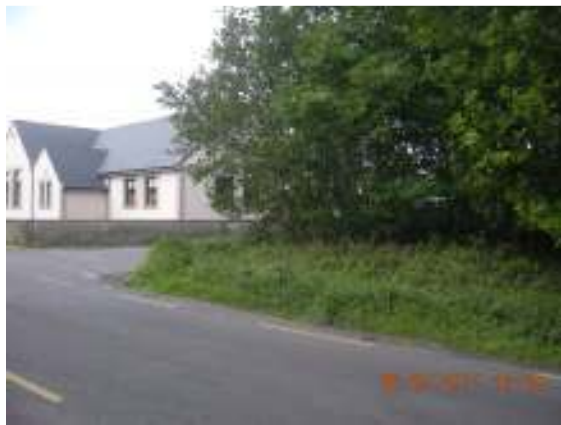
**Photo 1:** Looking NW at Carhoonaknock School, on the right bank of the river the road slopes up to the school

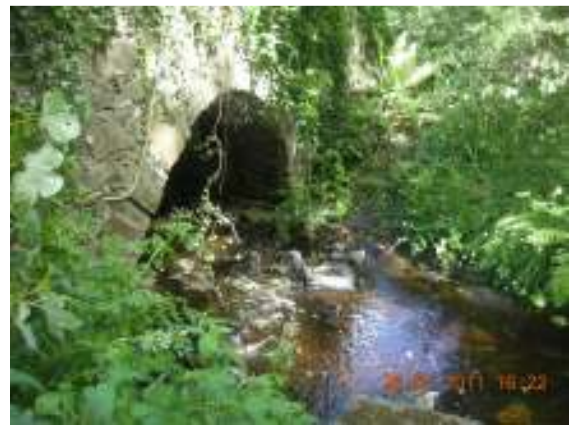
**Photo 2:** D/s side of the single arch bridge southeast of the school

<b>(also note any key receptors noted during visit that are not identified by PFRA)</b>	School		Yes	L
<b>2.3 Local knowledge - on-site comments</b> <b>(OPW, LA and any info volunteered by local residents during visit)</b>	No on site comments			
<b>2.4 Comments on hydraulic constrictions (bridges, etc.) and conveyance routes</b>	<p>Twin culverts present at Garryard (not on the watercourse of primary concern). Single arch bridge adjacent to the school. This could cause a constriction during high flows.</p> <p>Once water goes out of bank at this location, it would spill over the right bank first, between the bridge and the school, and would flow to the southwest away from the school, towards the GGA sports field and local road to the southwest. Water would then either continue along the road or would flow back into the watercourse downstream of the bridge.</p>

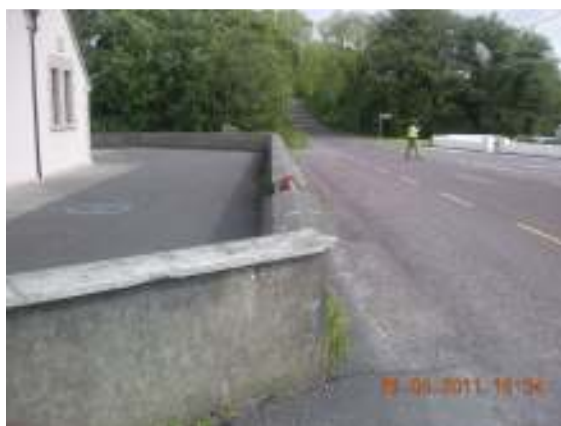
**Photo 3:** Looking SE with the school on the left of the road, can see the slope of the road towards the school with a slight dip in the road at the bridge crossing

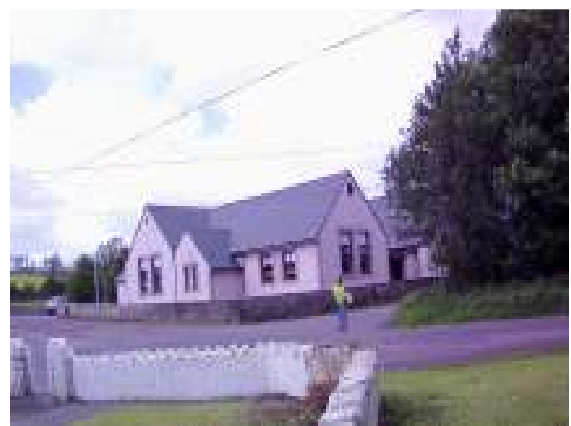
**Photo 4:** Looking towards the school, out of bank flows on the right bank u/s of the bridge will flow along the road between the school and the river then southwest towards the GAA sports field across the road from the school
