| Location: Derryquay, Co. Kerry | | Unique ID: 230349 (from PFRA database) | |

| Project | Shannon CFRAM Study Flood Risk Review Map | | |
| Title | Derryquay | | |

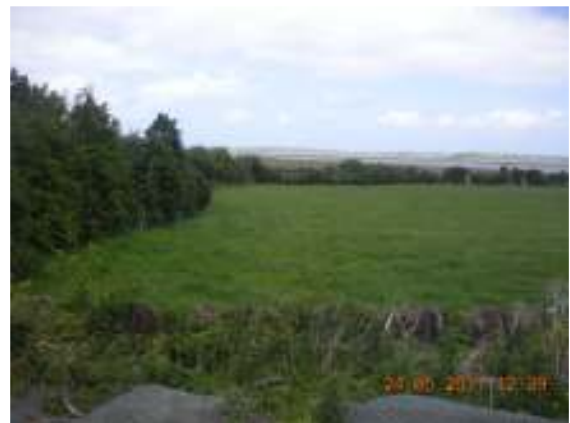
| | The extents of the PFRA mapping appear to be exaggerated north of the N89. The slope here is still quite steep and large areas of flooded land is not likely. | | | |

Photo 2: Lowlands to the north of the main road, dropping down to the tidal flood plain in the distance

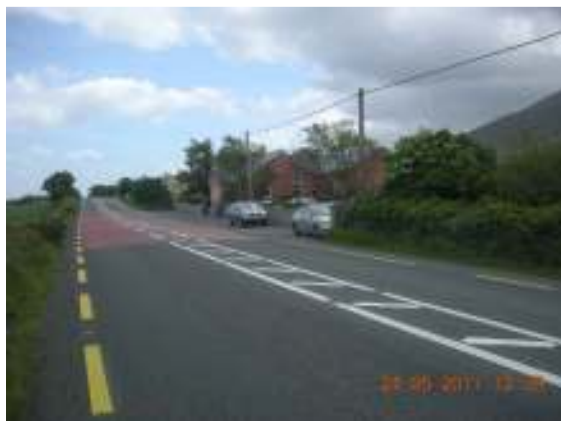
Photo 3: Derryquay School located on the main road through Derryquay

| Summary Comments (if required) | <p>In assessing potential flood risk to the school it was considered that if the culvert opening to the south of the school blocked, the flow path is likely to direct water away from the school (to the west) into the adjacent field (marshy vegetation), and then back towards the stream crossing u/s of the N89 bridge crossing.</p> <p>The school is not considered to be at significant risk.</p> |

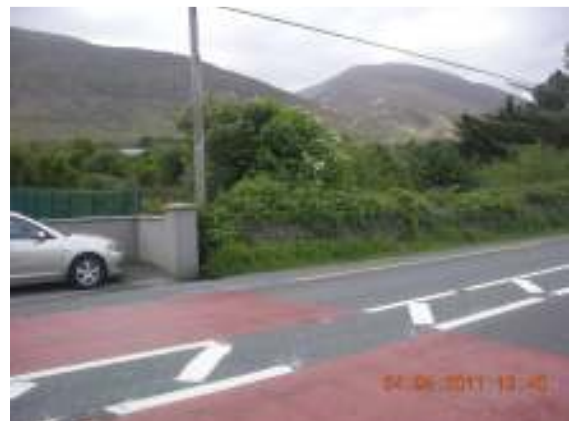
Photo 4: Small watercourse is culverted through the playing field, exiting at the junction of the green fence and the wall

| 2.4 Comments on hydraulic constrictions (bridges, etc.) and conveyance routes | Banks of stream next to school are heavily vegetated u/s of N86 road crossing; potential for blockage. Also, garden waste is dumped on the banks at this location. Unable to view culvert under school grounds. However, in the event that the entrance was blocked, flow would tend to be across the school field and west towards the downstream end of the culvert, rather than into the school. | | | |

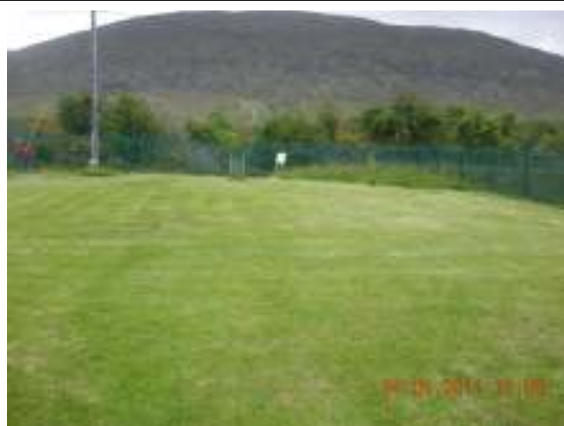
Photo 5: Watercourse is culverted across the school field. Out of bank flows will tend to flow to the west (right in this picture)

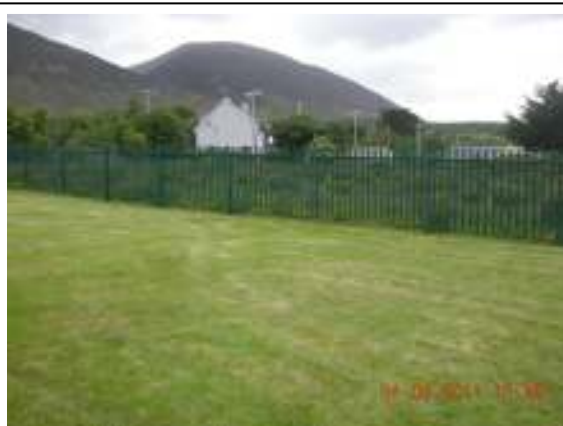
Photo 6: Marshy field adjacent (west) to the school grounds. Most of the properties are higher up, but the front lawns next to the road pond with water.

| 2.3 Local knowledge - on-site comments (OPW, LA and any info volunteered by local residents during visit) | School Principal: The Principal of the school has grown up in the house immediately west of the school. She has never experienced flooding problems associated with the stream that runs behind (and now culverted under) the school (field). Surface water runoff from the mountains has in the past entered the school yard from the fields to the rear (south). This has not impacted on school activities and has drained away naturally without any problem. Stream is culverted under the school field (west of the school building). Front lawns of two properties west of the school stream (and east of next stream) pond with water. Even before these properties were constructed, this field was known to pond. | | | |
