<b>Location: Bruree, Co. Limerick</b>		<b>Unique ID:</b> (from PFRA database)	
<b>Initial OPW Designation</b>	<b>APSR</b> <input type="checkbox"/>	<b>AFRR</b> <input checked="" type="checkbox"/>	<b>IRR</b> <input type="checkbox"/>
<b>Co-ordinates</b>	<b>Easting: 155170</b>	<b>Northing: 130420</b>	
<b>River / Catchment / Sub-catchment</b>	<b>River Maigue</b>		
<b>Type of Flooding / Flood Risk</b> (identify all that apply)	<b>Fluvial non-tidal</b> <input checked="" type="checkbox"/> <b>Fluvial tidal</b> <input type="checkbox"/> <b>Coastal</b> <input type="checkbox"/>

<b>Stage 2: Site Inspection</b>		<b>Level A Assessment</b>		
<b>Date and Time of Inspection</b>		<b>Date: 30/03/11</b>		
		<b>Time: 10:30</b>		
<b>Names of inspection team (including OPW/LA staff if present)</b>		<b>Iain Blackwell</b>		
		<b>Kelly Kasperczyk</b>		
<b>2.1 Ground-truthing of Hazard Mapping</b>	<b>Fluvial non-tidal</b> <input checked="" type="checkbox"/> <b>Fluvial tidal</b> <input type="checkbox"/> <b>Coastal</b> <input type="checkbox"/> <b>Not available</b> <input checked="" type="checkbox"/>			
	Flood outlines appear reasonable, reflecting local topography well.			
<b>2.2 Spot check ground-truthing of s

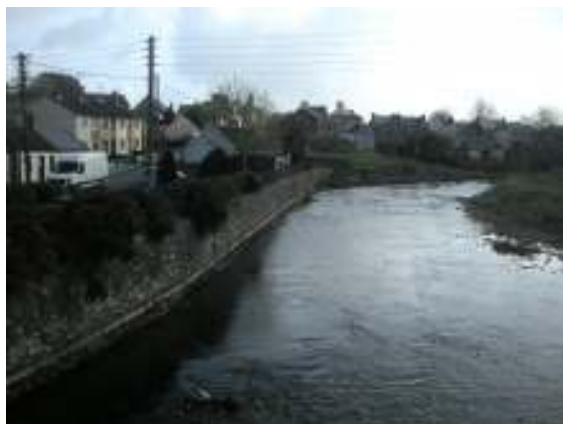
**Photo 1:** River Maigue u/s of multi-arch bridge. Properties on the right bank protected by a flood wall.

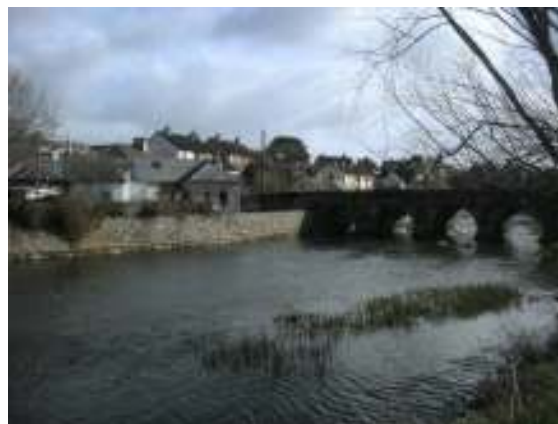
**Photo 2:** Downstream side of multi-arch bridge. Some low properties on d/s side on right bank.

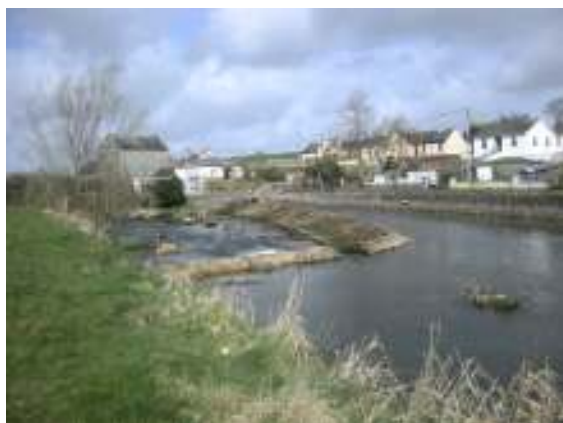
**Photo 3:** Mill and weir located d/s of the bridge. Most properties on the right bank are elevated above the flood plain.

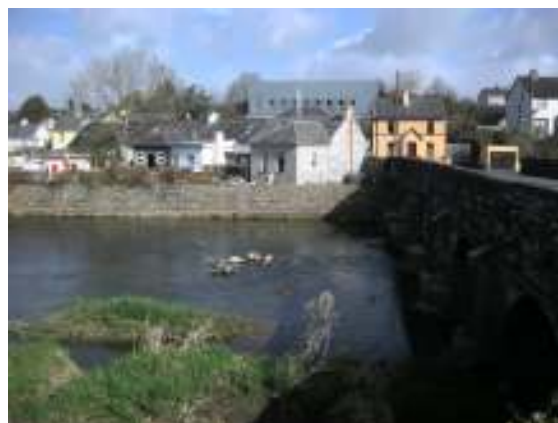
**Photo 4:** Low lying properties on the right bank immediately d/s of the bridge.

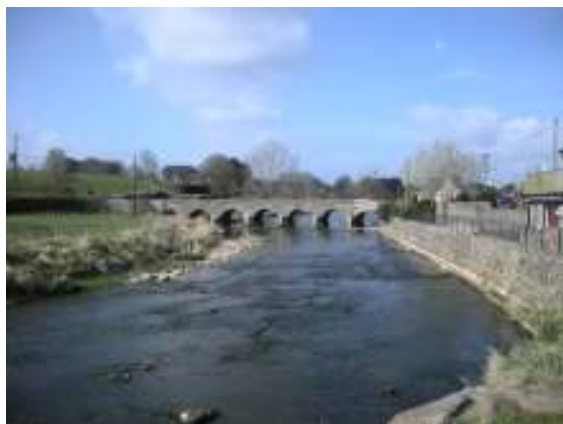
**Photo 5:** River looking d/s to the main bridge. Properties on the left bank have partial protection from the wall on the right bank. Limited flood plain on the left bank with the land rising sharply.

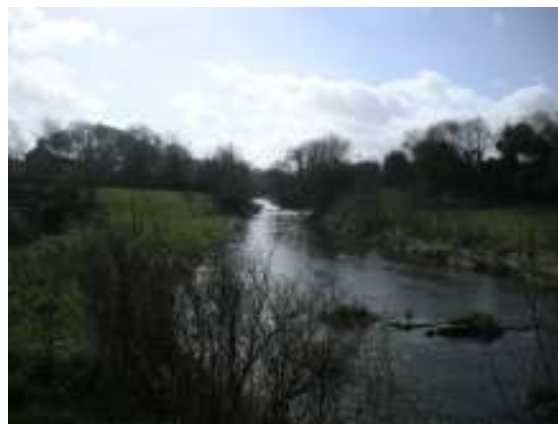
**Photo 6:** U/s view on the approach to Bruree. Left bank (on right on photo) is seen to much lower than the right bank.
