Location: Annacotty, Co. Limerick		Unique ID: 252771 (from PFRA database)	
Initial OPW Designation	APSR <input type="checkbox"/>	AFRR <input checked="" type="checkbox"/>	IRR <input type="checkbox"/>
Co-ordinates	Easting: 165211	Northing: 158095	
River / Catchment / Sub-catchment	Tributary to the Mulkear / Shannon		
Type of Flooding / Flood Risk (identify all that apply)	Fluvial non-tidal <input checked="" type="checkbox"/> Fluvial tidal <input type="checkbox"/> Coastal <input type="checkbox"/>

Stage 2: Site Inspection		Level A Assessment		
Date and Time of Inspection		Date: 09/06/11		
		Time: 13:00		
Names of inspection team (including OPW/LA staff if present)		Mathieu Valois		
		James Murray

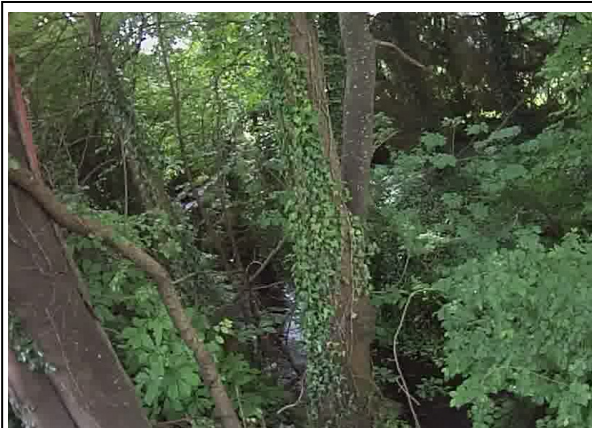
2.3 Local knowledge - on-site comments (OPW, LA and any info volunteered by local residents during visit)	No on-site comments			
2.4 Comments on hydraulic constrictions (bridges, etc.) and conveyance routes	There is a 450 diameter culvert in the corner of the public house car park. The culvert may provide a hydraulic constraint. However, this is unlikely to result in flooding as there is sufficient channel and floodplain capacity upstream of the culvert.

Photo1: Watercourse upstream of road culvert.

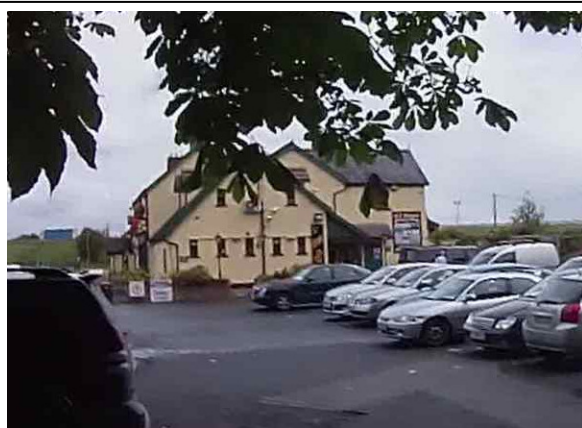
2.2 Spot check ground-truthing of selected receptor vulnerability (also note any key receptors noted during visit that are not identified by PFRA)	Receptor Type	Location description (if not obvious)	Exists?	Overall Vulnerability / Risk (L / M / H)
	There is a public house / restaurant	Situated on the left bank of the tributary	Yes	Low

Photo 2: Pub / restaurant off left bank of watercourse.
