Location: Longford, Co. Longford		Unique ID: 260464 (from PFRA database)	
Initial OPW Designation	APSR <input checked="" type="checkbox"/>	AFRR <input type="checkbox"/>	IRR <input type="checkbox"/>
Co-ordinates	Easting: 213,853	Northing: 274,765	
River / Catchment / Sub-catchment	Camlin River / River Shannon		
Type of Flooding / Flood Risk (identify all that apply)	Fluvial non-tidal <input checked="" type="checkbox"/>	Fluvial tidal <input type="checkbox"/>	Coastal <input type="checkbox"/>

Stage 2: Site Inspection		Level B Assessment	
Date and Time of Inspection		Date: 18/05/11	
		Time: 13:00	
Names of inspection team (including OPW/LA staff if present)		Alan Dew	
		James Murray

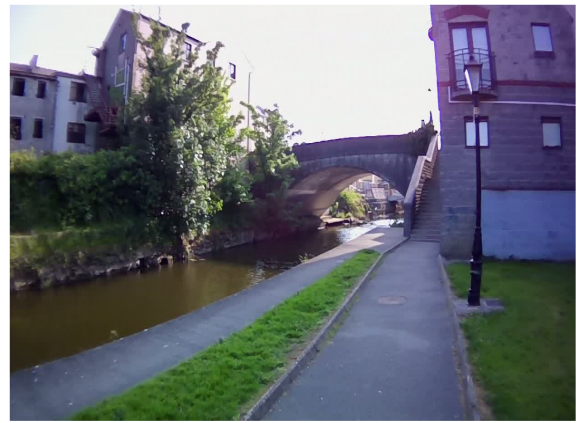
Photo 2: R198 road bridge over the River Camlin, viewed from the upstream right bank.

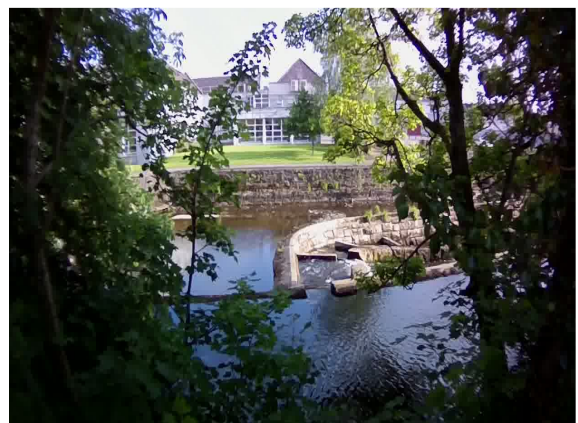
Photo 4: Weir on the River Camlin, viewed from the right bank, with Longford CoCo's offices at the rear on the left bank.
