Location: Portumna, Co. Galway		Unique ID: 250437 (from PFRA database)	
Initial OPW Designation	APSR <input checked="" type="checkbox"/>	AFRR <input type="checkbox"/>	IRR <input type="checkbox"/>
Co-ordinates	Easting: 185298	Northing: 204550	
River / Catchment / Sub-catchment	River Shannon / Shannon		
Type of Flooding / Flood Risk (identify all that apply)	Fluvial non-tidal <input checked="" type="checkbox"/> Fluvial tidal <input type="checkbox"/> Coastal <input type="checkbox"/>

Stage 2: Site Inspection		Level B Assessment	
Date and Time of Inspection		Date: 01/06/11	
		Time: 15:00	
Names of inspection team (including OPW/LA staff if present)		Peter Smyth	
		Mathieu Valois

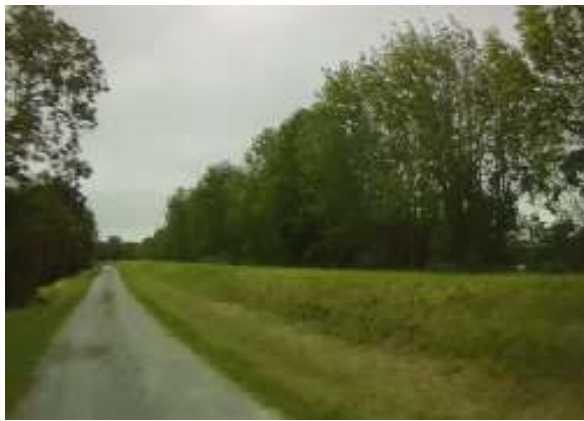
Photo1: ESB maintained embankments at Portumna.

2.3 Local knowledge - on-site comments (OPW, LA and any info volunteered by local residents during visit)	<p>An ESB representative was met on site informally. He confirmed ESB is maintaining the flood defence on the right bank of the Shannon. The floodplain behind the flood defence is drained by a network of ditches which are pumped into the Shannon. The pumping station is ESB asset.</p> <p>Local resident confirms flooding lasted at least 3 weeks in Nov 2009. He also mentioned localised flooding on St Joseph Rd from a tributary. A B&B by the road bridge was flooded.</p>

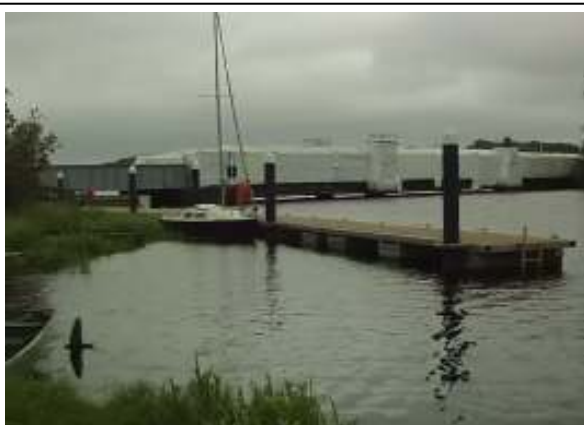
Photo 3: N65 Road Bridge at Portumna, maintenance works being carried out..

2.4 Comments on hydraulic constrictions (bridges, etc.) and conveyance routes	<p>N65 road bridge across Shannon and upstream of Lough Derg. Multi-span (rectangular openings) with steel parapet and low soffit level. There is a movable span to allow navigation along the Shannon, which is opened at fixed times every day.</p>

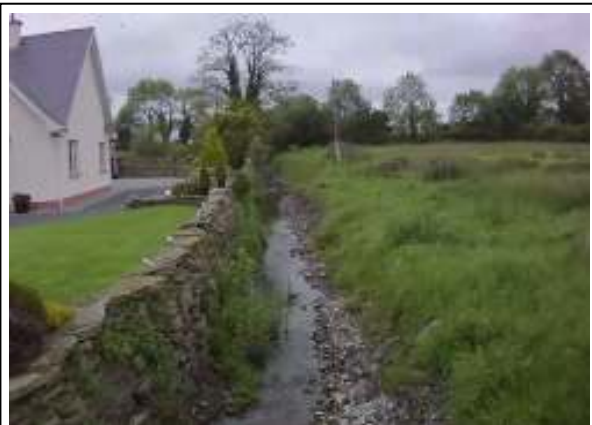
Photo 4: Tributary to the Shannon at Portumna.
