Location: Cranny, Co. Clare		Unique ID: 270473 (from PFRA database)	
Initial OPW Designation	APSR <input type="checkbox"/>	AFRR <input checked="" type="checkbox"/>	IRR <input type="checkbox"/>
Co-ordinates	Easting: 116750		Northing: 160500
River / Catchment / Sub-catchment	Cloon River / Shannon Estuary		
Type of Flooding / Flood Risk (identify all that apply)	Fluvial non-tidal <input checked="" type="checkbox"/> Fluvial tidal <input type="checkbox"/> Coastal <input type="checkbox"/>

Stage 1: Desktop Review

Stage 2: Site Inspection		Level A Assessment		
Date and Time of Inspection		Date: 07/06/11		
		Time: 19:20		
Names of inspection team (including OPW/LA staff if present)		Iain Blackwell		
		Lewis Maani

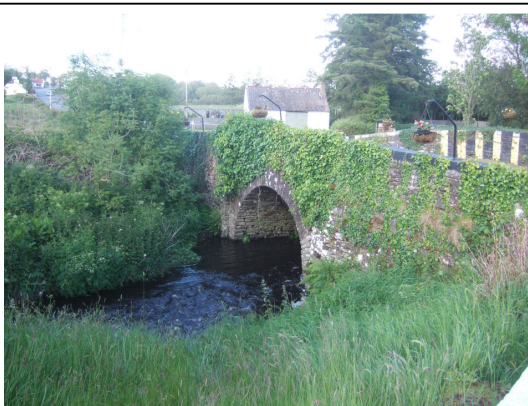
Photo 1: Bridge of the River Cloon in Cranny

2.3 Local knowledge - on-site comments (OPW, LA and any info volunteered by local residents during visit)	No on site comments			
2.4 Comments on hydraulic constrictions (bridges, etc.) and conveyance routes	Croony bridge appears to provide adequate conveyance capacity. However, there is the potential for severe flood events to cause flood low lying areas on the left bank. Generally the valley sides are steep and there are no alternative conveyance routes during flood flows.

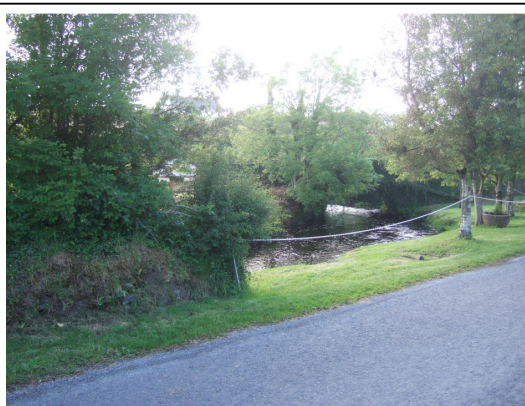
Photo 2: Road on the left bank just downstream of the bridge.

2.1 Ground-truthing of Hazard Mapping	Fluvial non-tidal <input checked="" type="checkbox"/> Fluvial tidal <input type="checkbox"/> Coastal <input type="checkbox"/> Not available <input type="checkbox"/>			
	Flood hazard mapping appears reasonable. Flooding of the road on the left on left bank immediately downstream of Croony Bridge (near to the ESB substation) is feasible.

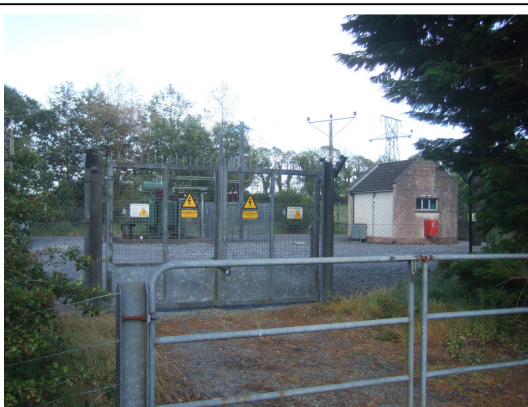
Photo 3: ESB 38 kV Substation compound

2.2 Spot check ground-truthing of selected receptor vulnerability	Receptor Type	Location description (if not obvious)	Exists?	Overall Vulnerability / Risk (L / M / H)
(also note any key receptors noted during visit that are not identified by PFRA)	ESB substation (local distribution)	Approximately 30m away from river on left bank downstream off bridge.	Yes	M
	Single Residential property/House	Right bank downstream of bridge.	Yes	L

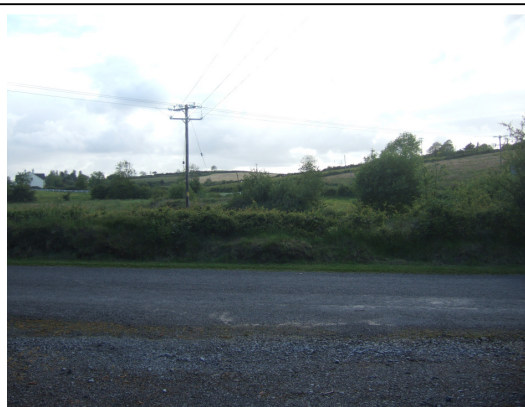
Photo 4: Gravelled area in the foreground is the entrance to the ESB compound. River is located behind small embankment (near the telegraph pole).

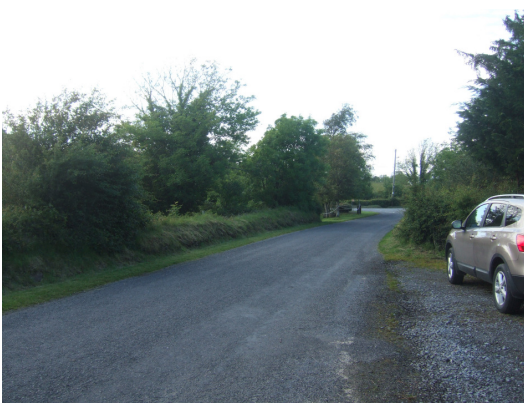
Photo 5: Road with the compound entrance on the right, looking upstream towards the bridge.

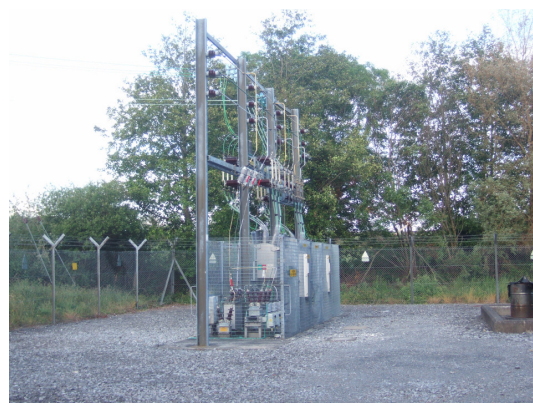
Photo 6: ESB substation equipment

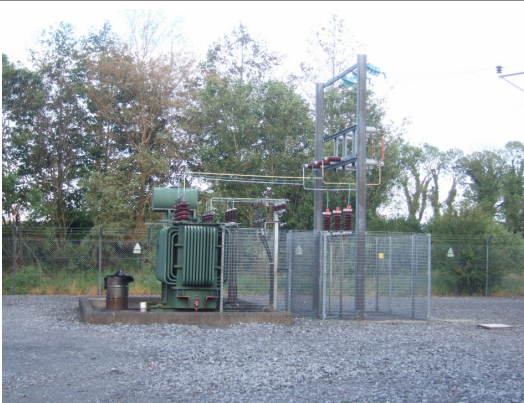
Photo 7: ESB substation equipment. Note the low bund around the transformer.

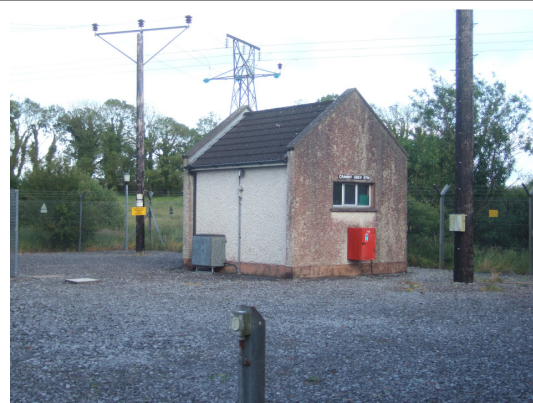
Photo 8: ESB substation equipment - control room
