<b>Location: Tromracastle, Co. Clare</b>		<b>Unique ID: 280483</b> (from PFRA database)	
<b>Initial OPW Designation</b>	<b>APSR</b> <input type="checkbox"/>	<b>AFRR</b> <input checked="" type="checkbox"/>	<b>IRR</b> <input type="checkbox"/>
<b>Co-ordinates</b>	<b>Easting: 99750</b>		<b>Northing: 173000</b>
<b>River / Catchment / Sub-catchment</b>	<b>Ballymakea River / Inagh Catchment</b>		
<b>Type of Flooding / Flood Risk</b> (identify all that apply)	<b>Fluvial non-tidal</b> <input type="checkbox"/> <b>Fluvial tidal</b> <input checked="" type="checkbox"/> <b>Coastal</b> <input type="checkbox"/>

## Stage 1: Desktop Review

<b>Stage 2: Site Inspection</b>		<b>Level A Assessment</b>		
<b>Date and Time of Inspection</b>		<b>Date: 08/06/11</b>		
		<b>Time: 10:00</b>		
<b>Names of inspection team (including OPW/LA staff if present)</b>		<b>Iain Blackwell</b>		
		<b>Lewis Maani</b>		
<b>2.1 Ground-truthing of Hazard Mapping</b>	<b>Fluvial non-tidal</b> <input type="checkbox"/> <b>Fluvial tidal</b> <input checked="" type="checkbox"/> <b>Coastal</b> <input checked="" type="checkbox"/> <b>Not available</b> <input checked="" type="checkbox"/>			
	Reasonable outline of fluvial flooding, show

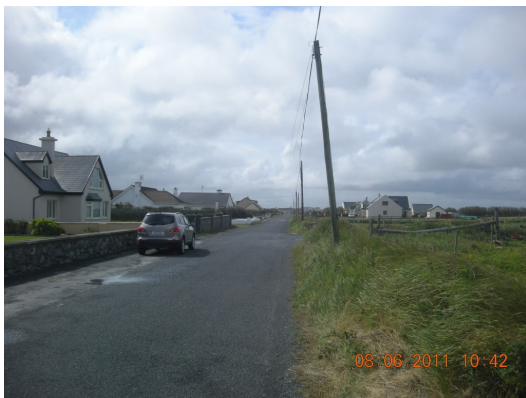
**Photo 1:** Properties along the N-S local road in Tromracastle. These are protected by dunes to the west (right of this picture).

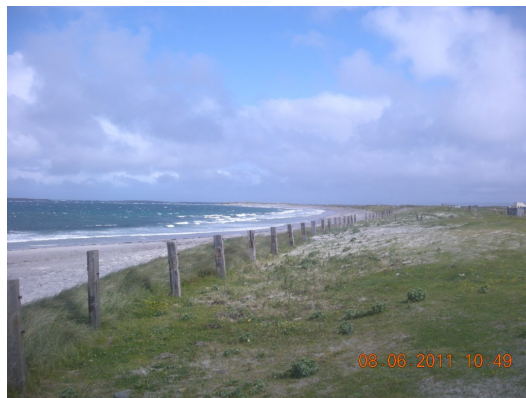
**Photo 2:** Dunes protecting Tromracastle. Line of fence posts (in place for many years) show no indication of active erosion at this location.

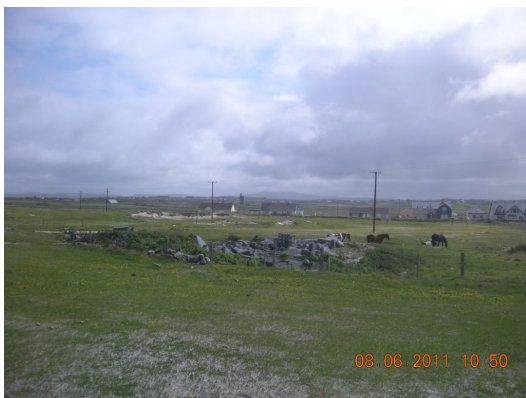
**Photo 3:** Looking inland towards the properties from the top of the dunes.

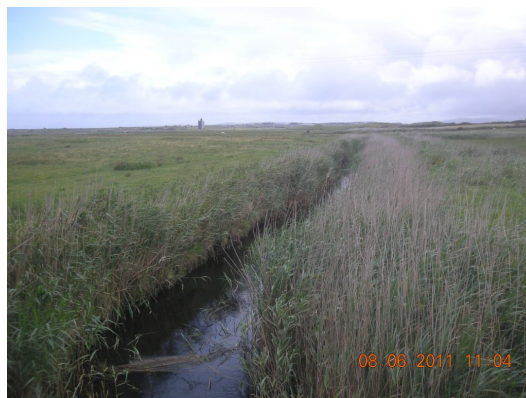
**Photo 4:** Watercourse behind the dunes and low lying area providing significant storage. Tromra Castle remains in the background on the horizon.

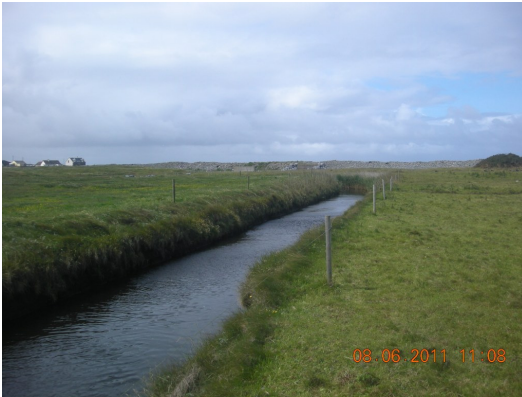
**Photo 5:** Watercourse immediately upstream of the outfall looking inland. Properties on the left next to road are elevated above the surrounding flood plain.

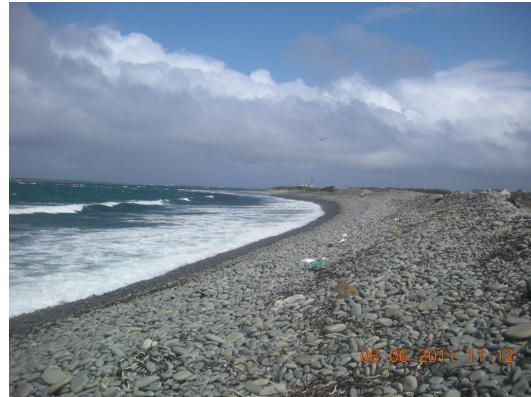
**Photo 6:** Shingle ridge at the south of Tromracastle through which the outfalls discharge.

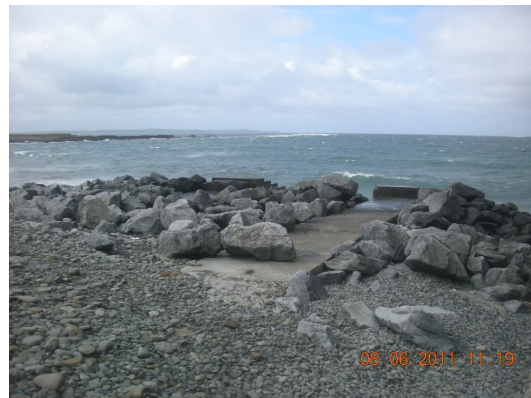
**Photo 8:** Downstream side of one of the outfall structures, heavily protected by rock armour.

<b>2.8 Initial Potential Mitigation Measures</b>	
<b>Non-structural measures</b>	<p>Planning and Development control <input checked="" type="checkbox"/>          Sustainable Urban Drainage Systems <input type="checkbox"/>          Flood forecasting / warning <input checked="" type="checkbox"/> (Extreme tides)          Change in Operating Procedures for water level control: <input type="checkbox"/>          Public awareness campaign <input type="checkbox"/>          Individual property protection <input checked="" type="checkbox"/>          Land use management <input type="checkbox"/></p>
<b>Structural measures</b>	<p><b>Strategic development management for floodplain development:</b> <input type="checkbox"/>  <i>(integration of measures into strategic development proposals)</i></p> <p><b>Storage:</b>      On-line <input checked="" type="checkbox"/>      Off-line <input type="checkbox"/></p> <p><b>Flow diversion:</b> Flood relief channel <input type="checkbox"/>      Flood relief culvert <input type="checkbox"/></p> <p><b>Increase conveyance:</b> Bridge works <input type="checkbox"/>      Channel works <input type="checkbox"/>      Floodplain <input type="checkbox"/></p> <p><b>Flood defences:</b>      Walls <input type="checkbox"/>      Embankments <input type="checkbox"/></p> <p><b>Localised works:</b>      Defence raising <input type="checkbox"/>      In-fill gaps <input type="checkbox"/>      Trash screen <input type="checkbox"/></p> <p><b>Maintenance works:</b> Culvert / channel clearance <input checked="" type="checkbox"/>      Asset maintenance <input checked="" type="checkbox"/></p> <p><b>Relocation of properties:</b> <input type="checkbox"/></p> <p><b>Improve existing defences:</b> <input type="checkbox"/> (describe)</p> <p><b>Other (describe):</b>          Intermittent monitoring of shingle ridge and sand dune levels to identify any changes in profile after major storm events. Intermittent condition inspection of the outfall structures at low tide to check for blockage and deterioration.</p>
