Location: Kildimo New, Co. Limerick		Unique ID: 240385 (from PFRA database)	
Initial OPW Designation	APSR <input checked="" type="checkbox"/>	AFRR <input type="checkbox"/>	IRR <input type="checkbox"/>
Co-ordinates	Easting: 145250	Northing: 152750	
River / Catchment / Sub-catchment	Unnamed tributary of the Maigue / Maigue Catchment		
Type of Flooding / Flood Risk (identify all that apply)	Fluvial non-tidal <input checked="" type="checkbox"/> Fluvial tidal <input checked="" type="checkbox"/> Coastal <input type="checkbox"/>

Stage 2: Site Inspection		Level A Assessment		
Date and Time of Inspection		Date: 13/04/11 and 08/09/11		
		Time: 18:00 and 10:00		
Names of inspection team (including OPW/LA staff if present)		Iain Blackwell (13/04/11)		
		Kelly Kasperczyk (13/04/11)		
		Iain Blackwell (08/09/11)		
		Peter Smyth (08/09/11)

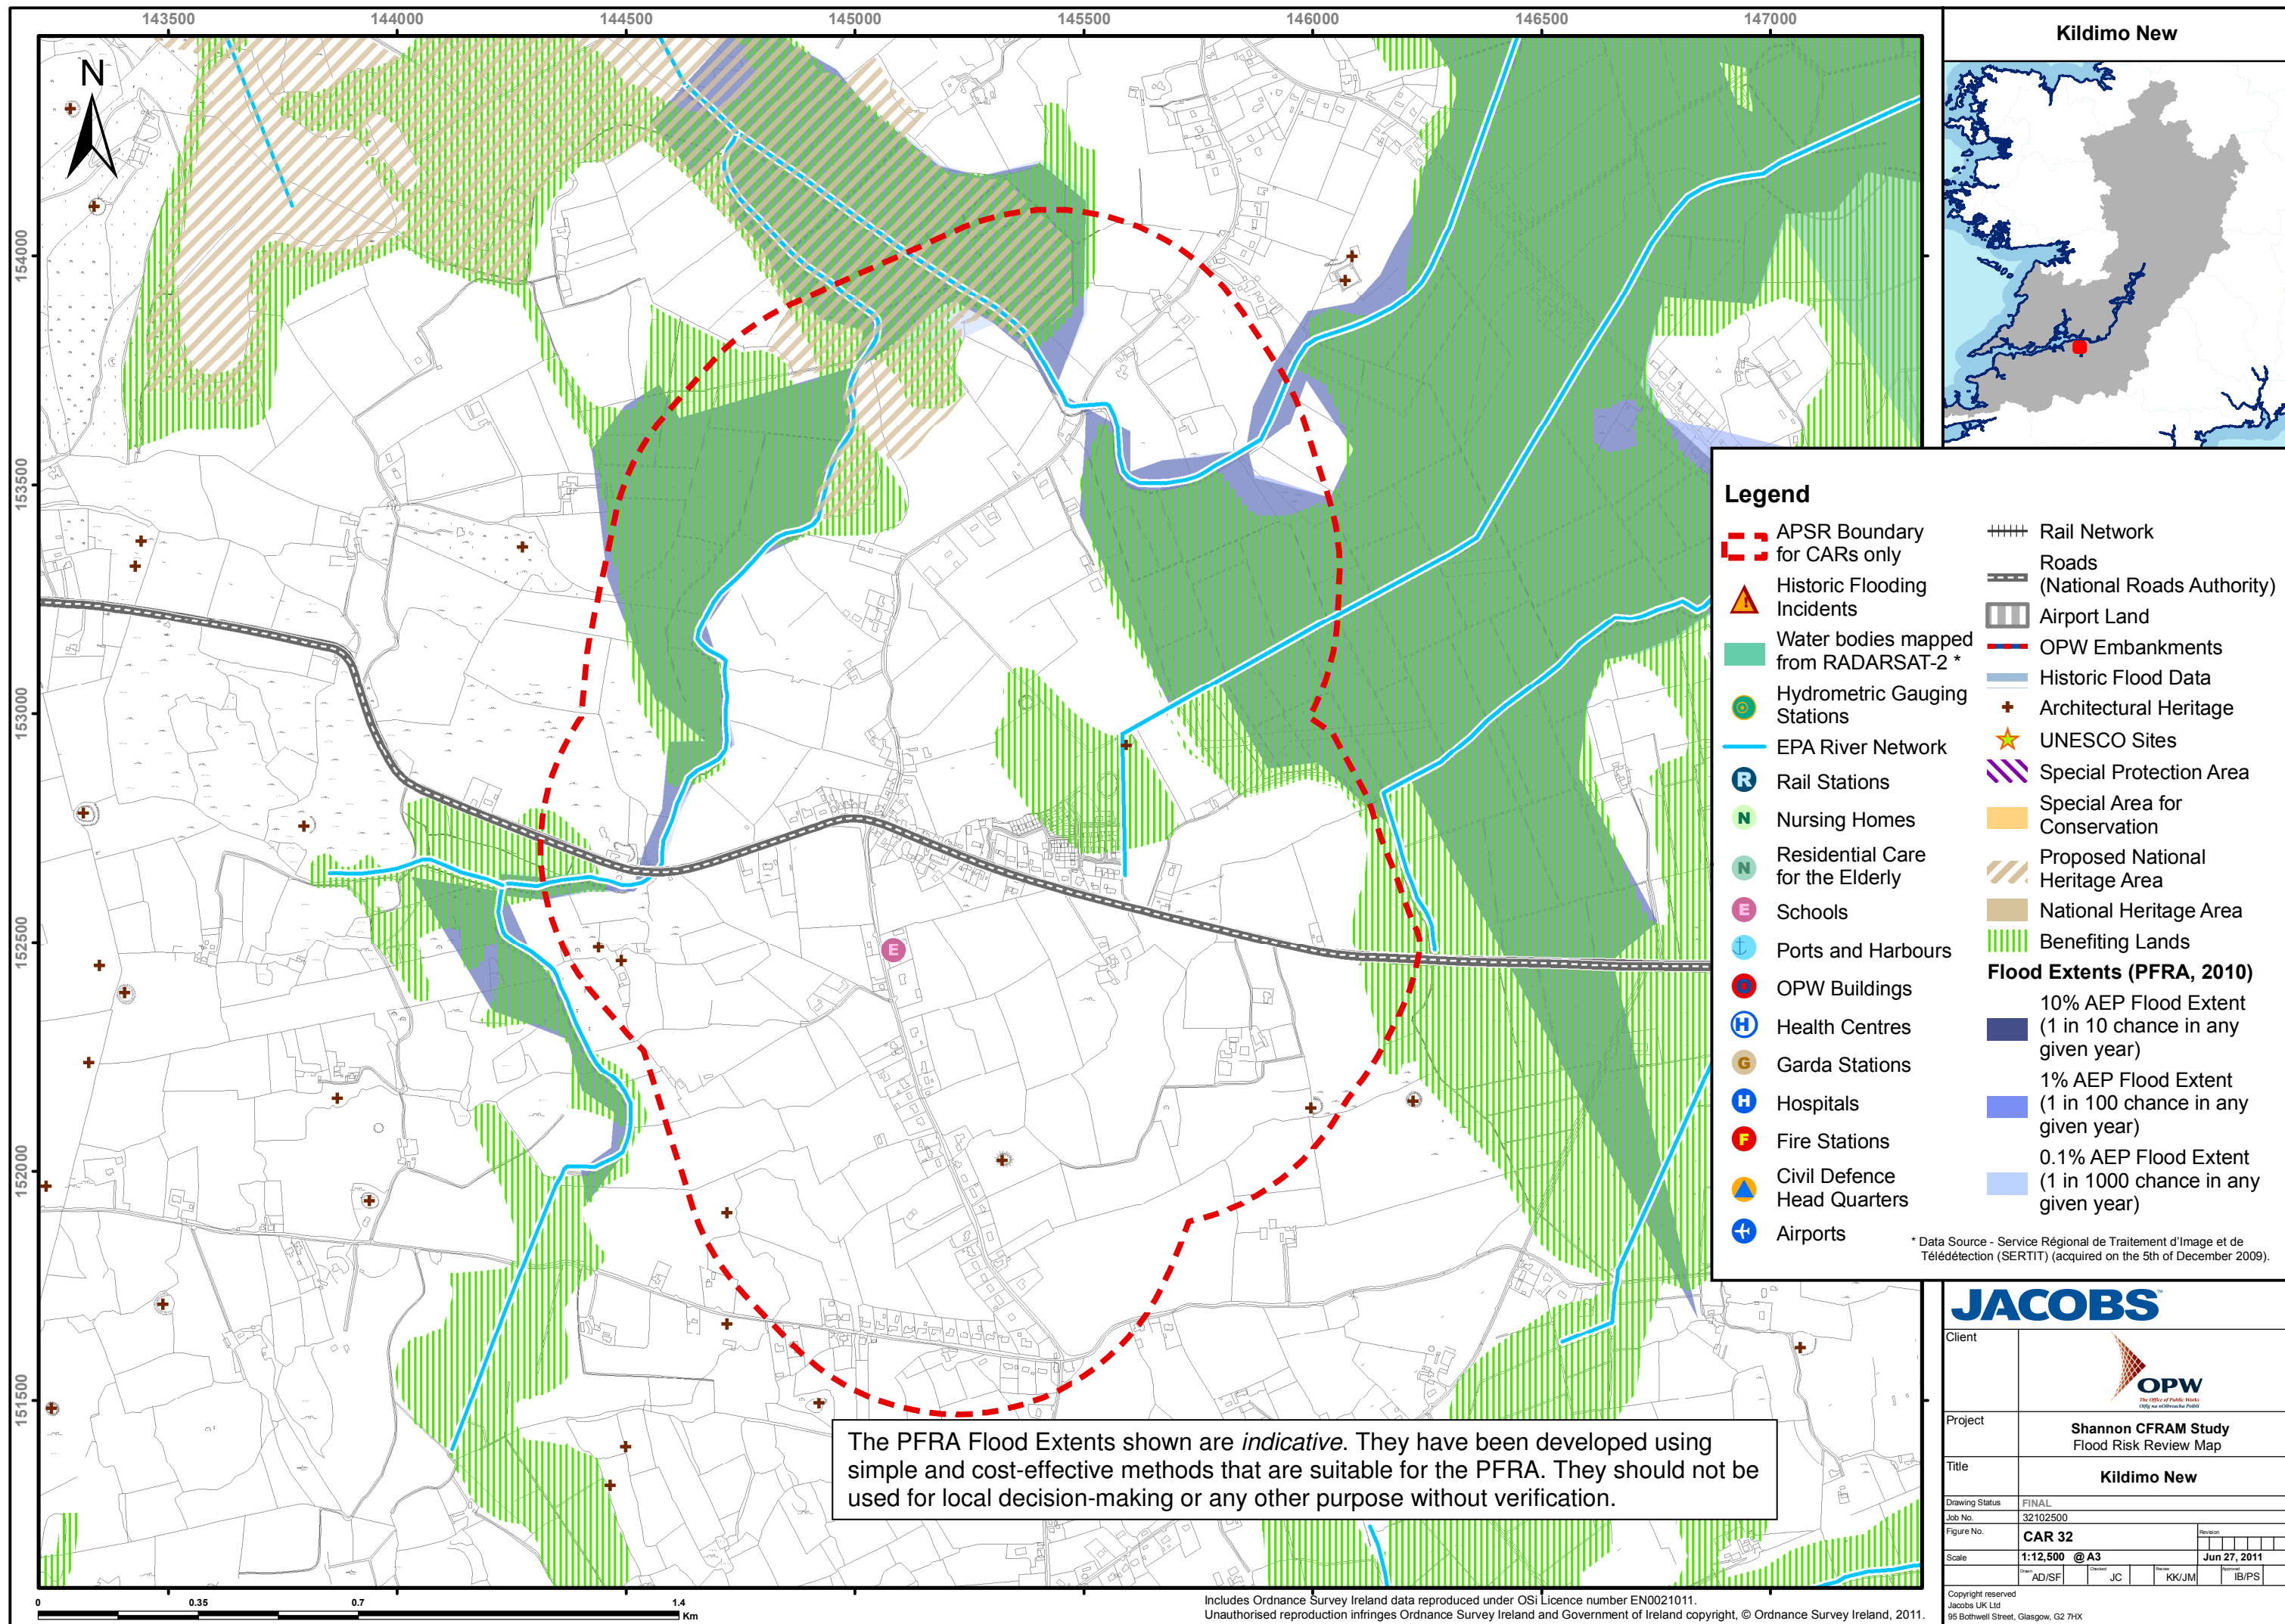
It is noted that in the event of a breach of the Maigue embankments, the townland of Faha, north-east of Kildimo New, could be considered to be at potentially significant risk. However, this is well outside the APSR boundary for Kildimo New.

Photo 8: Low lying land behind the Maigue embankment on the left bank, northeast of Kildimo New near Faha. Ground level here is estimated to be around 1.5 to 2.0m below the ground level at the housing estate.
