<b>Location: Carrowmore, Co. Clare</b>		<b>Unique ID: 280484</b> (from PFRA database)	
<b>Initial OPW Designation</b>	<b>APSR</b> <input checked="" type="checkbox"/>	<b>AFRR</b> <input type="checkbox"/>	<b>IRR</b> <input type="checkbox"/>
<b>Co-ordinates</b>	<b>Easting: 98741</b>		<b>Northing: 166936</b>
<b>River / Catchment / Sub-catchment</b>	<b>Skivileen River/ Inagh Catchment</b>		
<b>Type of Flooding / Flood Risk</b> (identify all that apply)	<b>Fluvial non-tidal</b> <input type="checkbox"/> <b>Fluvial tidal</b> <input checked="" type="checkbox"/> <b>Coastal</b> <input type="checkbox"/>

## Stage 1: Desktop Review

<b>Stage 2: Site Inspection</b>		<b>Level A Assessment</b>		
<b>Date and Time of Inspection</b>		<b>Date: 08/06/11</b>		
		<b>Time: 12:00</b>		
<b>Names of inspection team (including OPW/LA staff if present)</b>		<b>Iain Blackwell</b>		
		<b>Lewis Maani</b>		
<b>2.1 Ground-truthing of Hazard Mapping</b>	<b>Fluvial non-tidal</b> <input type="checkbox"/> <b>Fluvial tidal</b> <input checked="" type="checkbox"/> <b>Coastal</b> <input type="checkbox"/> <b>Not available</b> <input type="checkbox"/>			
	Outline appears to be reasonable for most areas. However, the accommod

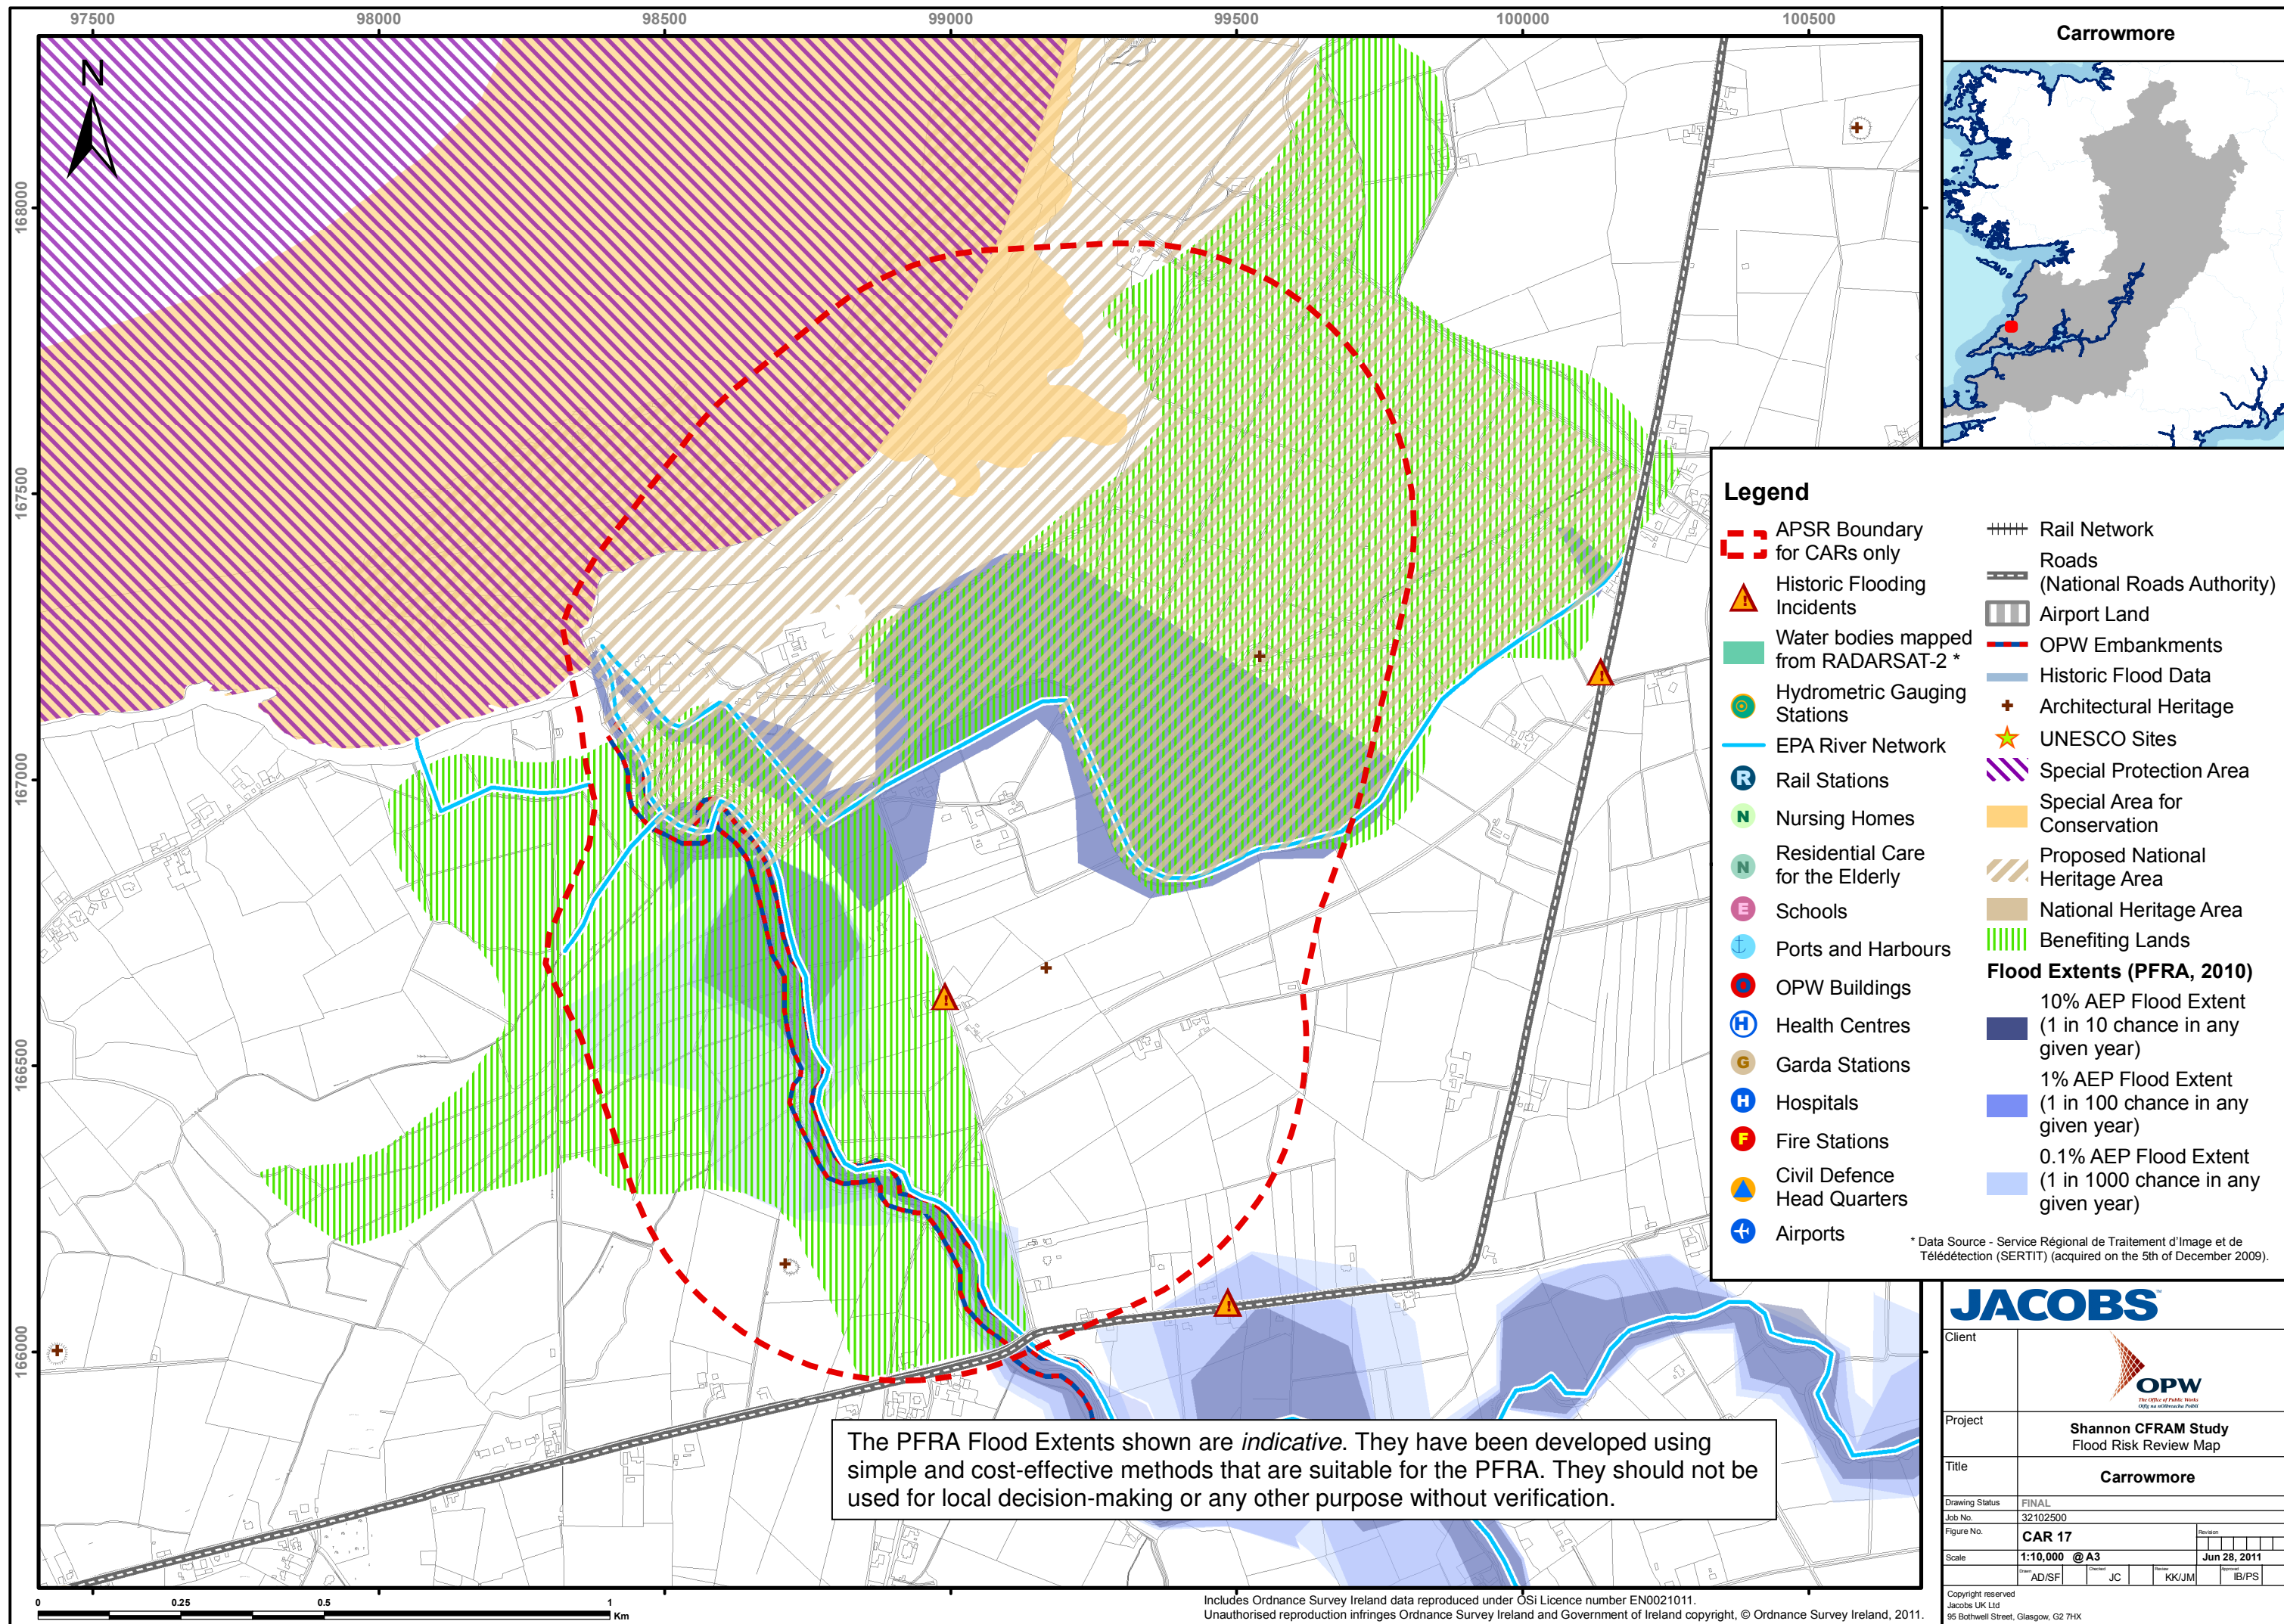
Clare County Council noted that there are flooding problems on the N67 just to the east of the small road leading to Carrowmore. On inspection, this is considered to be surface water flooding. The area is very flat, but also elevated up to 2m above the N67 road level at the crossing of the Skivleen River. Hence, this reported regular flooding of the road is considered to be a surface water / land drainage issue rather than fluvial flooding.

**Photo 8:** N67 just east of the crossing of the Skivileen River. This road is approximately 2m higher than the road level at the bridge crossing. Flooding here is considered to be surface water and land drainage related, rather than fluvial.
