Location: Bruff, Co. Limerick		Unique ID: 242701 (from PFRA database)	
Initial OPW Designation	APSR <input type="checkbox"/>	AFRR <input checked="" type="checkbox"/>	IRR <input type="checkbox"/>
Co-ordinates	Easting: 162739	Northing: 135960	
River / Catchment / Sub-catchment	Morningstar River/ Maigne Catchment		
Type of Flooding / Flood Risk (identify all that apply)	Fluvial non-tidal <input checked="" type="checkbox"/> Fluvial tidal <input type="checkbox"/> Coastal <input type="checkbox"/>

Stage 2: Site Inspection		Level A Assessment		
Date and Time of Inspection		Date: 29/03/11		
		Time: 13:50		
Names of inspection team (including OPW/LA staff if present)		Iain Blackwell		
		Kelly Kasperczyk

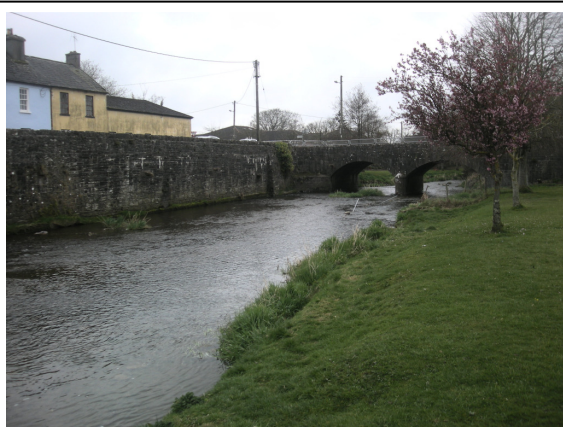
Photo 1: River in between the two main bridges in Bruff, looking d/s. The wall on the left bank (informal defence) provides protection to properties on the left bank under extreme events.

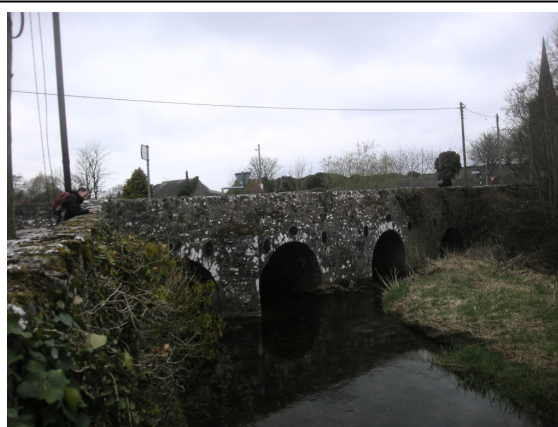
Photo 2: Upstream side of the u/s bridge. Skew angle, channel vegetation and restrictive arches would lead to significant head loss across the bridge in high flows. Wall on left (informal defence) provides protection to left bank.

2.3 Local knowledge - on-site comments (OPW, LA and any info volunteered by local residents during visit)	No on site comments			
2.4 Comments on hydraulic constrictions (bridges, etc.) and conveyance routes	Two main multi-arch bridges through town. Upstream bridge (5-arch) is more of a constriction than the d/s bridge (2-arch). Skew angle and approach of water to u/s bridge will give significant hydraulic losses. Flow almost parallel across the entrance to the two left hand arches. Conveyance restricted in places due to vegetation. No alternative conveyance routes.

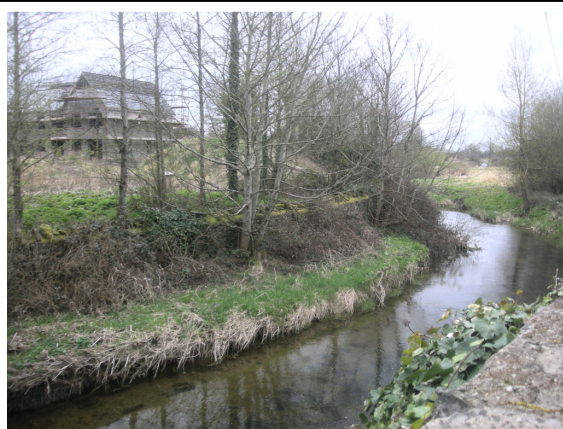
Photo 3: River u/s of the most upstream bridge. Incomplete development on right bank potentially at risk of flooding.

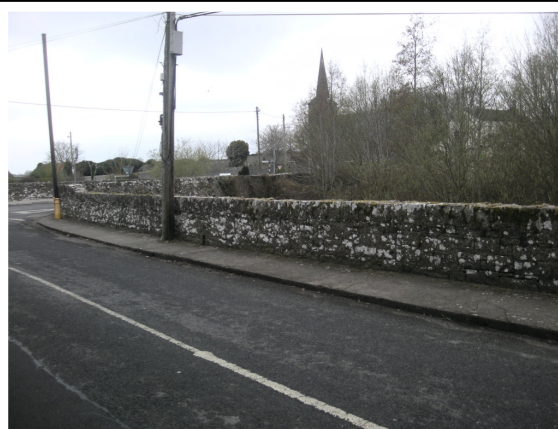
Photo 4: Informal flood defence asset on the left bank, u/s of the most upstream bridge in Bruff.

Outfalls Flapped outfall(s) into watercourse <input type="checkbox"/> Unflapped outfall(s) into watercourse <input type="checkbox"/> <i>i.e. from smaller watercourses, drains etc. into river / estuary / sea</i> Tidal flap(s) <input type="checkbox"/> Tidal sluice(s) <input type="checkbox"/> <i>i.e. from main watercourse into estuary / sea</i> Other Pumping Station <input type="checkbox"/> Erosion Protection <input type="checkbox"/> Sand Dunes <input type="checkbox"/> Additional notes (if required): Informal flood defence walls between 2 bridges and u/s on left bank for approx 400m. Appears to be an effective flood defence asset.
--	--
