Location: Kildimo New, Co. Limerick		Unique ID: 240385 (from PFRA database)	
Initial OPW Designation	APSR <input checked="" type="checkbox"/>	AFRR <input type="checkbox"/>	IRR <input type="checkbox"/>
Co-ordinates	Easting: 145250	Northing: 152750	
River / Catchment / Sub-catchment	Unnamed tributary of the Maigue / Maigue Catchment		
Type of Flooding / Flood Risk (identify all that apply)	Fluvial non-tidal <input checked="" type="checkbox"/>	Fluvial tidal <input checked="" type="checkbox"/>	Coastal <input type="checkbox"/>

Stage 2: Site Inspection		Level A Assessment		
Date and Time of Inspection		Date: 13/04/11 and 08/09/11		
		Time: 18:00 and 10:00		
Names of inspection team (including OPW/LA staff if present)		Iain Blackwell (13/04/11)		
		Kelly Kasperczyk (13/04/11)		
		Iain Blackwell (08/09/11)		
		Peter Smyth (08/09/11)

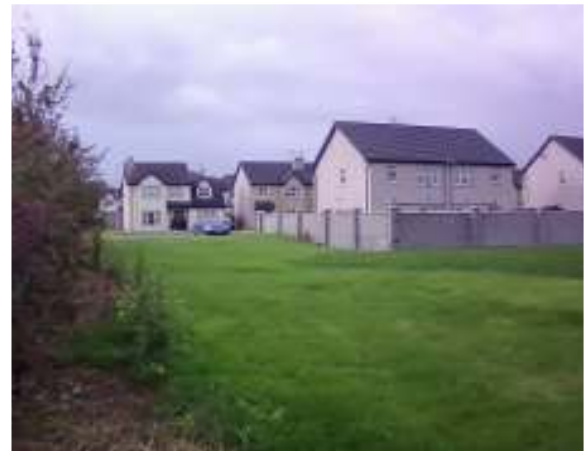
Photo 2: Properties on housing estate on eastern edge of New Kildimo.

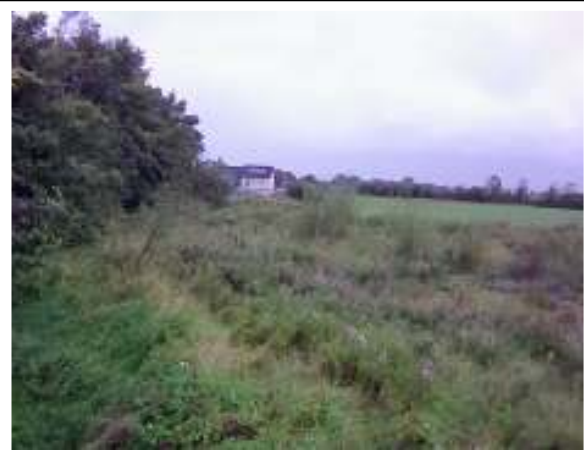
Photo 4: New Kildimo Looking d/s from the culvert crossing on the N69 at the eastern edge of the village. Property in the distance is on the edge of the housing estate. Minor watercourse is located adjacent to the trees on the left.

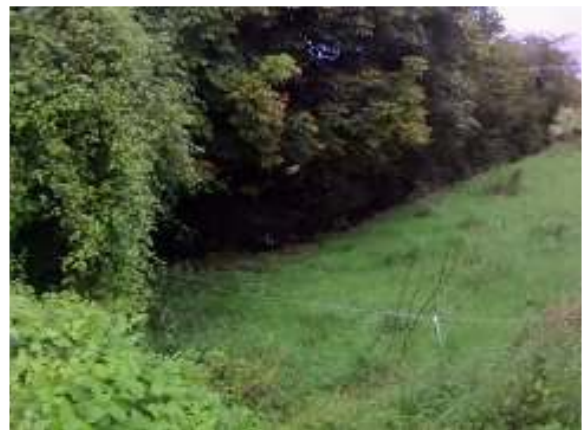
Photo 6: Watercourse downstream of crossing (shown in Photo 5) located in rural area with only a few properties located nearby (not at significant risk).
