Location: Kilmallock, Co. Limerick		Unique ID: 240388 (from PFRA database)	
Initial OPW Designation	APSR <input checked="" type="checkbox"/>	AFRR <input type="checkbox"/>	IRR <input type="checkbox"/>
Co-ordinates	Easting: 161126	Northing: 127573	
River / Catchment / Sub-catchment	River Loobagh / Maigue Catchment		
Type of Flooding / Flood Risk (identify all that apply)	Fluvial non-tidal <input checked="" type="checkbox"/> Fluvial tidal <input type="checkbox"/> Coastal <input type="checkbox"/>

Stage 2: Site Inspection		Level A Assessment		
Date and Time of Inspection		Date: 29/03/11		
		Time: 16:15		
Names of inspection team (including OPW/LA staff if present)		Iain Blackwell		
		Kelly Kasperczyk

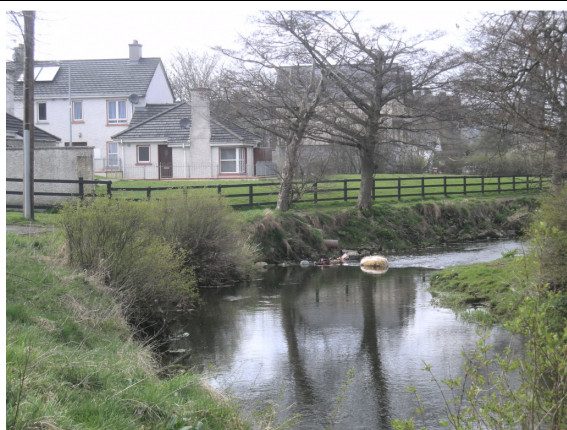
Photo 1: Housing built on relatively low lying land next to the River Loobagh

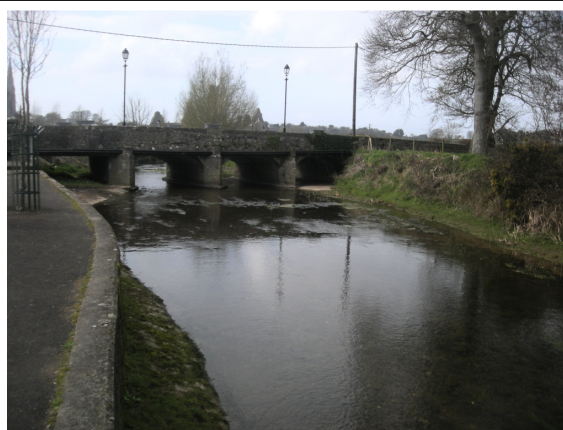
Photo 2: 4 Arch bridge at the u/s end of town

2.3 Local knowledge - on-site comments (OPW, LA and any info volunteered by local residents during visit)	No on site comments			
2.4 Comments on hydraulic constrictions (bridges, etc.) and conveyance routes	There are three main bridges. These become more restrictive as the river flows downstream. One arch on the 5-arch bridge (at the downstream end of the town) is blocked with soil. River / streams at the bottom of the valley have limited flat areas, and no clear alternative conveyance routes.

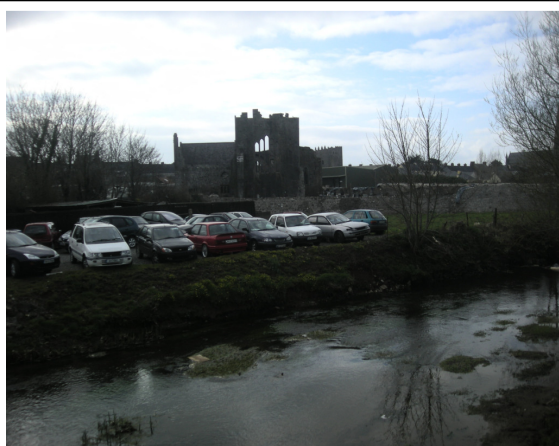
Photo 3: Abbey relatively high on flood plain

2.2 Spot check ground-truthing of selected receptor vulnerability (also note any key receptors noted during visit that are not identified by PFRA)	Receptor Type	Location description (if not obvious)	Exists?	Overall Vulnerability / Risk (L / M / H)
	Abbey		Y	M - Potential for flood in area, but the Abbey itself is raised slightly
	School		Y	L - High up, not in flood plain
	WWTP x 2		Y	H
	New Fire Station constructed		Y	H

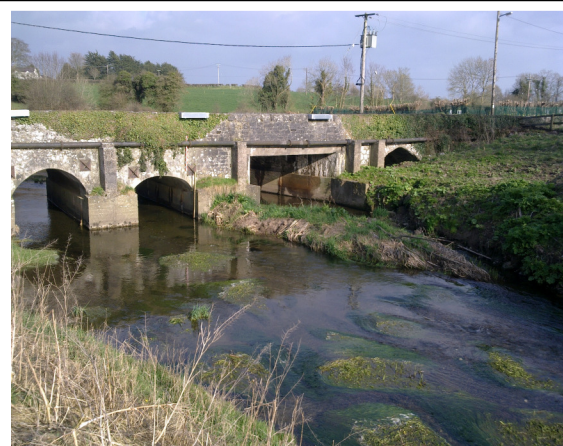
Photo 4: 5 Arch bridge at d/s end of town with one arch blocked by soil
