Location: Athleague, Co. Roscommon		Unique ID: 265481 (from PFRA database)	
Initial OPW Designation	APSR <input type="checkbox"/>	AFRR <input checked="" type="checkbox"/>	IRR <input type="checkbox"/>
Co-ordinates	Easting: 182846	Northing: 257436	
River / Catchment / Sub-catchment	Suck / Shannon		
Type of Flooding / Flood Risk (identify all that apply)	Fluvial non-tidal <input checked="" type="checkbox"/> Fluvial tidal <input type="checkbox"/> Coastal <input type="checkbox"/>

Stage 2: Site Inspection		Level A Assessment		
Date and Time of Inspection		Date: 11/05/11		
		Time: 17:00		
Names of inspection team (including OPW/LA staff if present)		Peter Smyth		
		James Murray

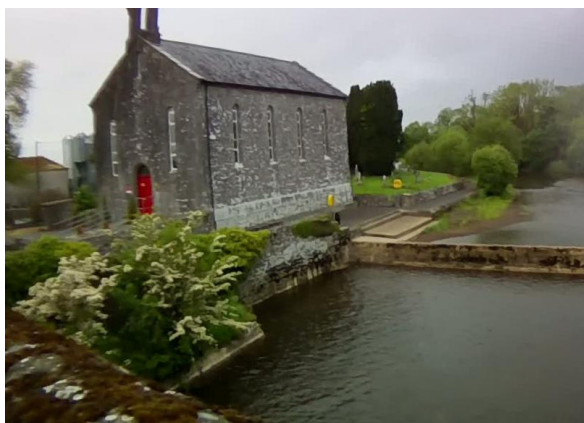
Photo1: Right bank upstream of bridge in Athleague.

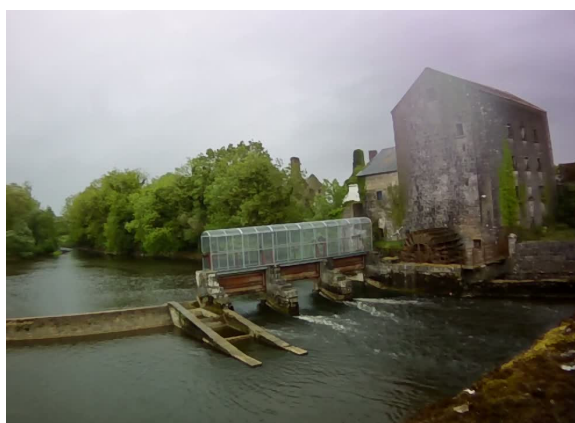
2.3 Local knowledge - on-site comments (OPW, LA and any info volunteered by local residents during visit)	No on-site comments.			
2.4 Comments on hydraulic constrictions (bridges, etc.) and conveyance routes	The bridge over the Suck at Athleague has 4 arches and two relief arches. There is a weir and sluices upstream of the bridge. There is also an inoperable mill wheel on the left bank just upstream of the bridge.

Photo 2: Sluice gates upstream of bridge in Athleague.

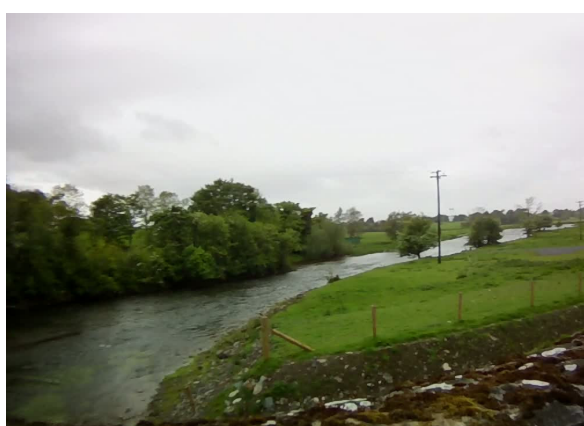
Photo 3: River Suck downstream of Bridge in Athleague.

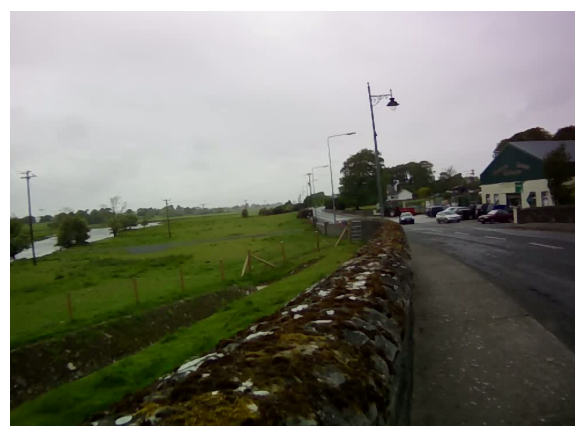
2.2 Spot check ground-truthing of selected receptor vulnerability (also note any key receptors noted during visit that are not identified by PFRA)	Receptor Type	Location description (if not obvious)	Exists?	Overall Vulnerability / Risk (L / M / H)
	Properties	Left bank	Yes	High
	Retail	Right bank	Yes	High

Photo 4: Properties on right bank of River Suck downstream of bridge, potentially at risk.
