Location: Athleague, Co. Roscommon		Unique ID: 265481 (from PFRA database)	
Initial OPW Designation	APSR <input type="checkbox"/>	AFRR <input checked="" type="checkbox"/>	IRR <input type="checkbox"/>
Co-ordinates	Easting: 182846	Northing: 257436	
River / Catchment / Sub-catchment	Suck / Shannon		
Type of Flooding / Flood Risk (identify all that apply)	Fluvial non-tidal <input checked="" type="checkbox"/> Fluvial tidal <input type="checkbox"/> Coastal <input type="checkbox"/>

Stage 2: Site Inspection		Level A Assessment		
Date and Time of Inspection		Date: 11/05/11		
		Time: 17:00		
Names of inspection team (including OPW/LA staff if present)		Peter Smyth		
		James Murray

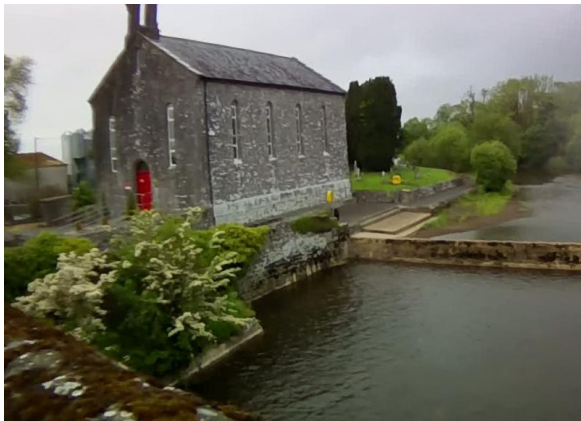
Photo 1: Right bank upstream of bridge in Athleague.

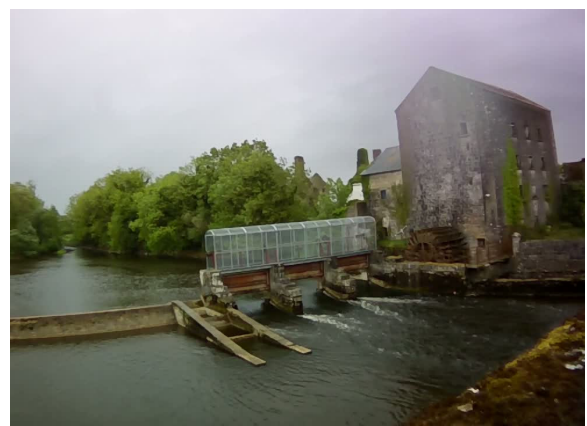
2.3 Local knowledge - on-site comments (OPW, LA and any info volunteered by local residents during visit)	No on-site comments.			
2.4 Comments on hydraulic constrictions (bridges, etc.) and conveyance routes	The bridge over the Suck at Athleague has 4 arches and two relief arches. There is a weir and sluices upstream of the bridge. There is also an inoperable mill wheel on the left bank just upstream of the bridge.

Photo 2: Sluice gates upstream of bridge in Athleague.

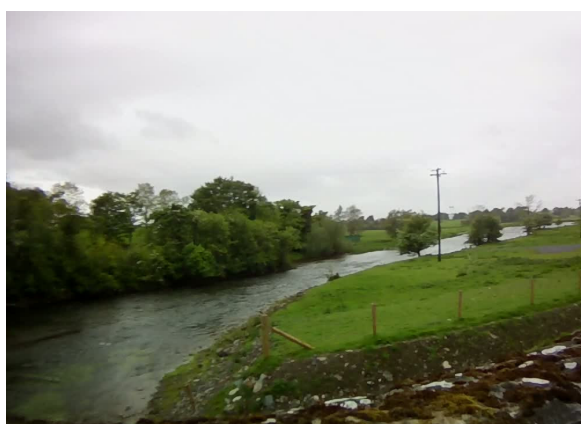
Photo 3: River Suck downstream of Bridge in Athleague.

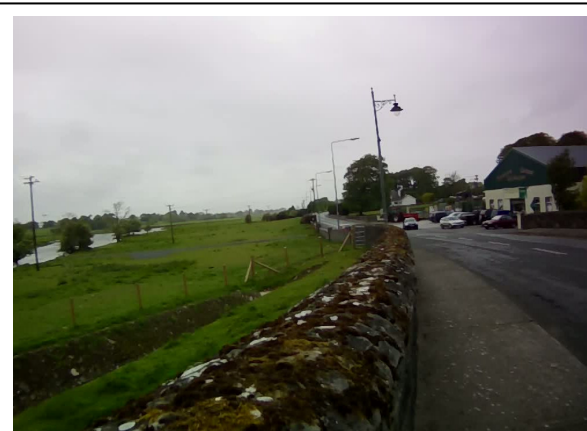
2.2 Spot check ground-truthing of selected receptor vulnerability (also note any key receptors noted during visit that are not identified by PFRA)	Receptor Type	Location description (if not obvious)	Exists?	Overall Vulnerability / Risk (L / M / H)
	Properties	Left bank	Yes	High
	Retail	Right bank	Yes	High

Photo 4: Properties on right bank of River Suck downstream of bridge, potentially at risk.
