Location: Longford, Co. Longford		Unique ID: 260464 (from PFRA database)	
Initial OPW Designation	APSR <input checked="" type="checkbox"/>	AFRR <input type="checkbox"/>	IRR <input type="checkbox"/>
Co-ordinates	Easting: 213,853	Northing: 274,765	
River / Catchment / Sub-catchment	Camlin River / River Shannon		
Type of Flooding / Flood Risk (identify all that apply)	Fluvial non-tidal <input checked="" type="checkbox"/> Fluvial tidal <input type="checkbox"/> Coastal <input type="checkbox"/>

Stage 2: Site Inspection		Level B Assessment	
Date and Time of Inspection		Date: 18/05/11	
		Time: 13:00	
Names of inspection team (including OPW/LA staff if present)		Alan Dew	
		James Murray

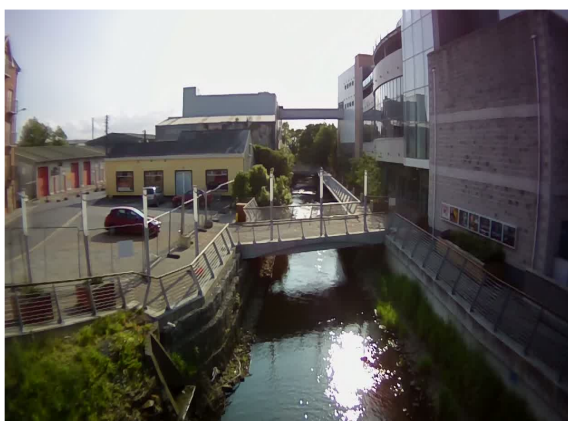
Photo 1: River Camlin viewed from the R198 road bridge, looking downstream, with the recent cinema development on the right bank.

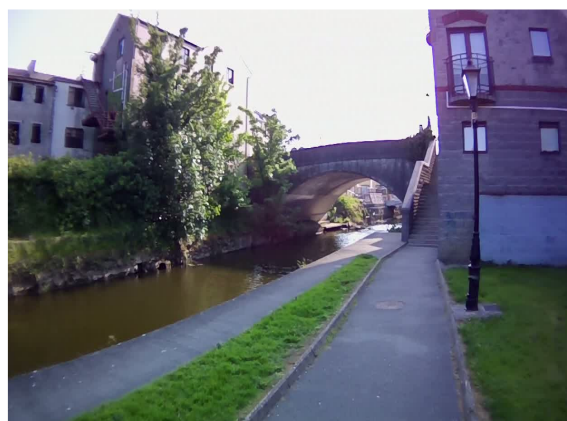
Photo 2: R198 road bridge over the River Camlin, viewed from the upstream right bank.

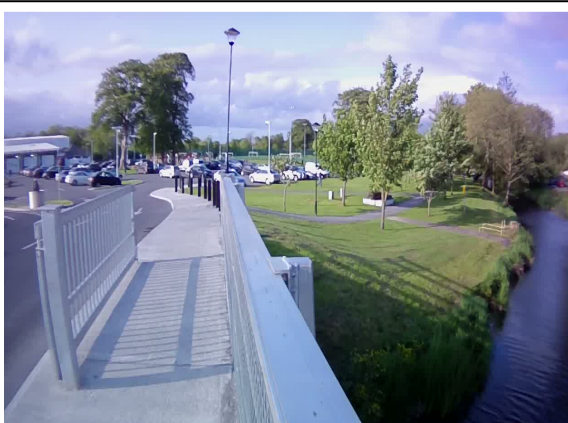
Photo 3: Access bridge over the River Camlin for the leisure centre, looking towards the upstream right bank.

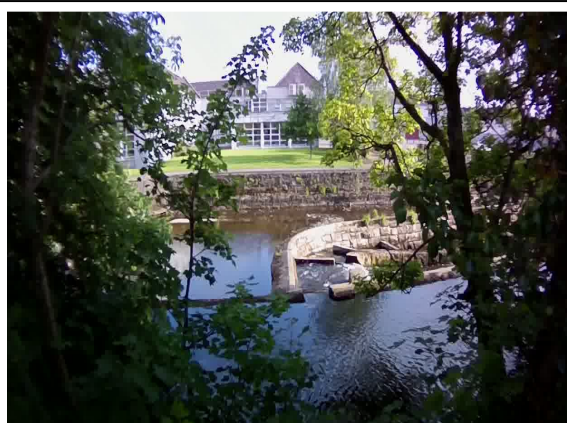
Photo 4: Weir on the River Camlin, viewed from the right bank, with Longford CoCo's offices at the rear on the left bank.
